NOREASTER DISASTER RESTORATION, LLC

Property Owner: xxx xxxxx xxxxxx, xxx Berndt Dr, Attleboro, MA 02703

Taken: 4/7/2014

CONCLUSION & COMMENTS

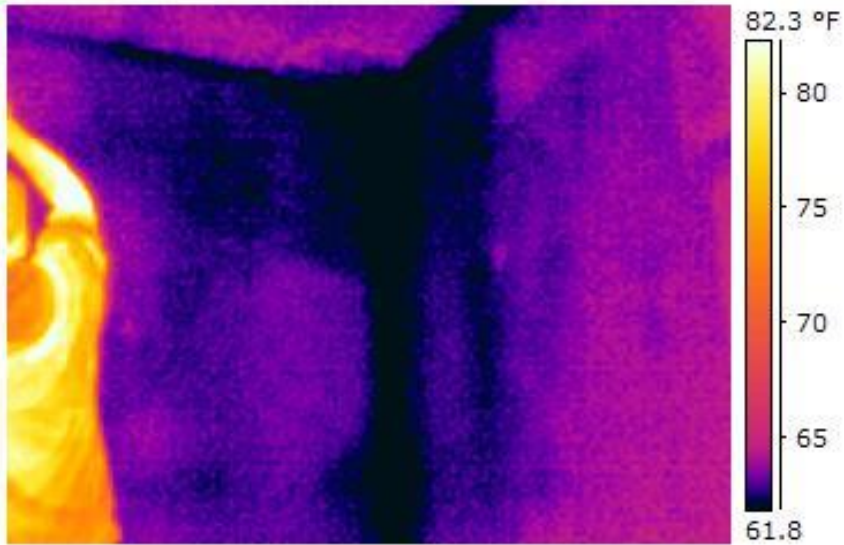
1)

Water from baseboard hot water pipe in the bedroom above heavily saturated a first floor bedroom. Infrared shows the general water migration paths, close to four feet wide or more each of two walls.

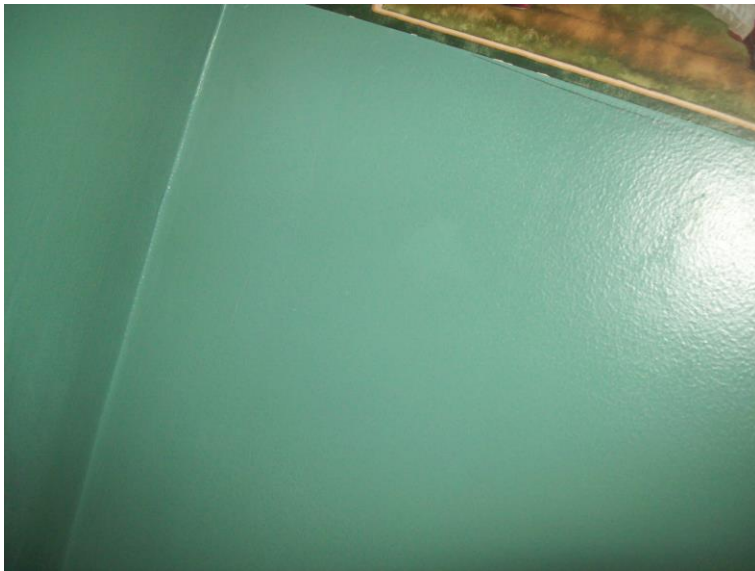
3)

Though the loss was a week ago, very saturated drywall (maximum moisture meter readings) and both sides of plastic vapor barrier are wet – pulled insulation in that zone.

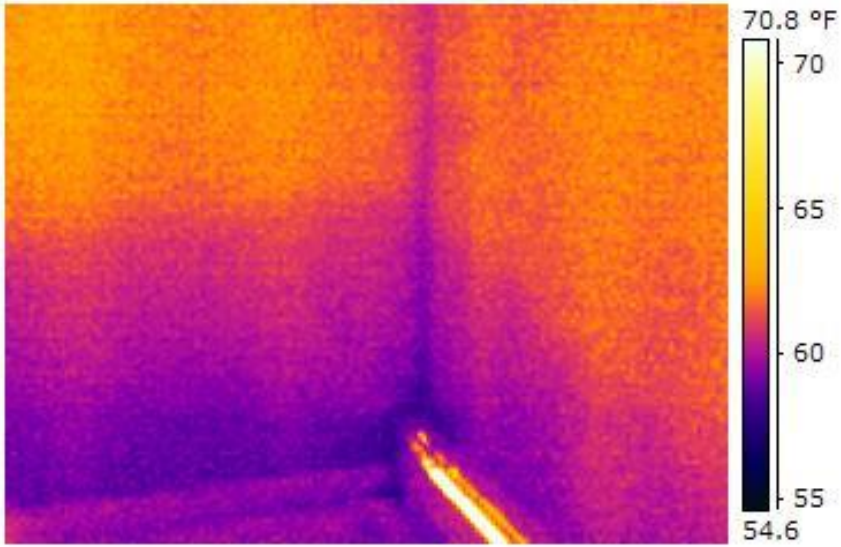
5) The lower portion of the same bedroom wall with heat turned on.

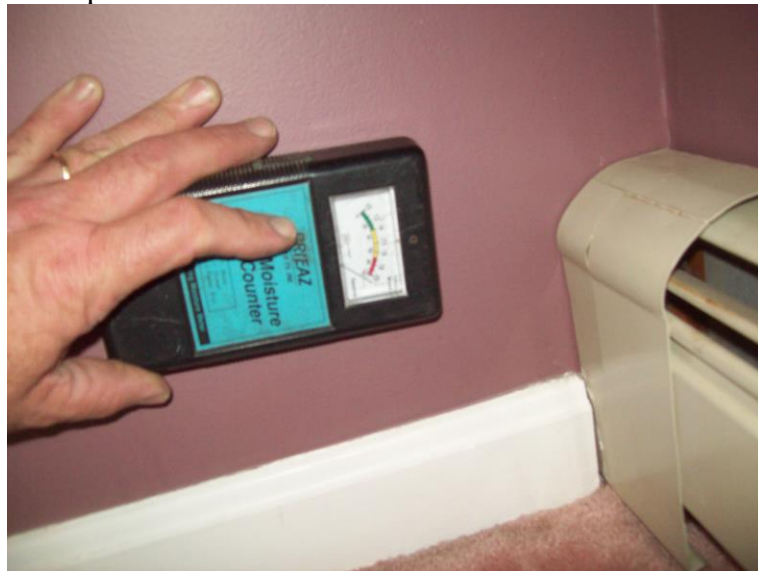
7)

**#7 Is the bedroom where the water leak started; drywall is wet, but the subfloor is dry at this time. Jetting air into the walls in the bedroom.
#8 is the garage ceiling and wall area, where we will also jet in dry air. This will allow for very minimal drywall repairs in these two zones.**
