1912 Pound Hill Road, North Smithfield, RI 02896 Phone (401) 229-2600 NDRCPR.COM Property Owner: XXXXX XXXXX – for Narragansett Property Mgt Taken: 1/29 thru 2/3/2014

Photos 1 through 4 are the home at XXX Meadowrue Trail and close-ups of the exterior in the area of the interior pipe break.

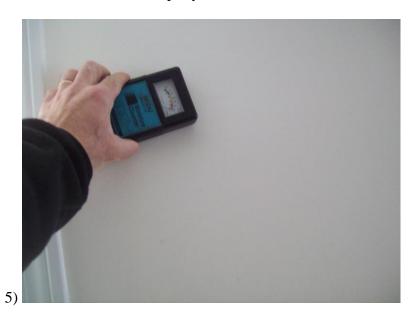
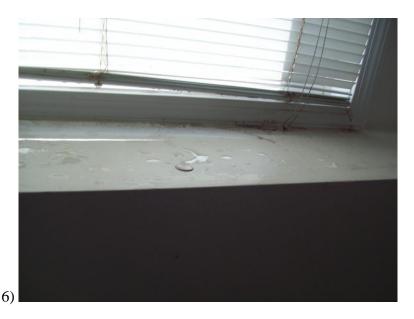
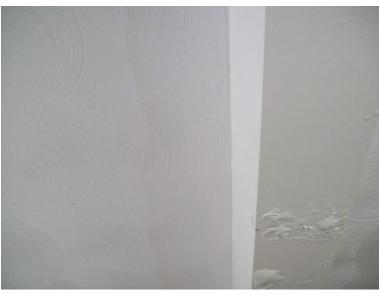
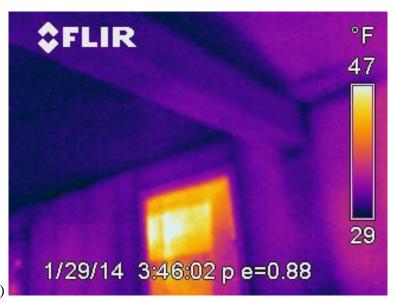
These digital and thermal images were obtained in the bottom floor bedroom of the raised ranch home immediately below the pipe break.

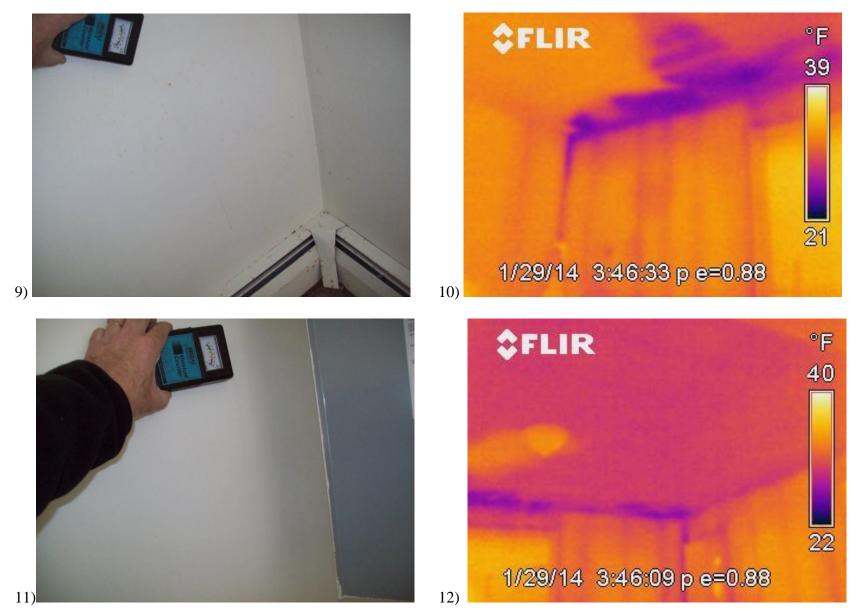
These images are also the common wall and common corner below the top floor pipe break.

More basement bedroom images – the staining in image 13 is from the main carrier beam where leaking water turned dark brown and flowed down to the carpet.

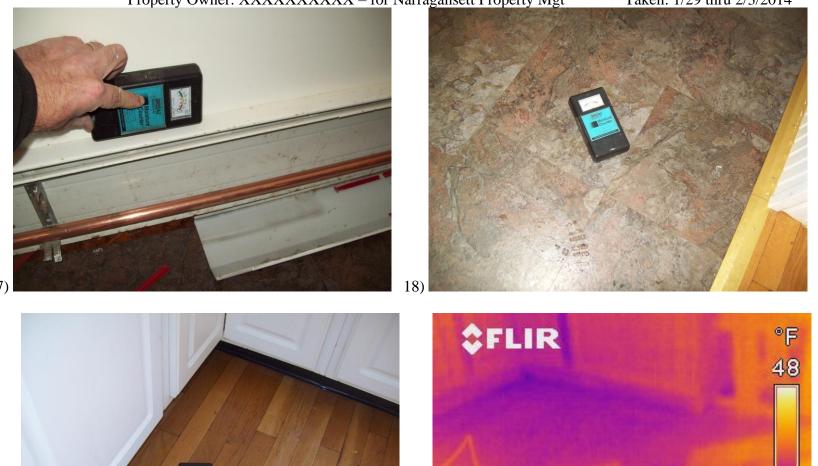
Top floor images- #17 is right at the frozen pipe repair zone. The remaining photos and images show flooring damage.

First floor pipe break that affected first floor flooring with a lot of additional damage to the basement bedroom below it. Water is actually flowing through the outside walls of the house.

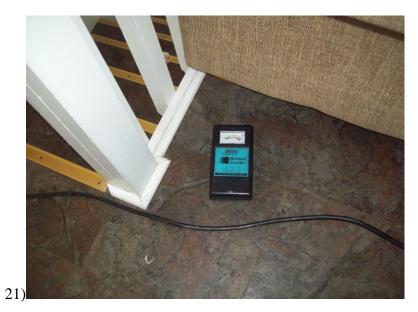
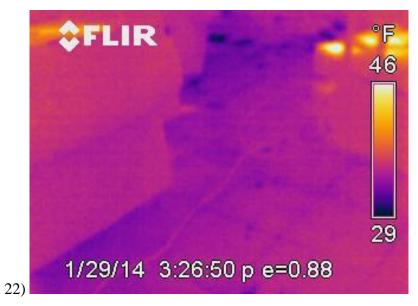
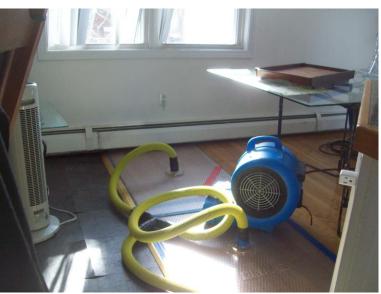
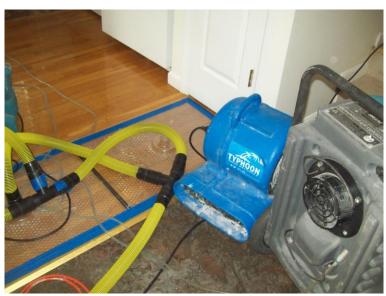
More first floor damage/moisture mapping and drying technique photos

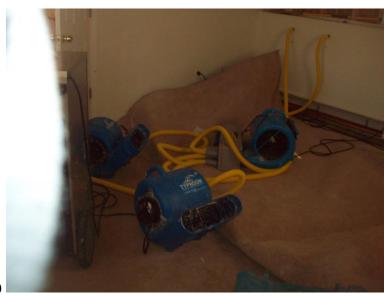
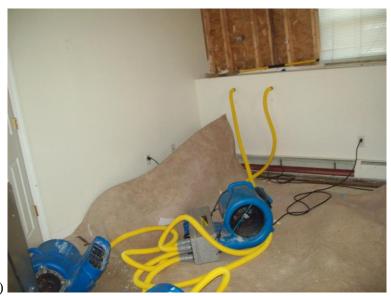
Basement wall and carpet dryout – We will not be able to save the carpet due to heavy saturation and stains previously mentioned.
