# NOREASTER DISASTER RESTORATION, LLC

Property Owner: XXX XXXX XXXXXXXXXXXX, North Smithfield, RI 02896

Taken: 6/1/2014

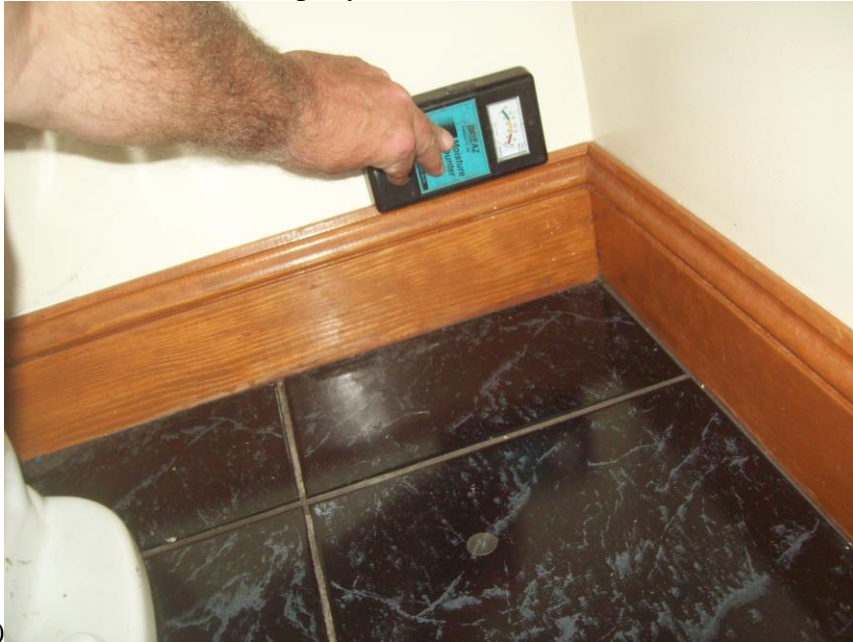
1) Second floor bathroom about two feet from the cold water toilet feed line.

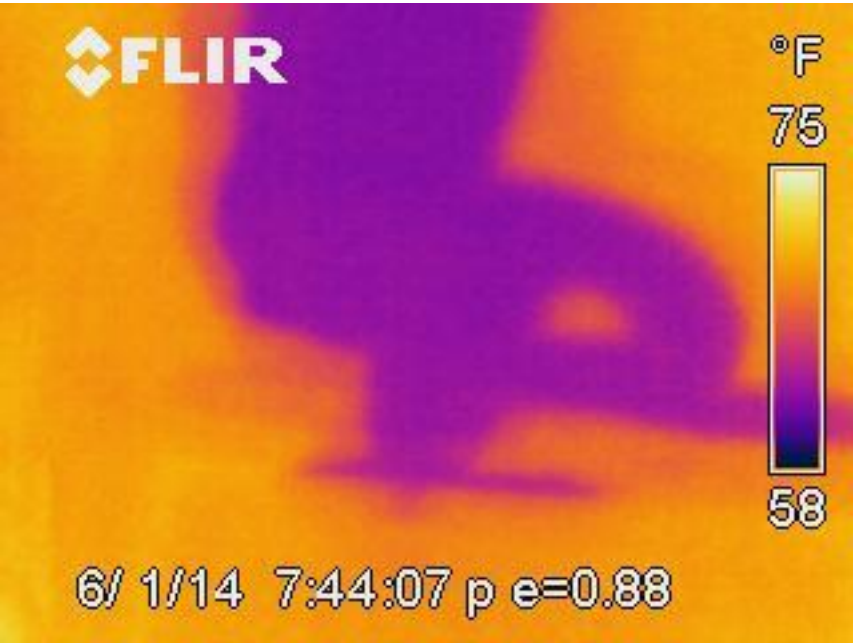
3) Water from the ceiling absorbed in the wall below the toilet and then migrated across the ceiling into the wall common to the staircase.

We believe the floor and the walls in the dining room will respond to the drying techniques - simple patching of drying access holes in the walls and sand/refinish the floor, which extends continuously to the adjacent hall and office area.
