1912 Pound Hill Road, North Smithfield, RI 02896 Phone (401) 229-2600 NDRCPR.COM Property Owner: xxxx xxxx xxxxx xxxxx xxxx Court, North Smithfield, RI Taken: 2/11/2015 and 2/16/2015

Stairway landing area at xxxxxxxx Court, North Smithfield

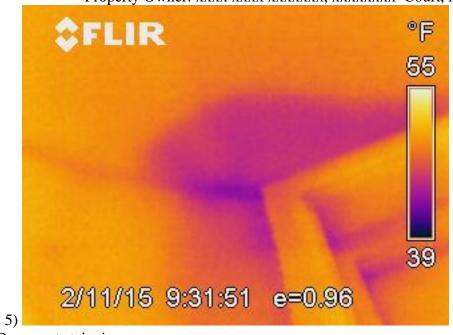
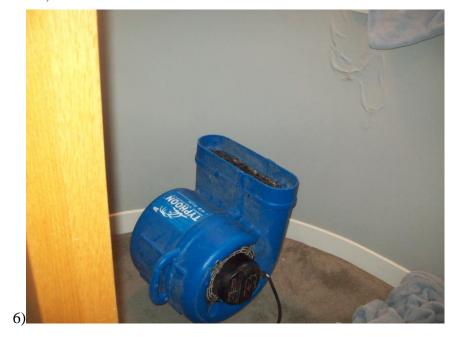
Basement stairs images

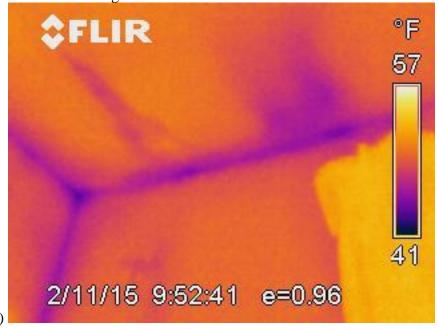
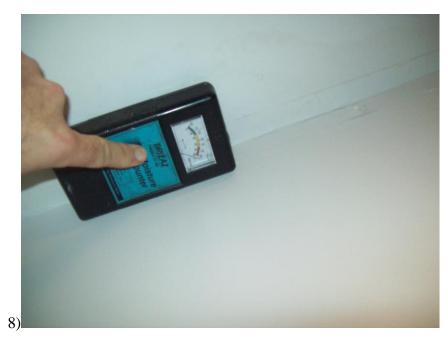
Master bathroom images

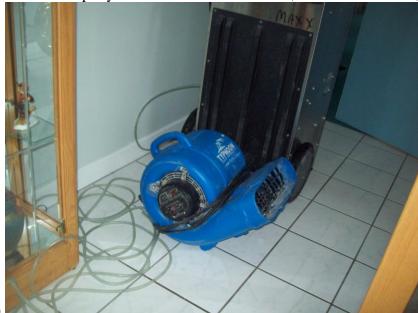
Equipment at setup – part of what was used to dehumidify both the Basement and first floor landing and upward of that

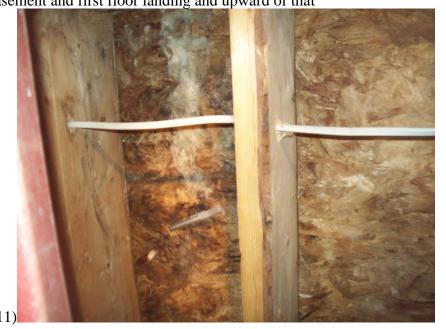
This is accumulated ice on 2/15 when we went to remove the last of the drying equipment. We still have Phoenix Maxx and two fans due to this.

Loss called in to Noreaster at February 10, 2015, and we serviced the loss beginning February 11th. We did very limited demo at the onset, simply doing minimal wall openings. We were advised of the dry rot by the general contractor later, and upon scheduling the equipment pickup on 2/15, found even more water entering, actually frozen to the wall after the 10 to 12 inch storm on Feb 14-15<sup>th</sup>.

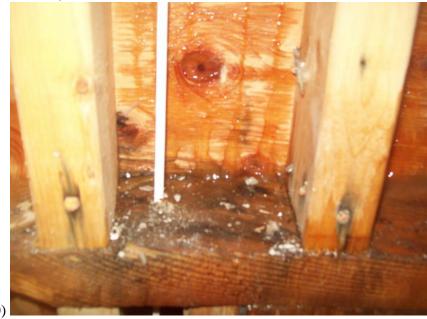
This dry rot is due to some other condition on the property that was hidden, and not realized until the tear out. I pushed a pen through the wall with ease.
