ADVOCATE DESIGN/BUILD & CONSTRUCTION, LLC

Service Start Date: 3/30/22

Service Address: xx xxxxxx Road, Smithfield, RI 02917

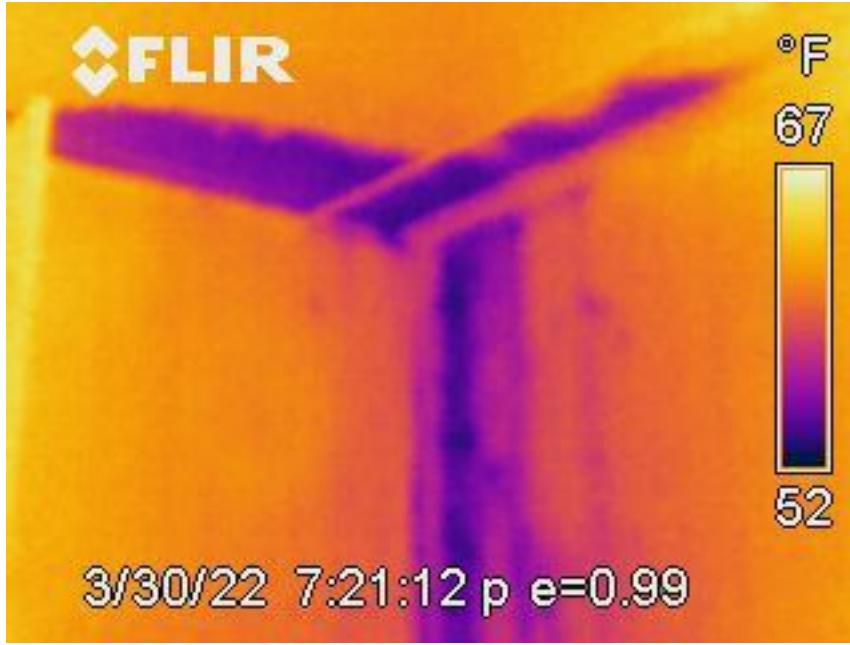
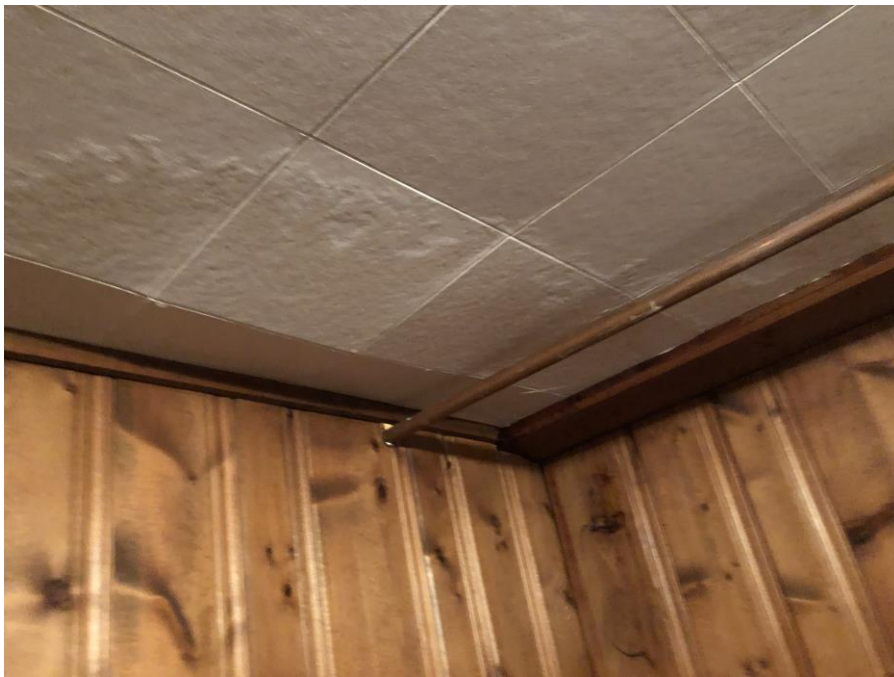
Customer found wet carpet in basement and saw water (still dripping down) to walls from above the acoustic ceiling.

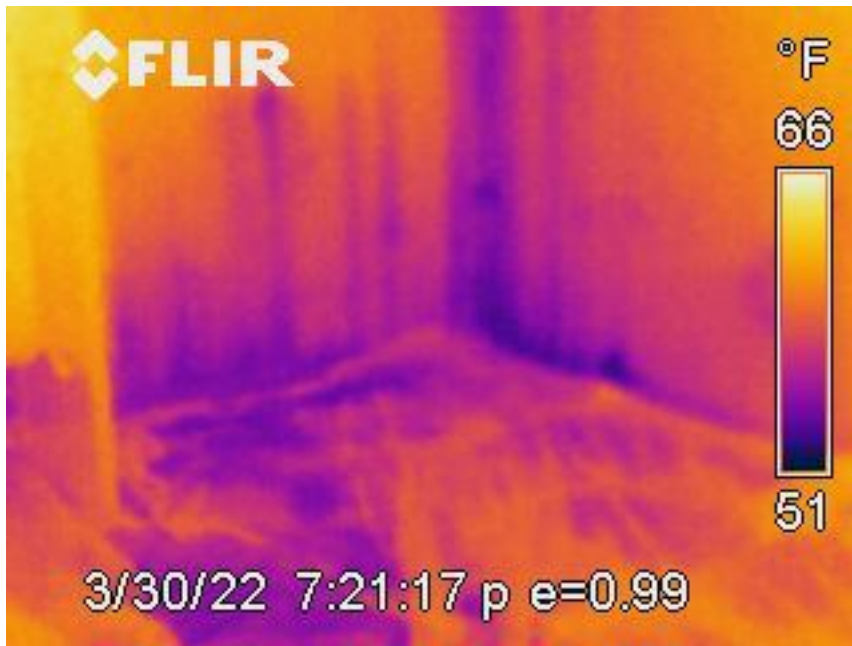
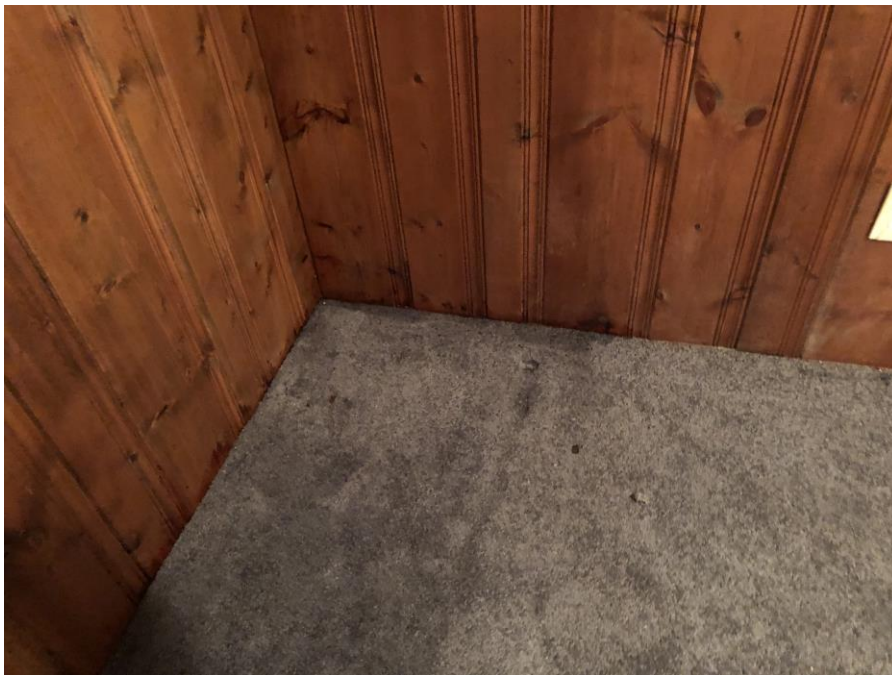
Heavy amount of accumulated water absorbed into wall framing plate and knotty pine walls as well as carpet and pad.

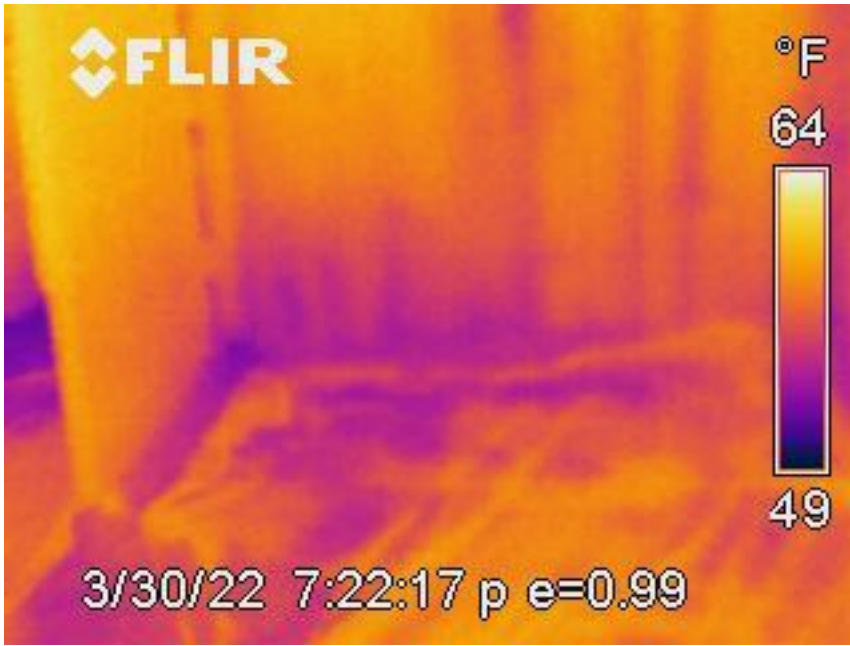
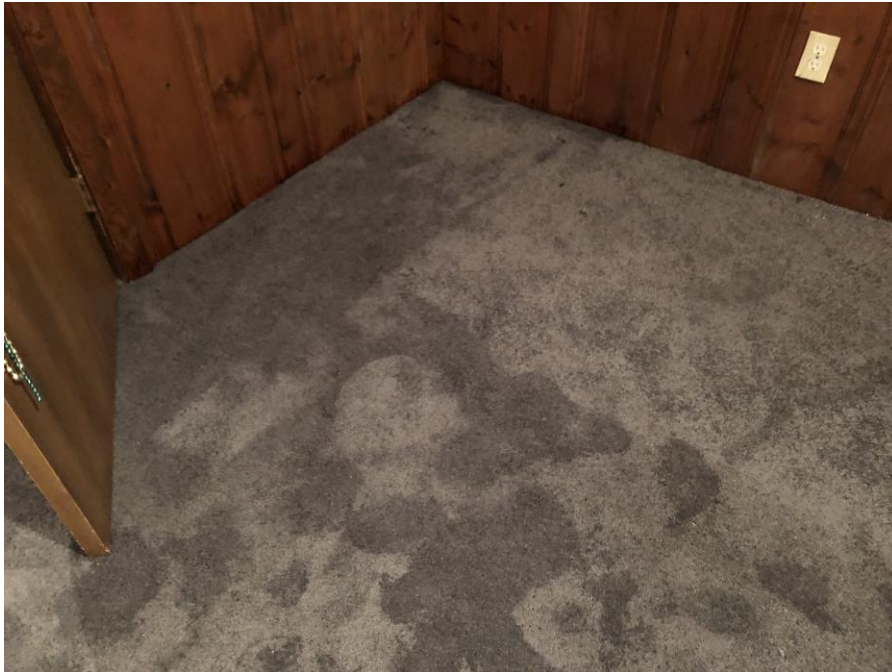
More carpet and wall images

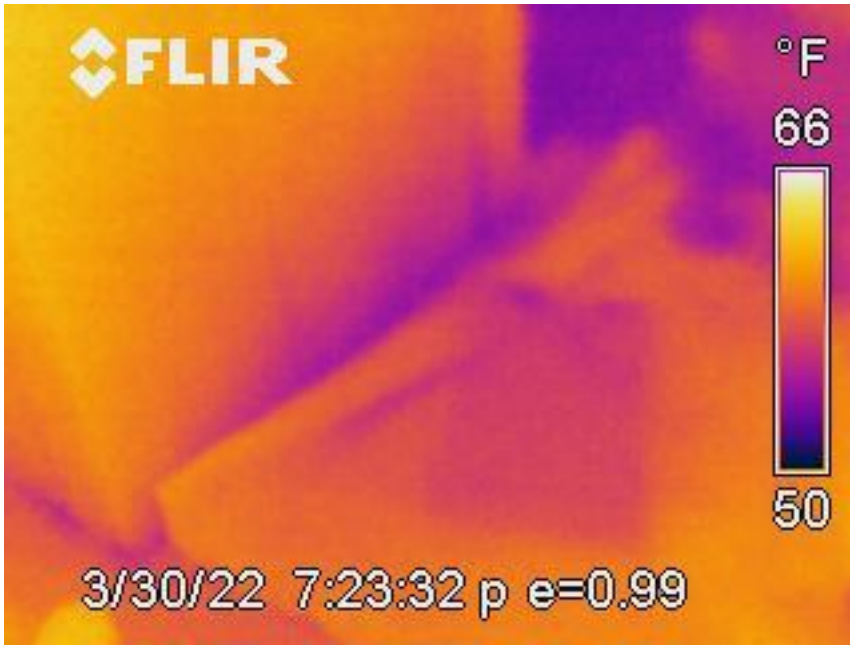
11)

Last basement image at emergency response to site.

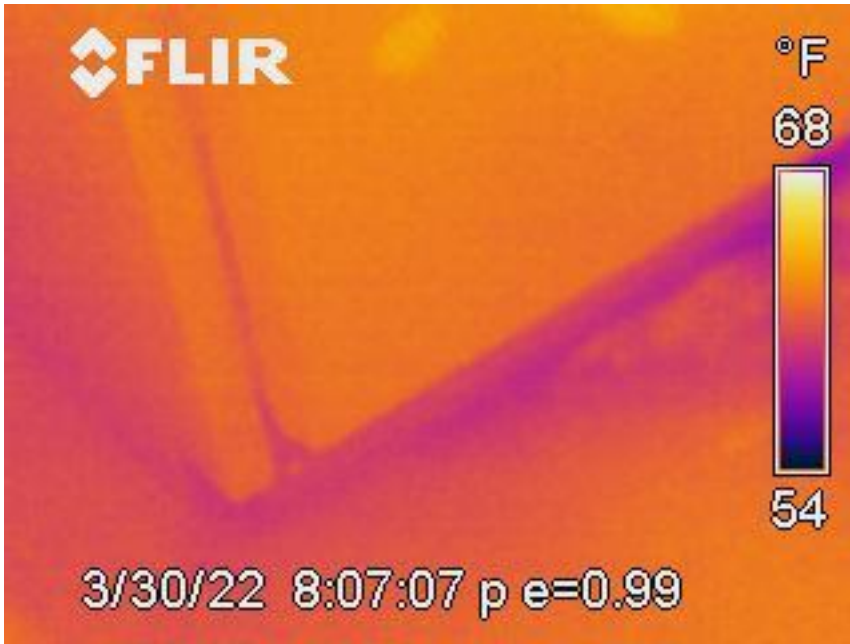
12)

#12) Kitchen image at emergency response
#13) Hardwood floor drying equipment 3/31/2022

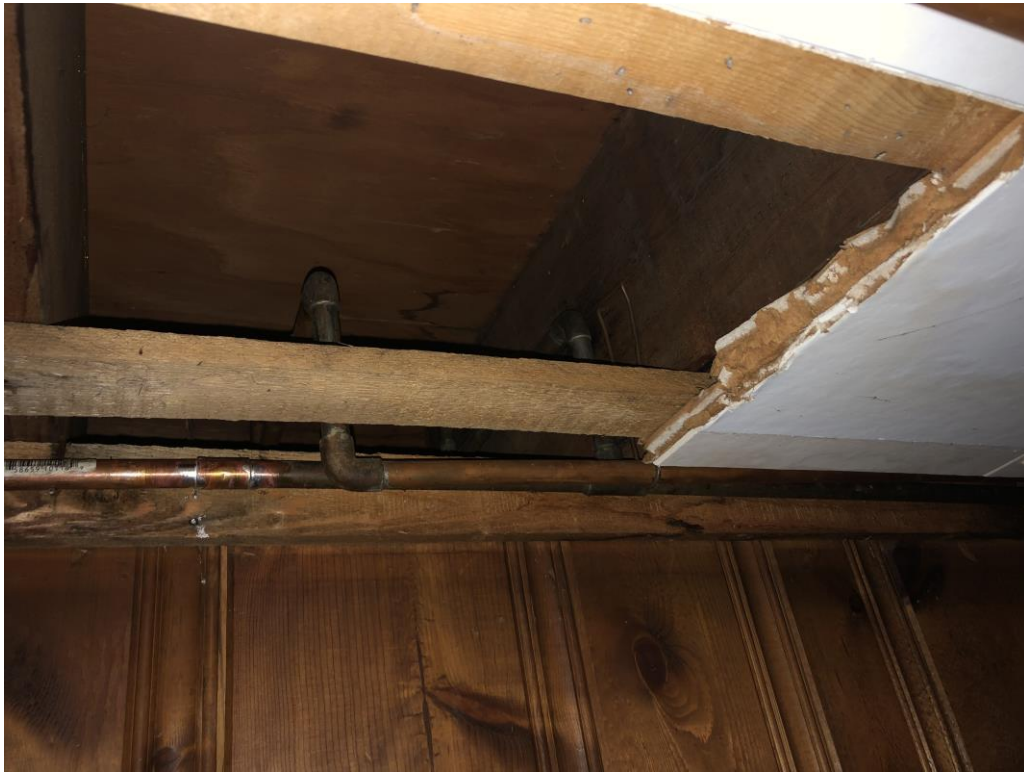
16)

Per homeowner's plumber, kitchen main feed had a leak. Lines only capped at the time of our monitoring visit 3/31/2022.

As per caption under image 16, plumber found the leak. Insured's shut off the water main upon finding the standing water, Advocate responded that evening.
