NOREASTER DISASTER RESTORATION, LLC

Property Owner: xxxxxx xxxxxxxx, xx Cider Mill Ln, Lincoln, RI Taken: 2/16/2015 *supplemented 2/23/15

CONCLUSION & COMMENTS

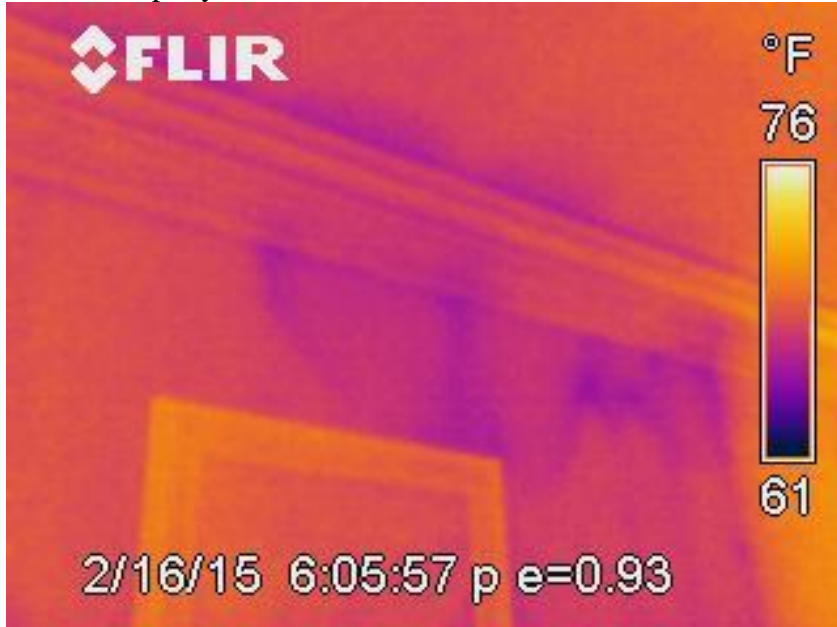
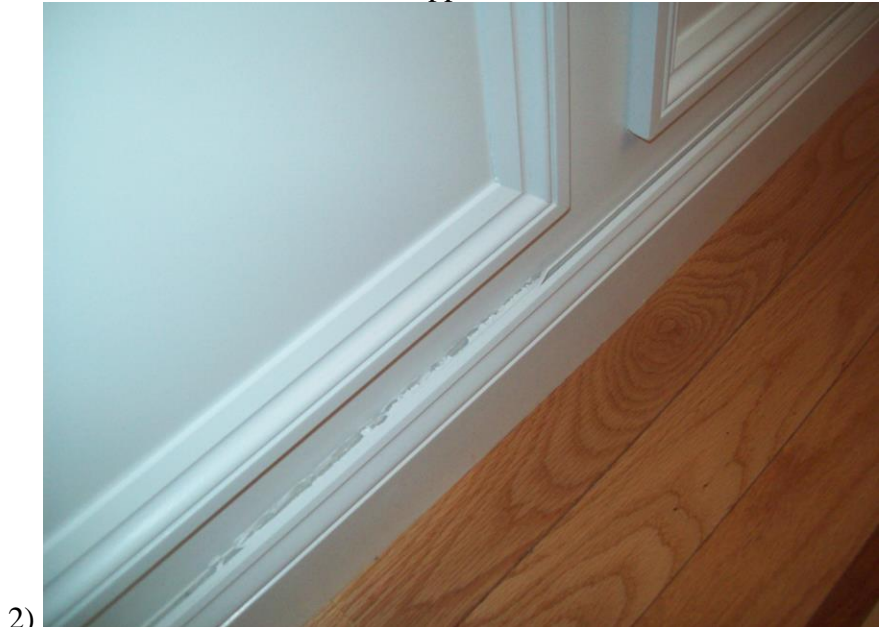
1) Water in the dining room extends from the ceiling level down through the Judges Paneling, and into the inlaid floor

Inside the garage at xx Cider Mill Lane – water is descending to the sill plate below it, and is entering into the dining room; those images are #1-4 shown on first page of this report.

On 2/19, floor area was equalized in the breakfast nook and the Dri-Eaz Rescue Mat System was moved to the formal dining room (See images 1-4 and new images 11 & 12)

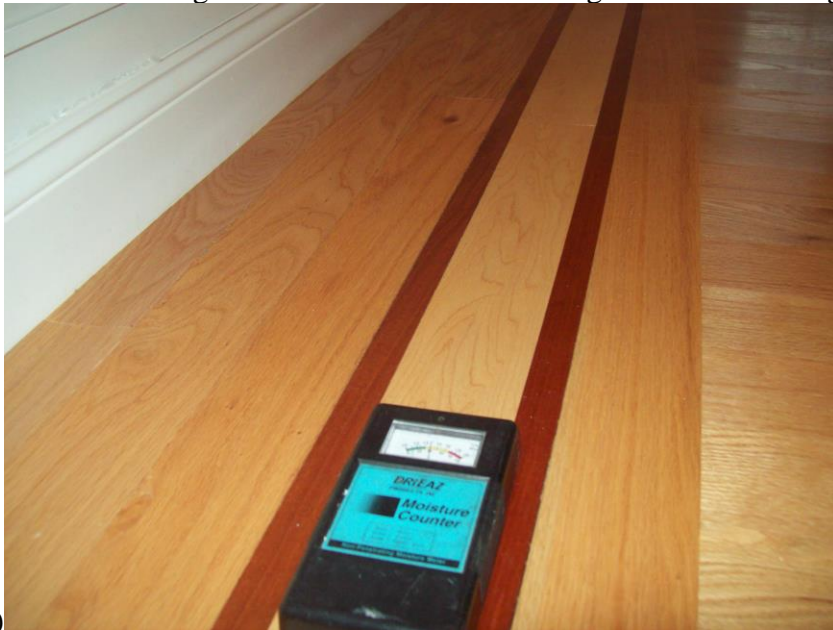
3) Note minor cupping right of inlay, but heavier cupping against paneling.

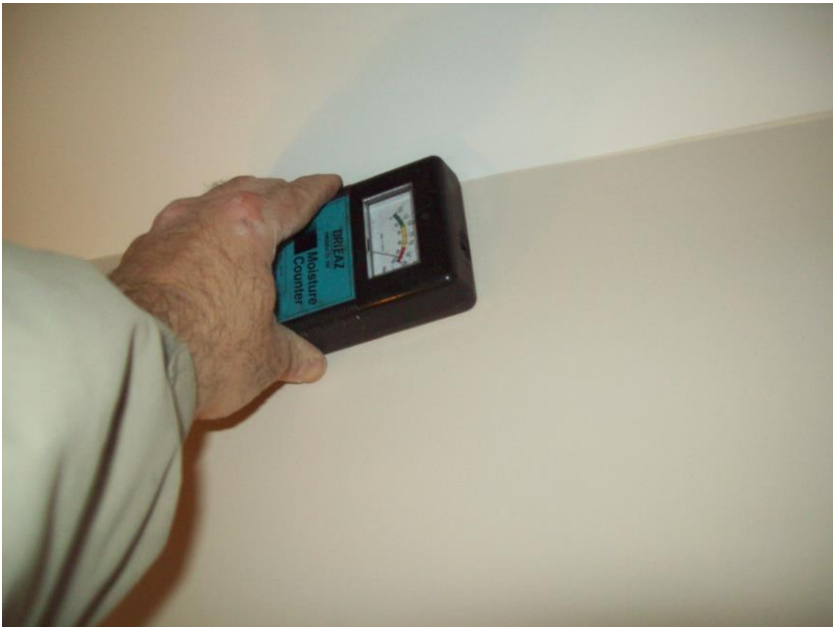
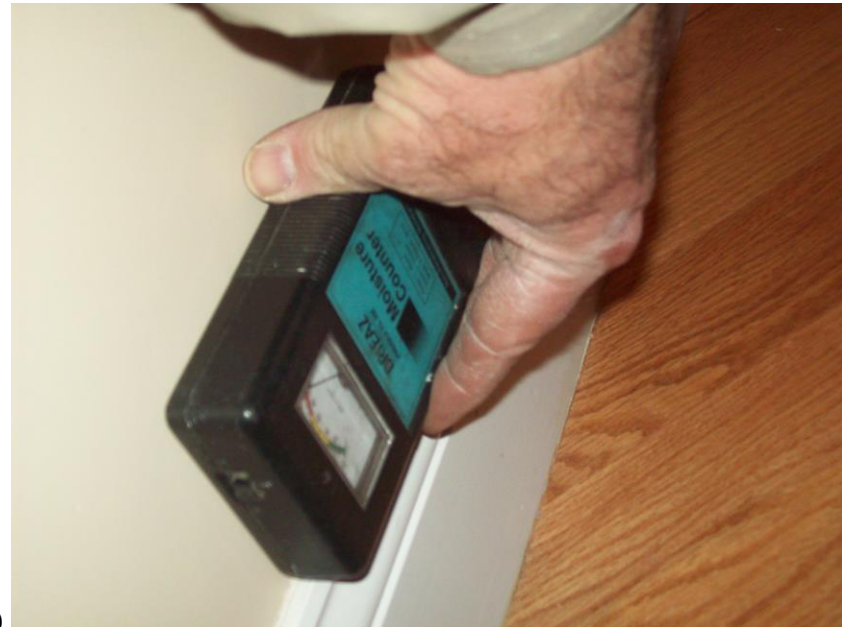
Living room extended off the kitchen area – flooring and walls are wet

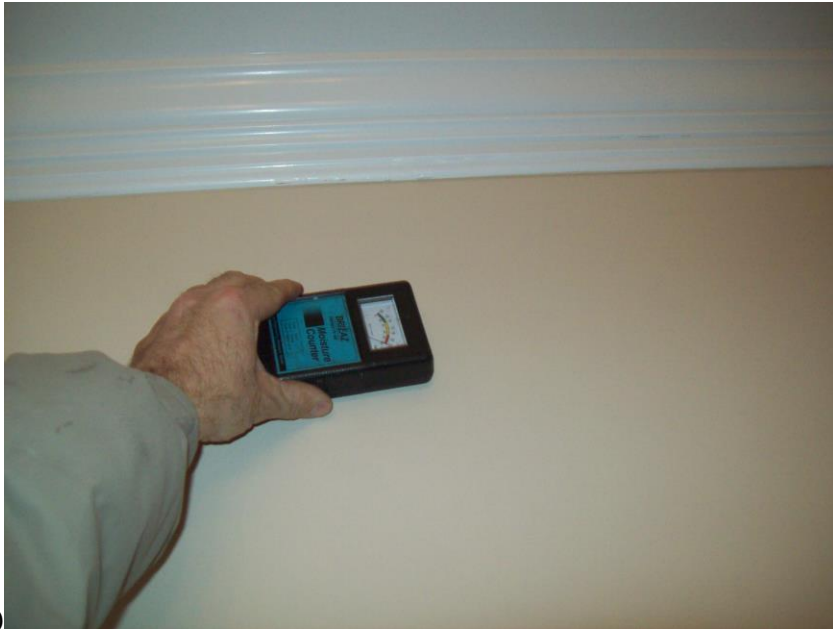
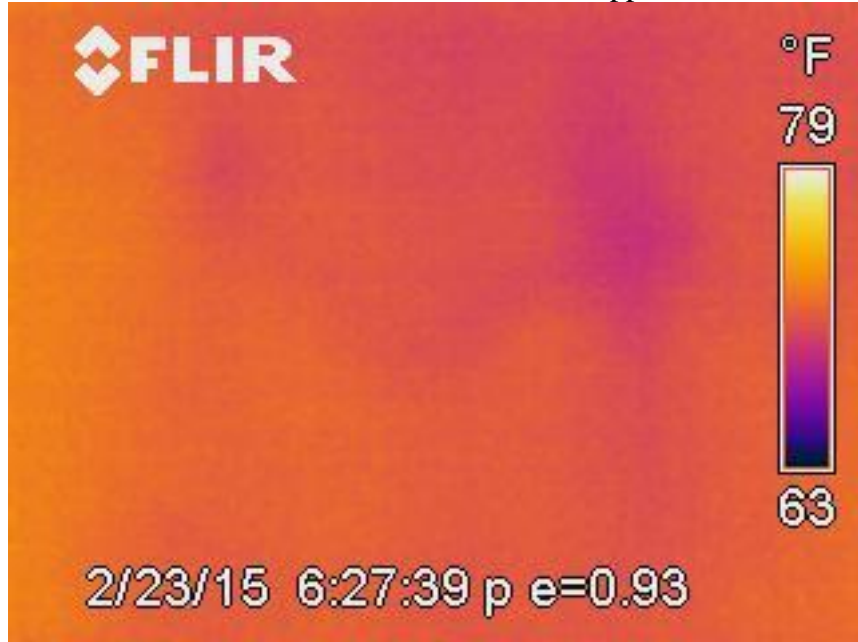
Dining room ceiling still has trace moisture following a wall stud. Four 2" holes being drilled to allow positive negative air flow to that cavity. That same operation will occur in the breakfast nook off the kitchen*****

On 2/23, all equipment was removed from main living areas in favor of ambient drying and positive/negative air flow drying with the insured's forced hot air system being able to penetrate holes. **HOWEVER, THE GARAGE IS STILL WET AND HOLDING INSULATION.**

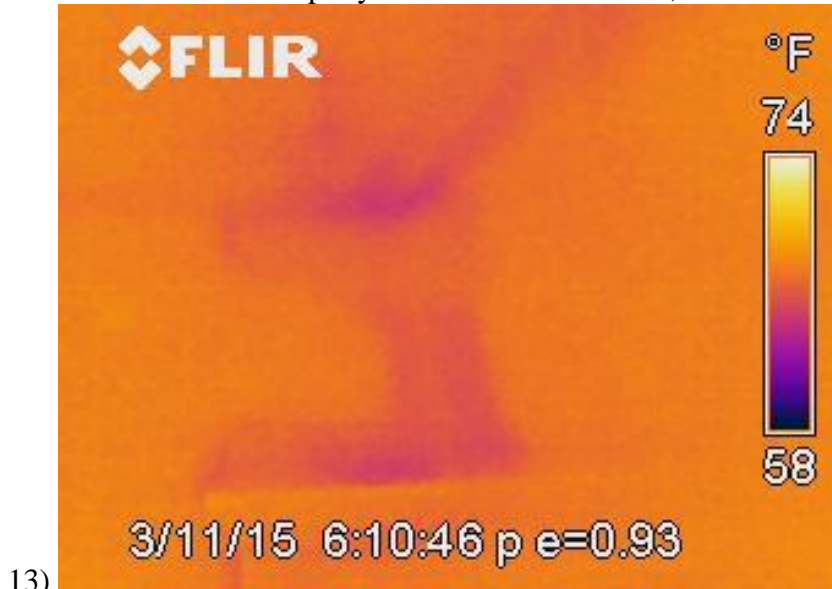
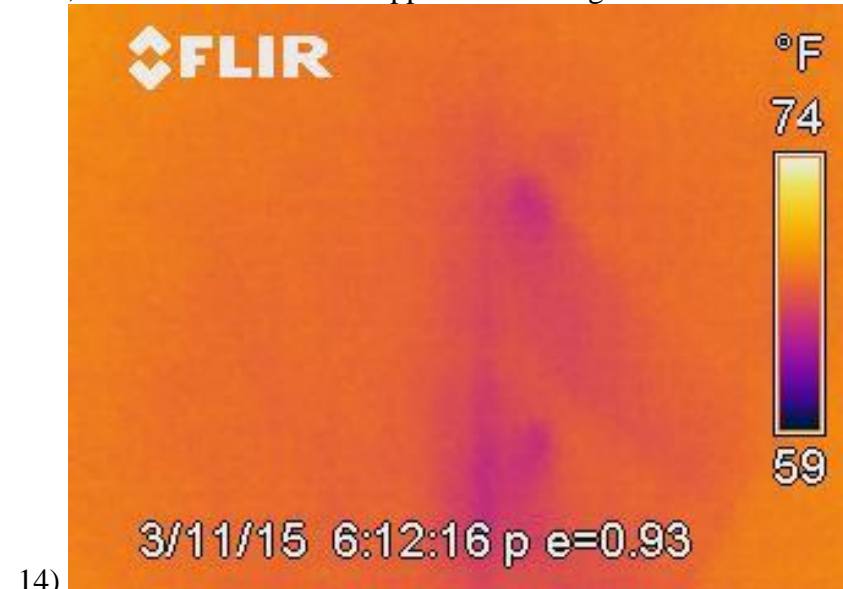
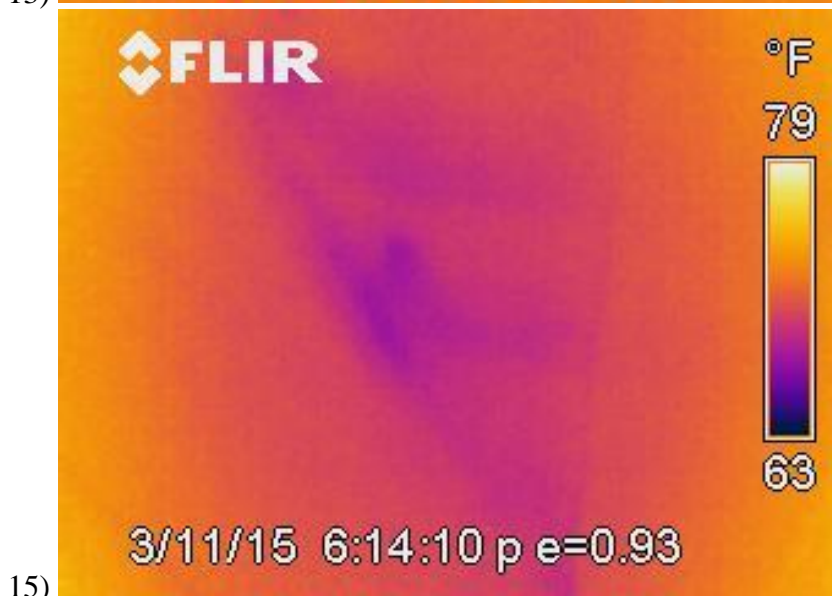
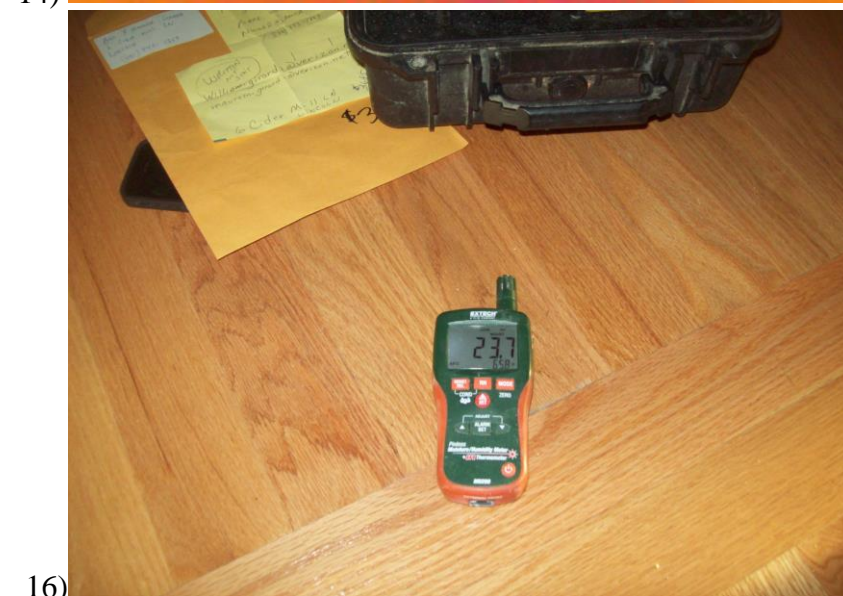
THERMAL IMAGES 13-15 SHOW EITHER A NEWER OR LARGER LEAK IN THE SAME VALLEY OF THE HOME AT XX CIDER MILL LANE IN LINCOLN. CLEARLY THIS IS A VALLEY LEAK IN THIS TWO YEAR OLD HOME. IMAGE 14 SHOWS COLD WATER PENETRATION ABOUT 10 FEET UP THE VALLEY OF THE REAR SLOPE OF THIS ROOF FROM THE INSIDE. IMAGE 16 SHOWS VERY HEAVY WATER PENETRATION INTO THE FLOOR THOUGH THE FLOOR HAD APPEARED DRY IN THIS LOCATION. IN FACT WE HAD REMOVED THE RESCUE MAT SYSTEM FROM HERE AND PLACED IT IN THE DINING ROOM AREA THE DAY THE AMICA FIELD REPRESENTATIVE xxxxxx xxxxxxxx ARRIVED AT THE HOUSE FOR HIS ORIGINAL INSPECTION APPRAISAL.

INTERIM REPORT III 3/16/15 THERMAL IMAGES 13-15 SHOW EITHER A NEWER OR LARGER LEAK IN THE SAME VALLEY OF THE HOME AT xxx CIDER MILL LANE IN LINCOLN. CLEARLY THIS IS A VALLEY LEAK IN THIS TWO YEAR OLD HOME. IMAGE 14 SHOWS COLD WATER PENETRATION ABOUT 10 FEET UP THE VALLEY OF THE REAR SLOPE OF THIS ROOF FROM THE INSIDE. IMAGE 16 SHOWS VERY HEAVY WATER PENETRATION INTO THE FLOOR THOUGH THE FLOOR HAD APPEARED DRY IN THIS LOCATION. IN FACT WE HAD REMOVED THE RESCUE MAT SYSTEM FROM HERE AND PLACED IT IN THE DINING ROOM AREA THE DAY THE AMICA FIELD REPRESENTATIVE xxx xxx xxxxx ARRIVED AT THE HOUSE FOR HIS ORIGINAL INSPECTION APPRAISAL.
