ADVOCATE DESIGN/BUILD & CONSTRUCTION, LLC

Owner: XXXX XX XXXX, XXXX Mendon Road #XXX, Cumberland, RI 02864

Service Start Date: 2/20/2021

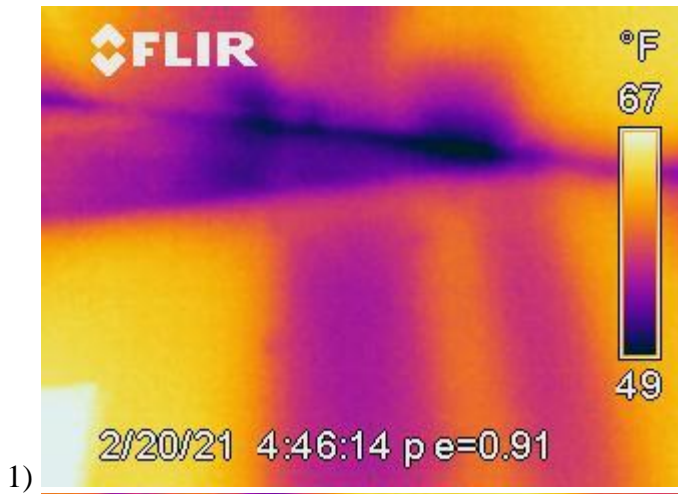
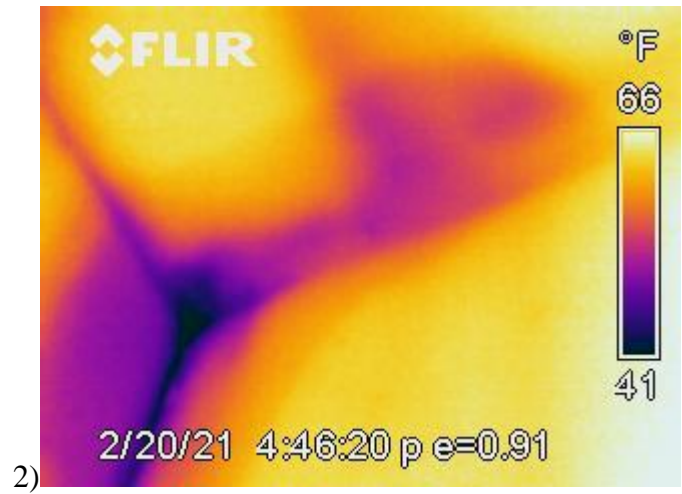
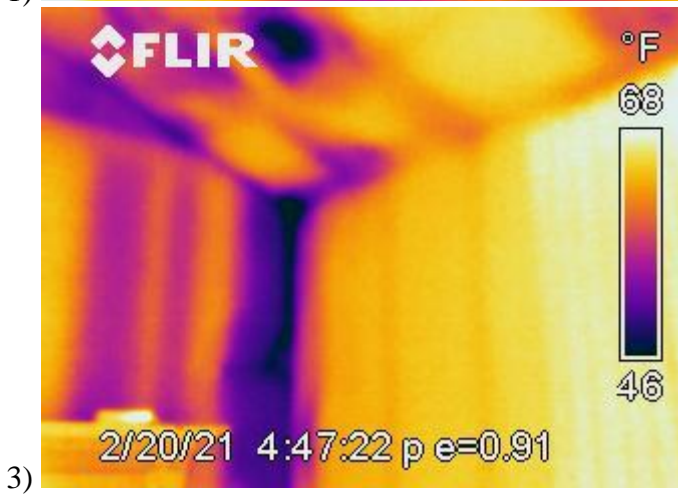
These three thermal images were taken during the emergency service call. The thermal images are date stamped. Heavy build up of water running down wall bays and up behind the ceiling in the living room. Since there was so much remaining snow build up, we only moisture mapped the loss on Saturday 2/20.**

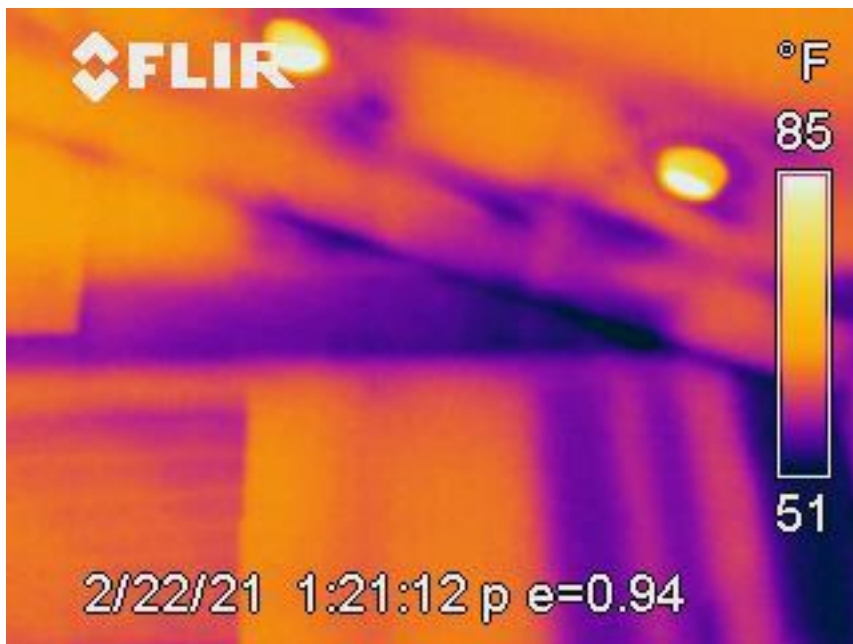
This thermal image taken as per date stamp on 2/22/2021

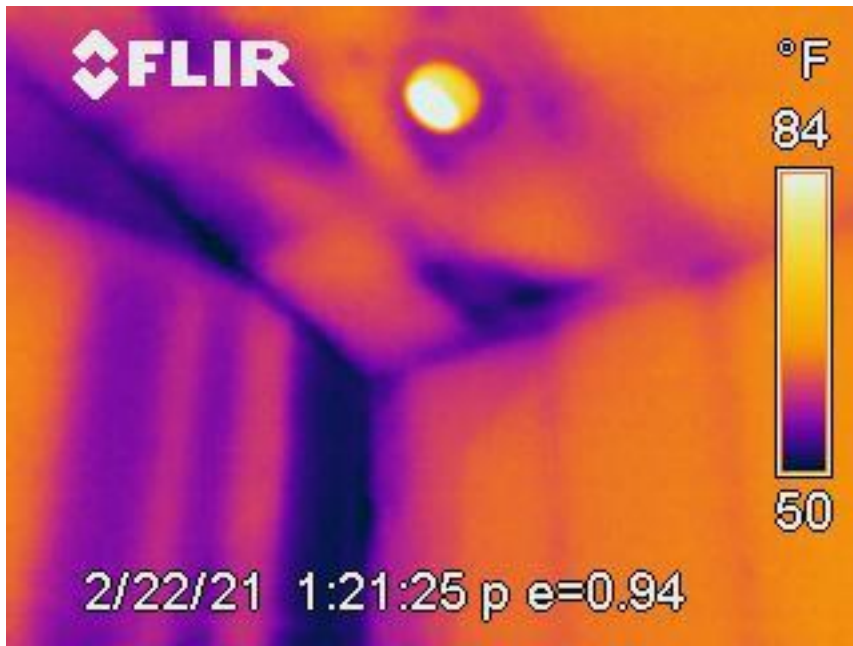
Water accumulation at the bottom of the ceiling slope and in the affected wall bays as shown.

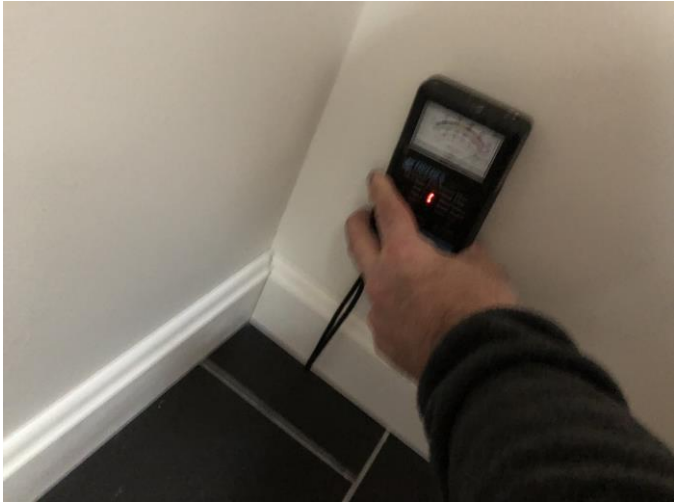
Water in wall bays on rear wall of great room 2/20

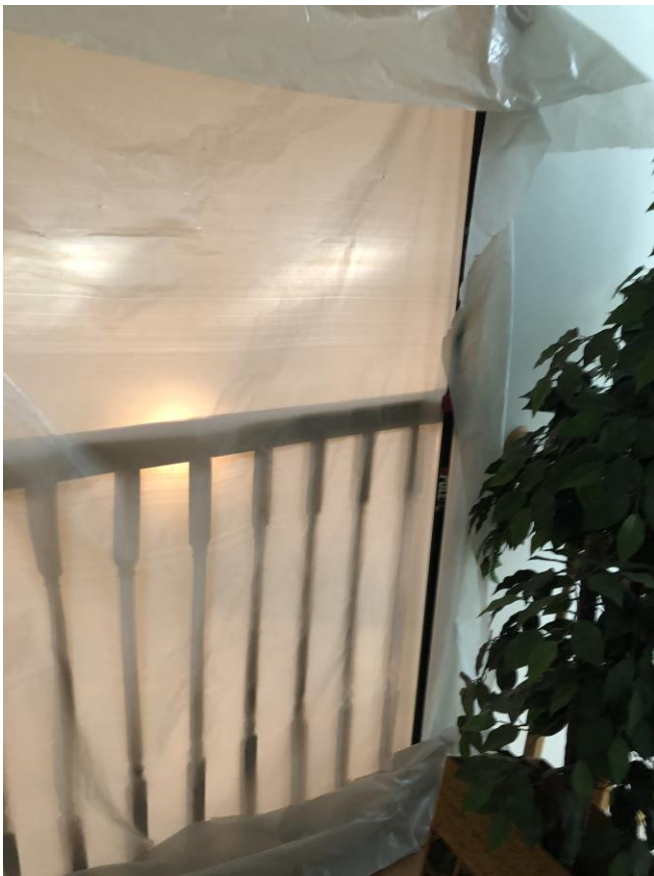
Containments – Second floor opera window opens to the Great Room. This is immediately adjacent to the Master Suite and bedroom two on the second floor.

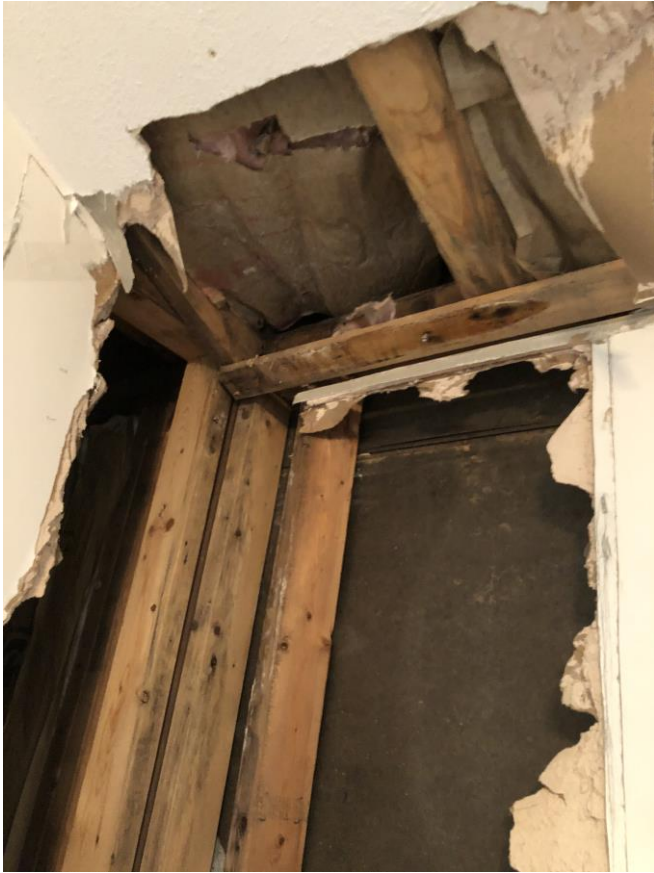
With the engineer floor finally dry, we opened ceiling to find additional mold conditions. These conditions were expected, which is why no fan drying was done on this job.
