ADVOCATE DESIGN/BUILD & CONSTRUCTION, LLC

Owner: XXXXX XXXXXX, XXX Greenville Road, North Smithfield, RI 02896

Inspection Date: 5/15/2022

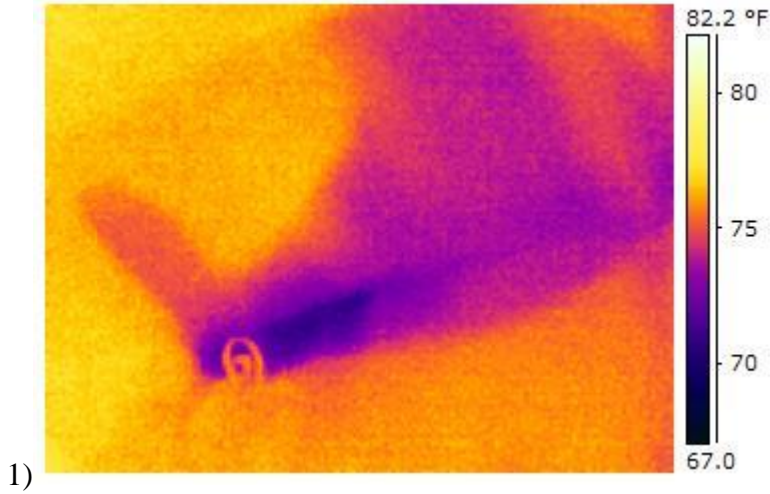
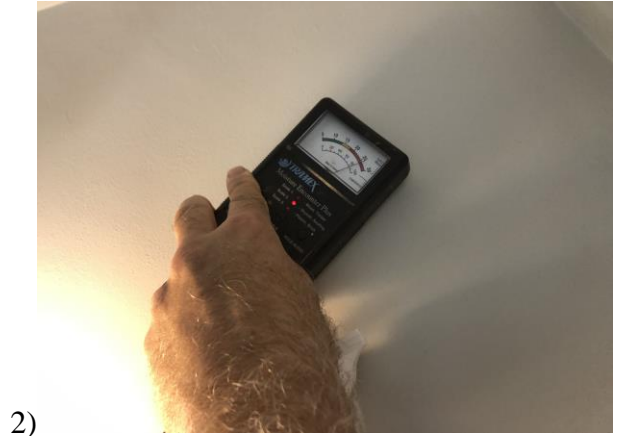
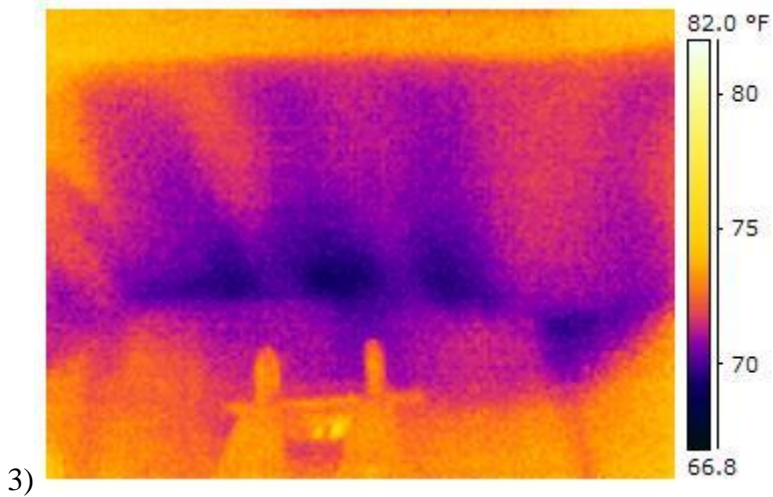
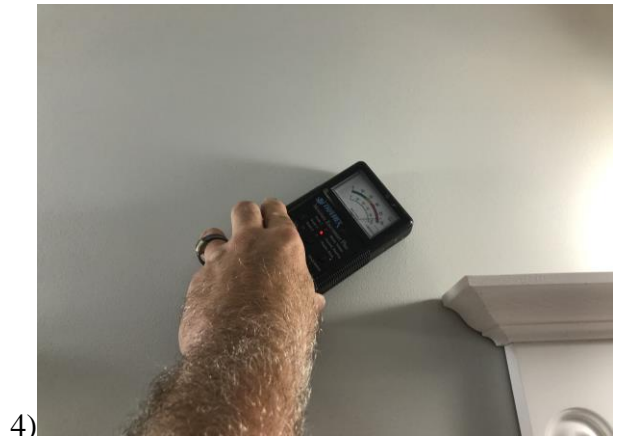
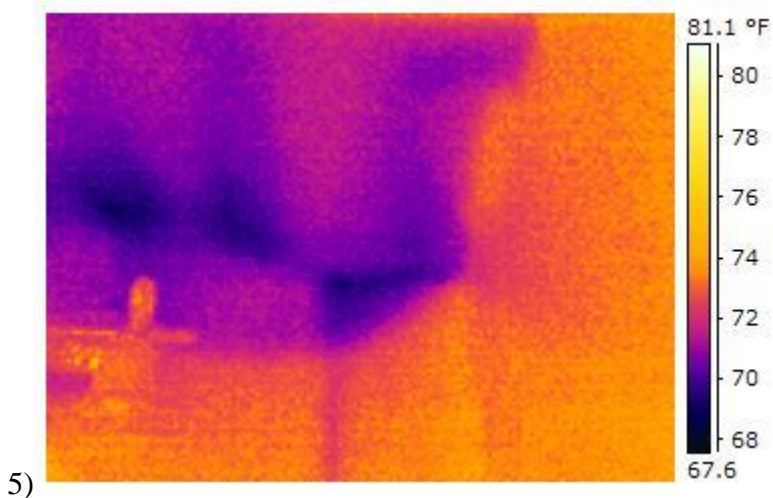
Pictures and thermal images of the master bathroom below the air conditioning unit in the attic.

Moderate to severe damage in all four affected areas of the master suite, and it extends into the living room at the property. There is un-emptied water in the air handler drip tray that seems to indicate a total blockage that caused the problem at the site.

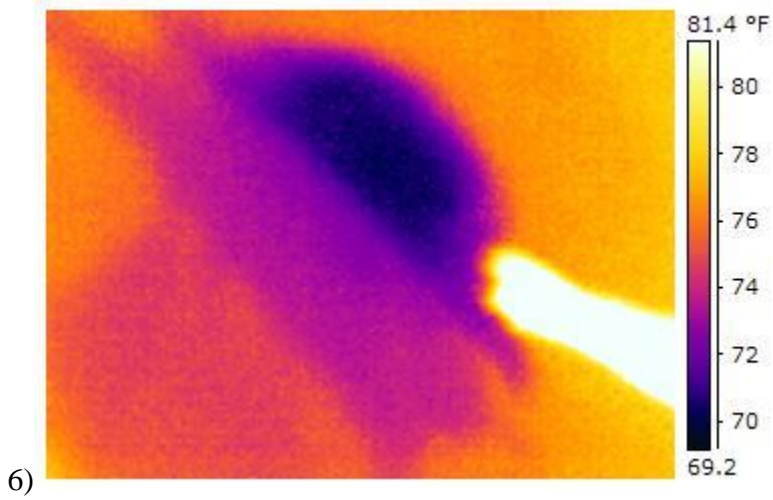
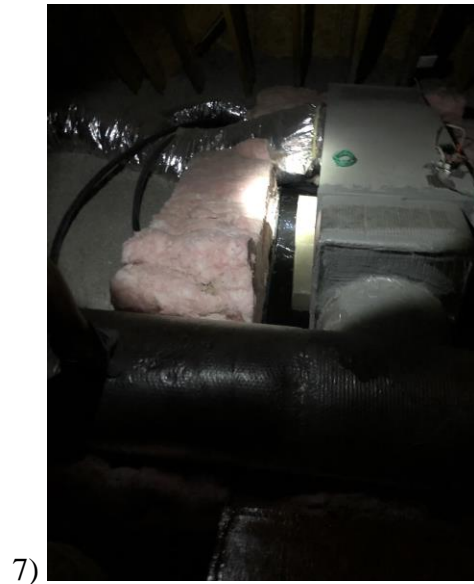
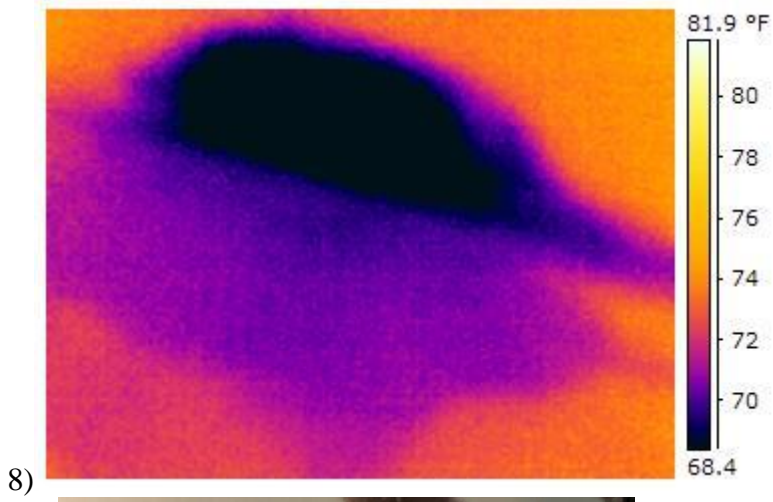
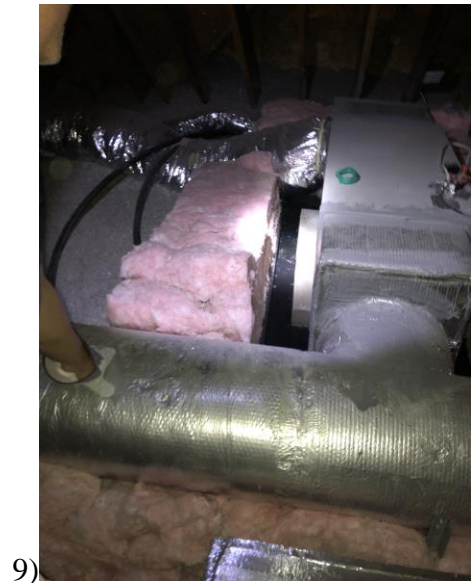
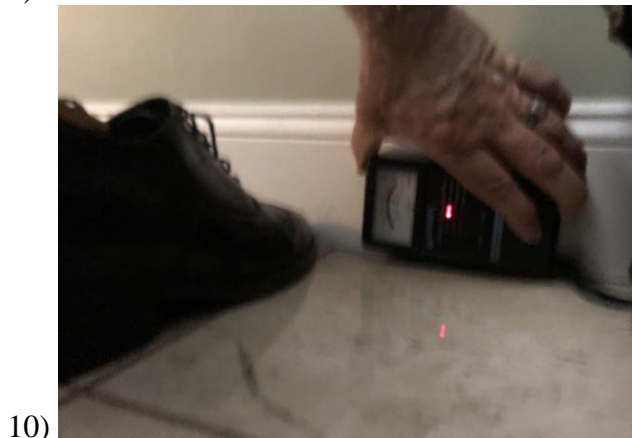
Master Bedroom closet thermal images and areas impacted by water damage. J-Peg images 7 and 9 are the air handler tray still loaded with water

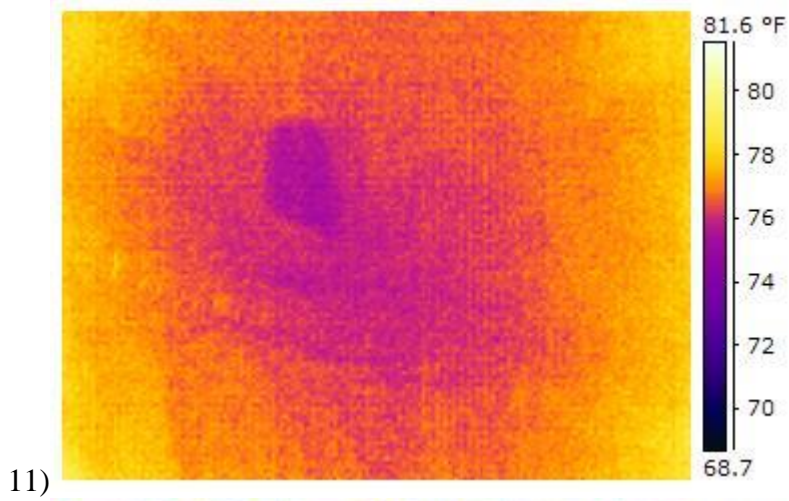
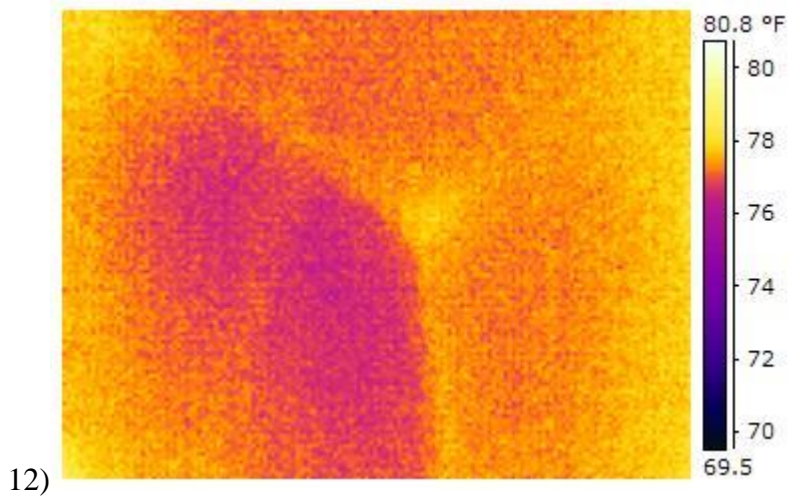
Images 11 and 12 are Master Bedroom closet 2. I was unable to get close enough to the wall surfaces to get moisture meter readings.

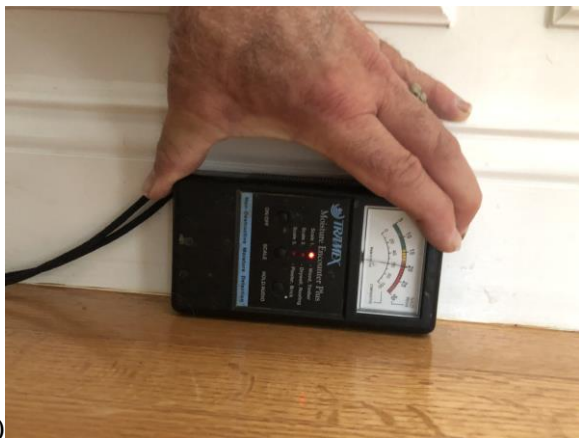
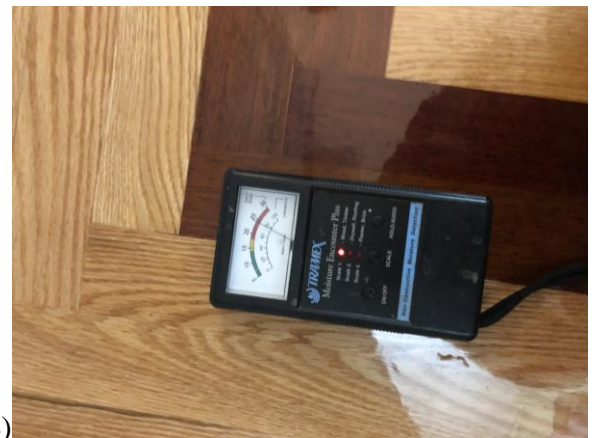
Images 13 & 14 are the master bedroom floor. High moisture content readings and baseboards are popping away from the wall surfaces

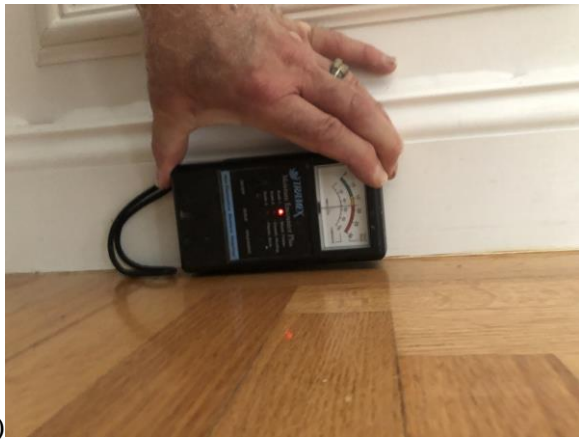
15)

Images 15 & 16 are the living room just outside the Master Bedroom, and base moldings are wet and popping away from the walls they are fastened to.
