# NOREASTER DISASTER RESTORATION, LLC

Property Owner: xxxxxx xxxx xxxxxxx, xxx Chestnut Ave, Narragansett, RI Taken: 2/16/2016 thru 3/2/2016

### **CONCLUSION & COMMENTS**

Pipe Freeze loss at the above listed location. Various images of pipe rupture locations, floor and wall damages on the first floor and in the basement space.

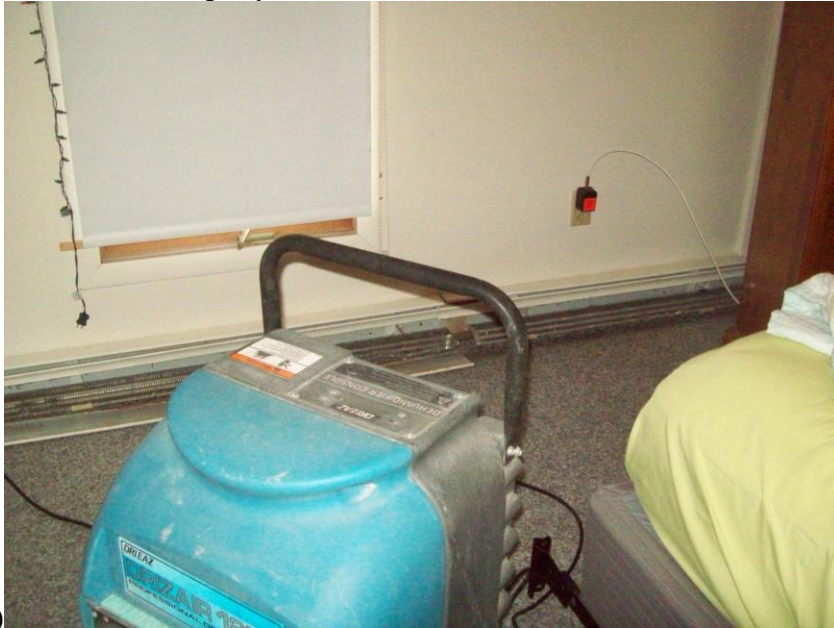
1) Pipe break in first floor bedroom near the electric service panel.

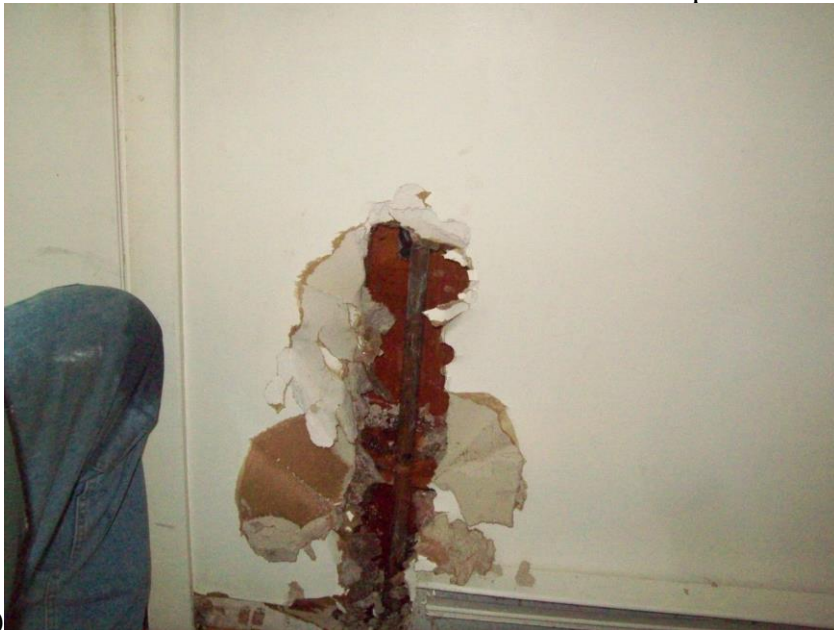
3) Pipe break to the right of the front door

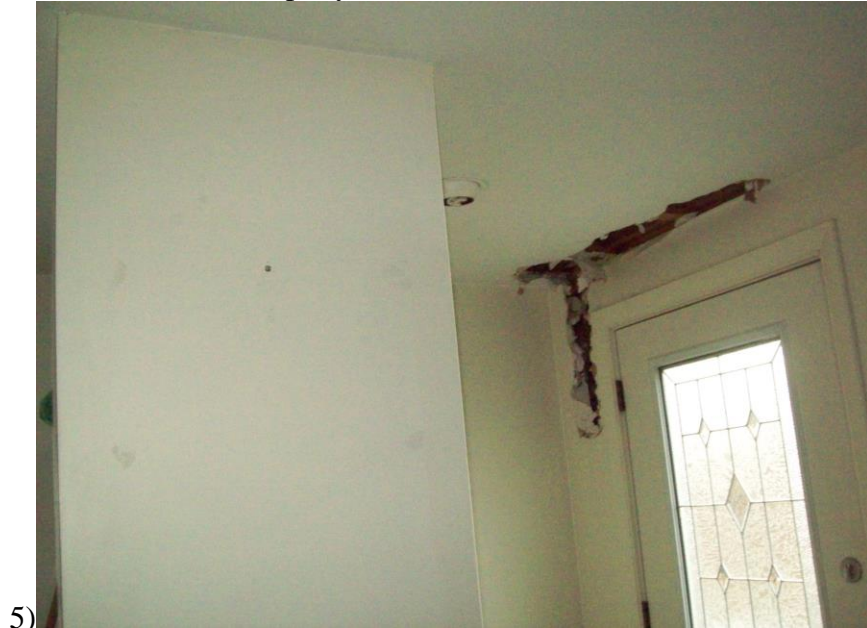
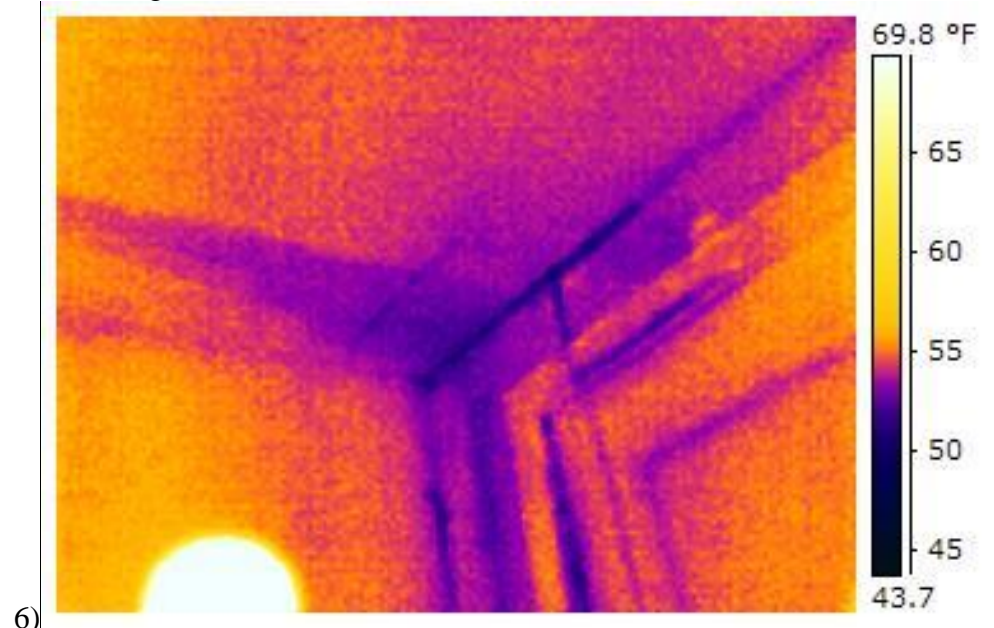
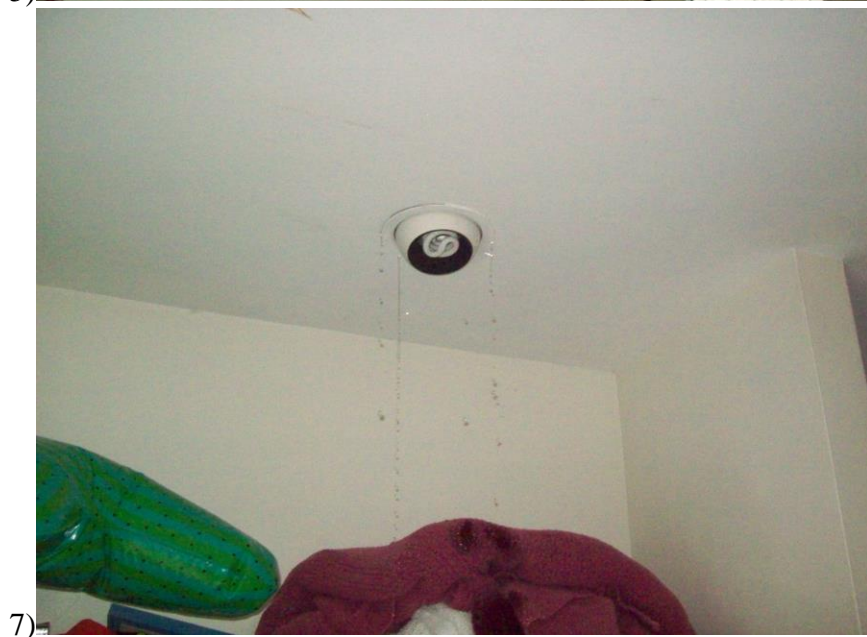
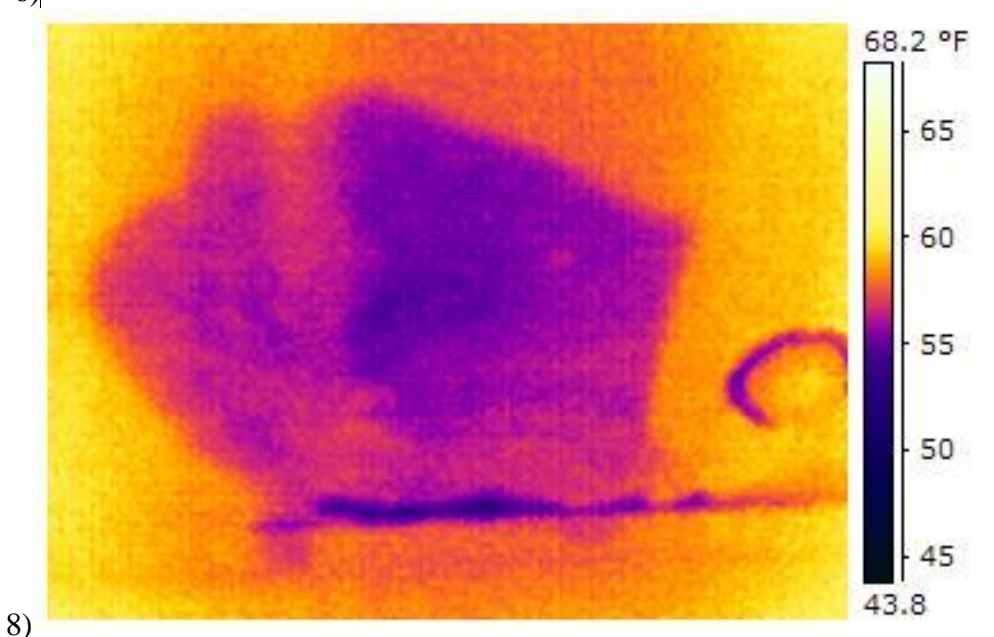
Pipe break over ceiling at the front door. When the line was re-energized to 80 lbs, another break was found and water came out of the recessed fixture in image #7, Thermal images show where the water was.

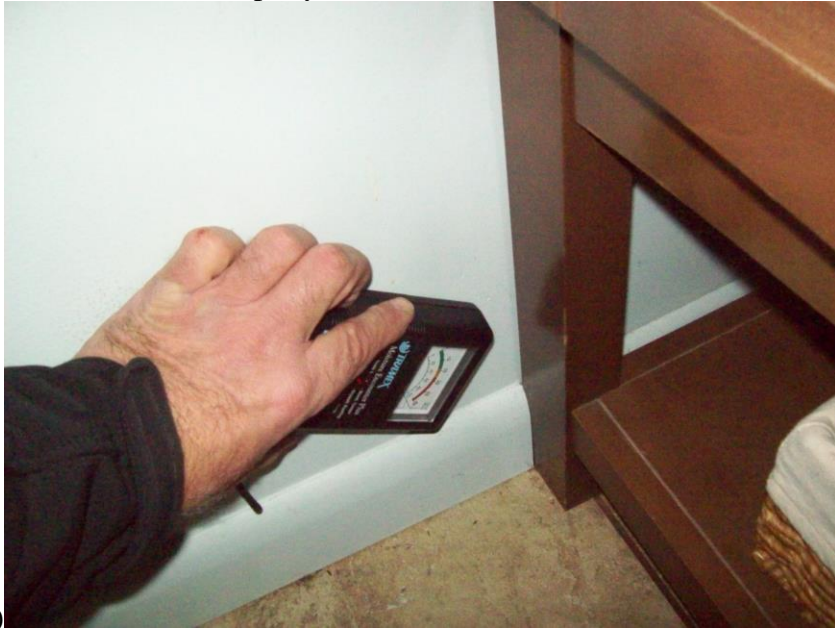
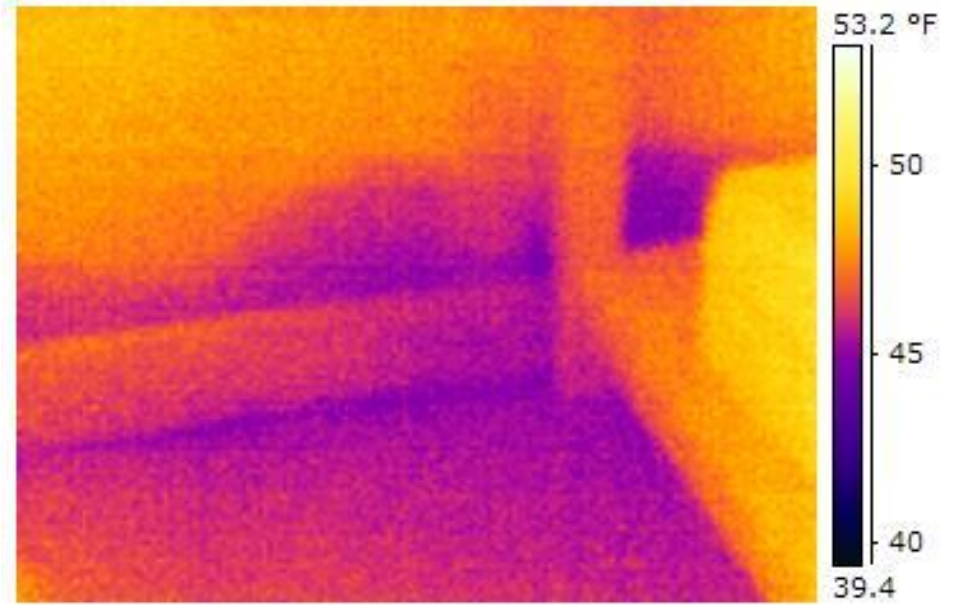
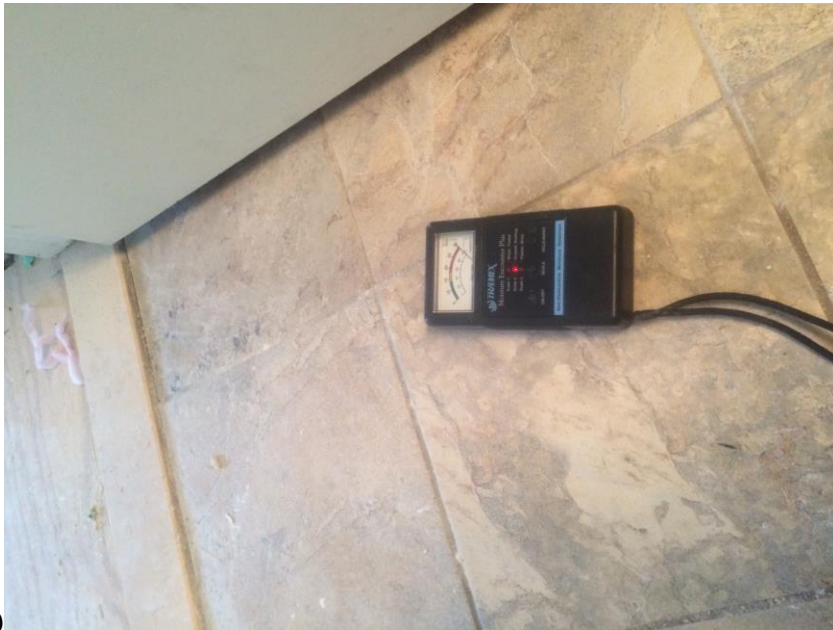
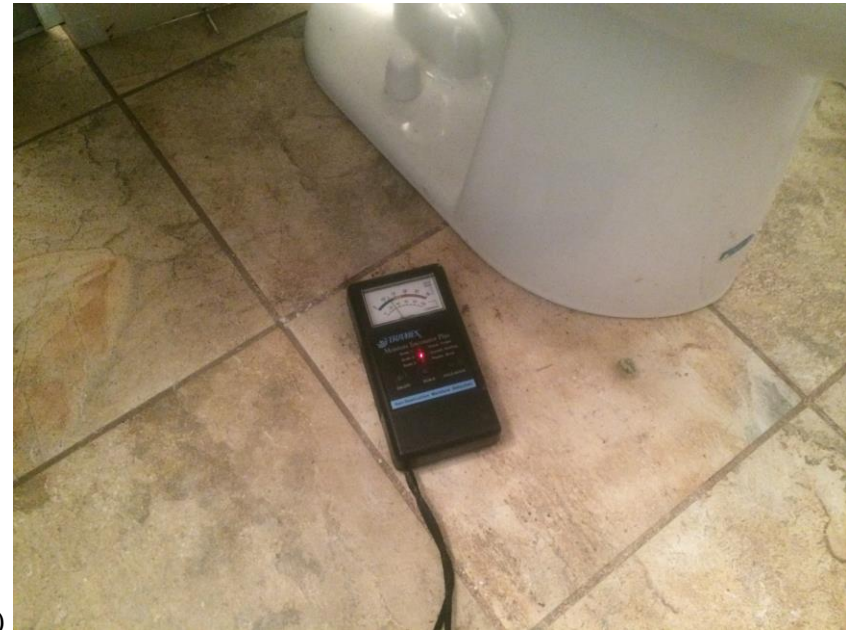
Bathroom has water damage both to the walls and to the tile floor substrate and tile all the way back to the vanity. It is dry near the toilet.

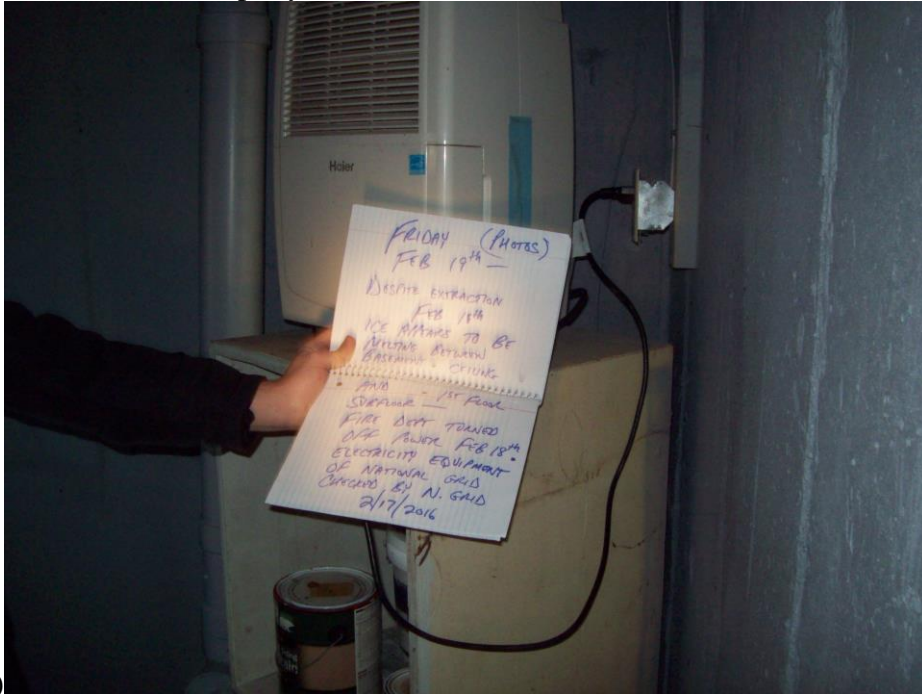
13)

Despite extraction, basement filled with accumulated water a second time

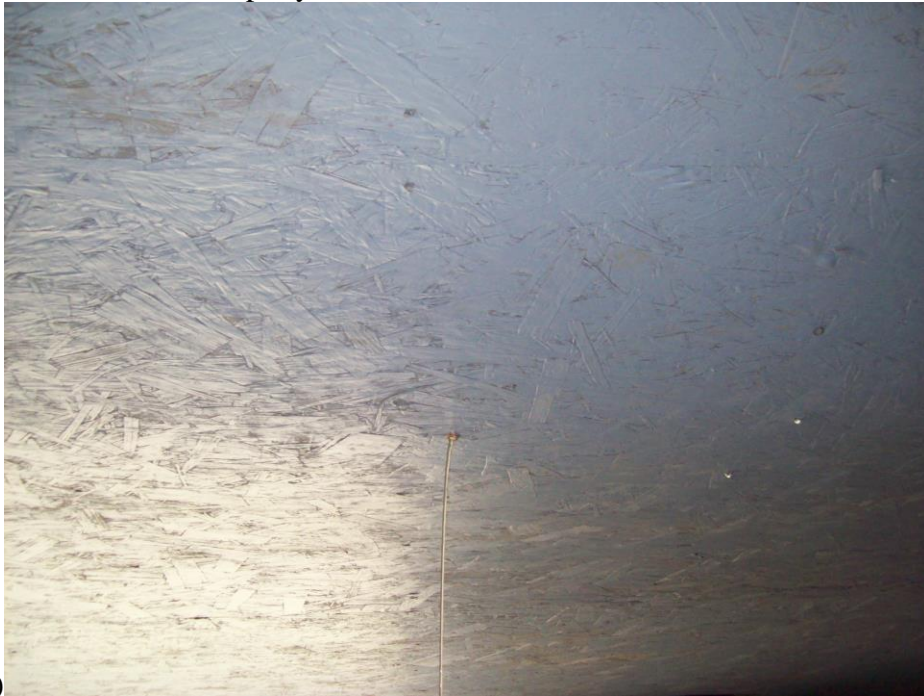
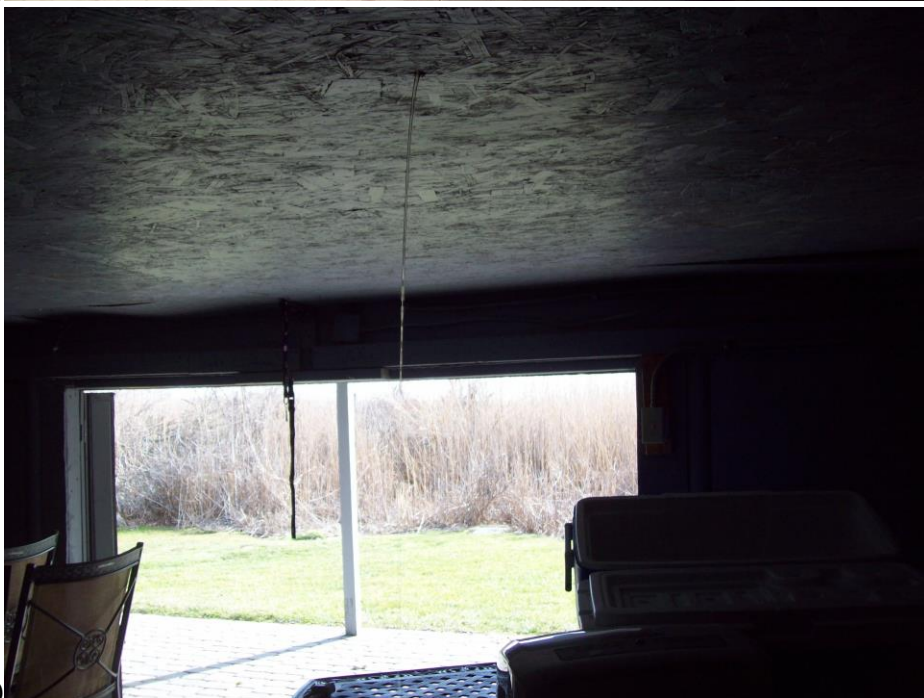
Water still running out of the ceiling – during the thawing period.

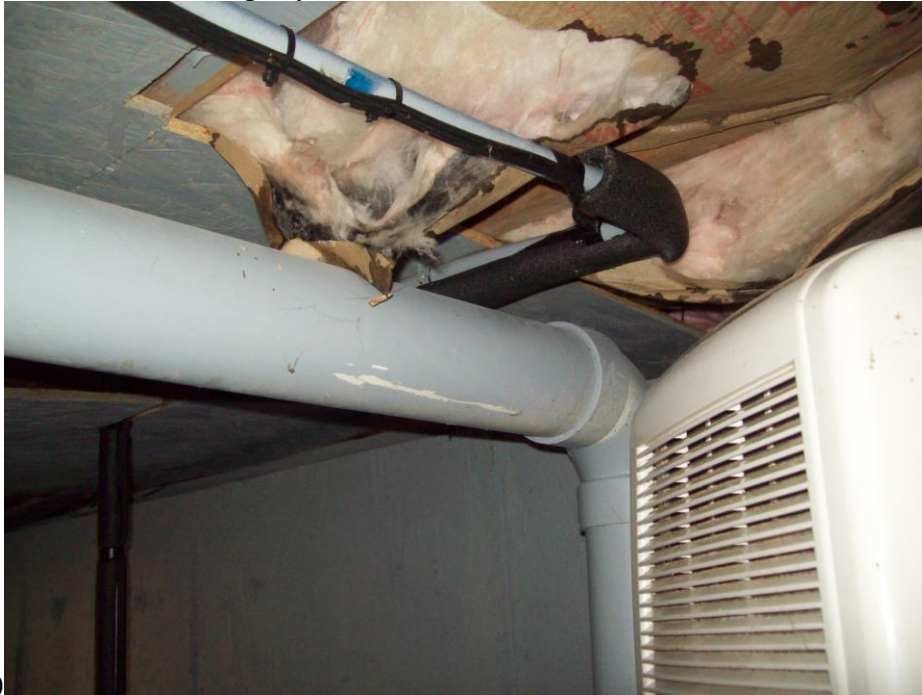
19)

Water main is attached to the ceiling and must be capped for demo

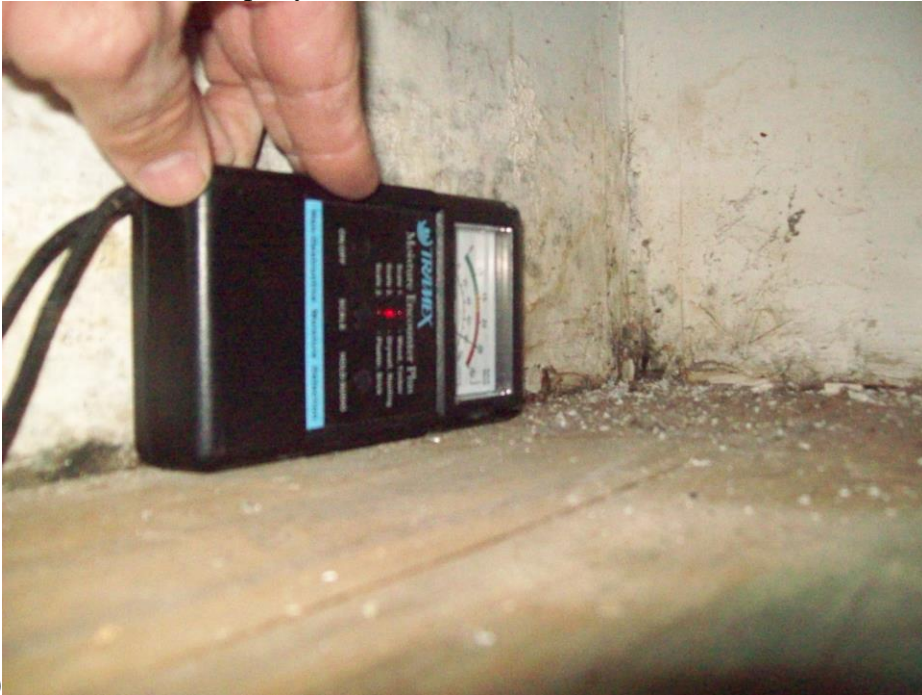
21)

Wet walls in the boiler area with suspect mold

Mold confirmed by CEI labs on suspect surfaces in boiler area on common walls to bathroom and first floor bedroom.

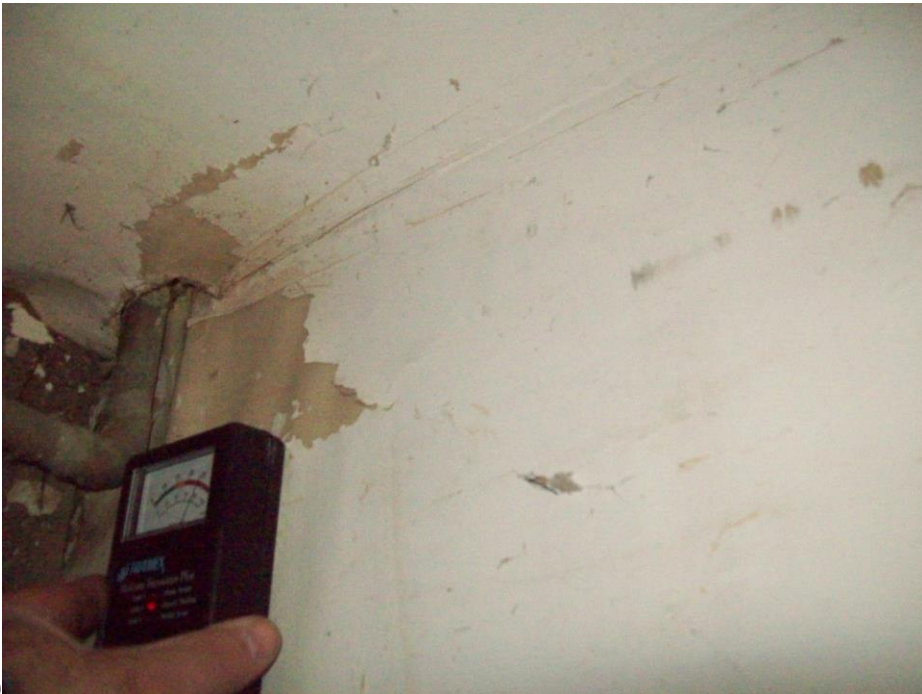
22)

Wet exterior wall in the boiler alcove

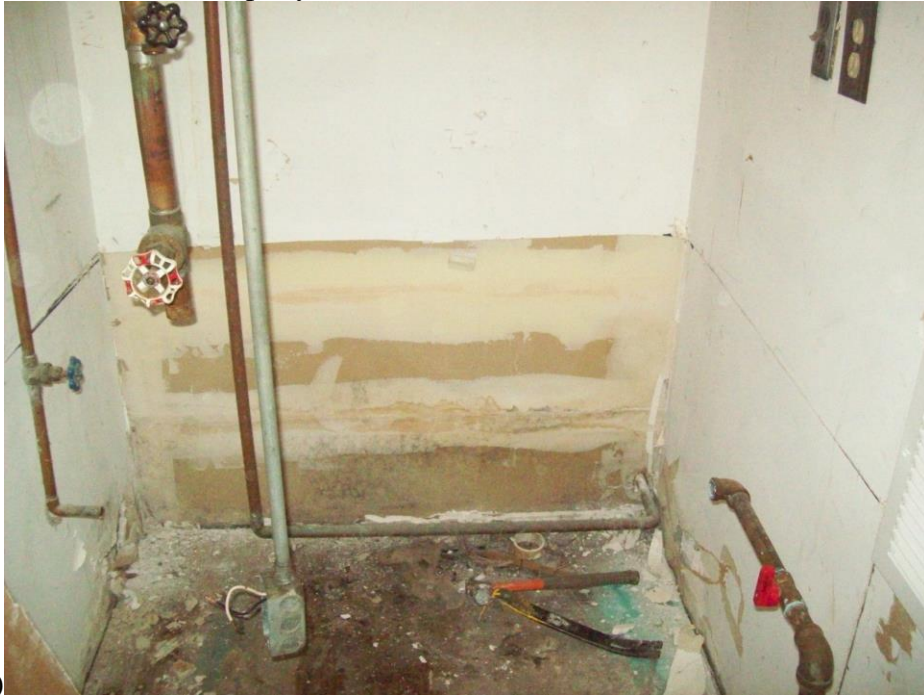
23)

After mold confirmed, abatement started – double walled drywall

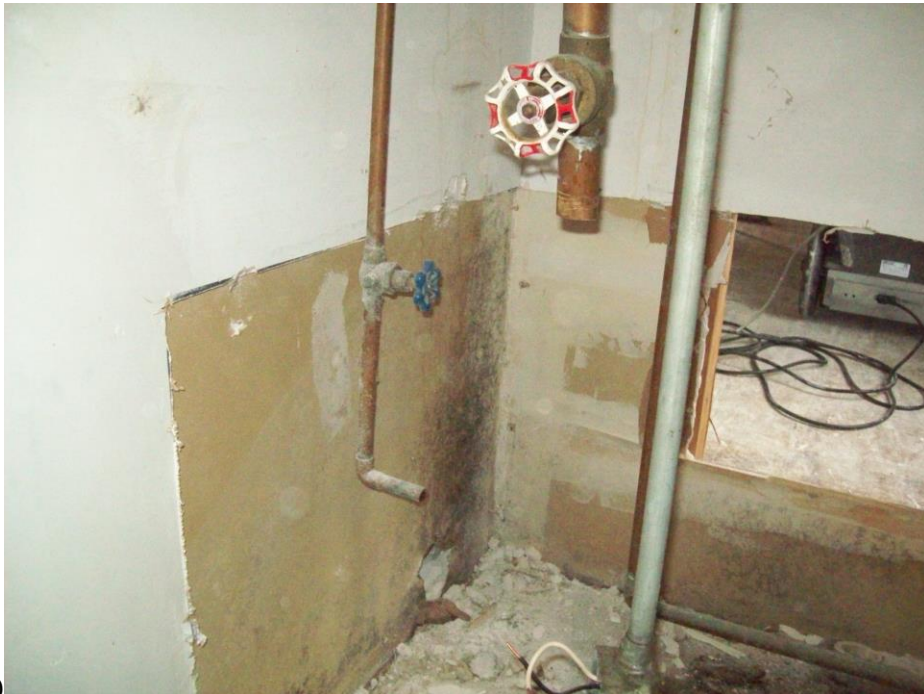
24)

Common wall to bathroom also a double wall.
