NOREASTER DISASTER RESTORATION, LLC

Property Owner: xxxxxx xxxx, xxx Bedford Circle, Narragansett, RI 02882

CONCLUSION & COMMENTS

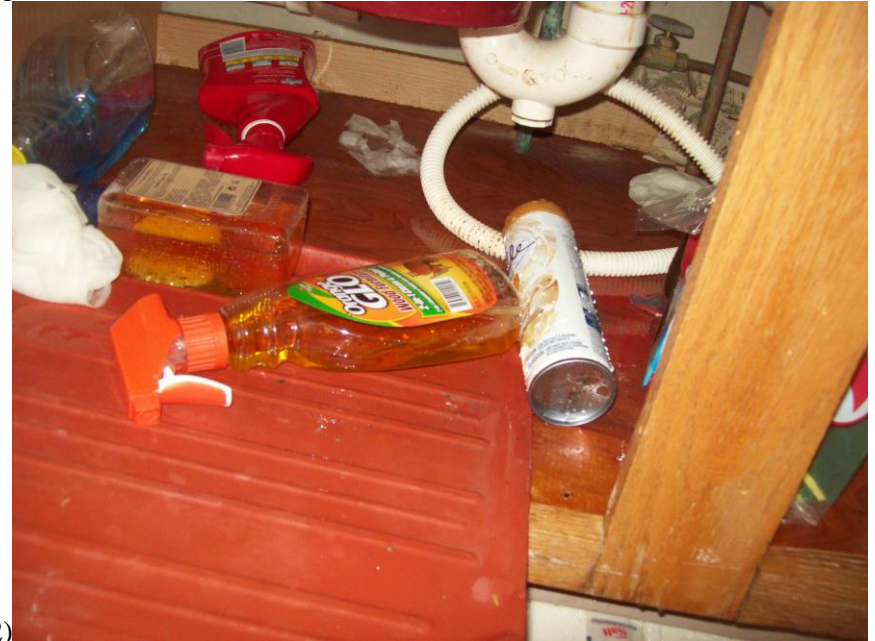
2)

This lower kitchen cabinet – located on the upper floor of subject raised ranch - is where one of the pipes burst and has standing water inside it

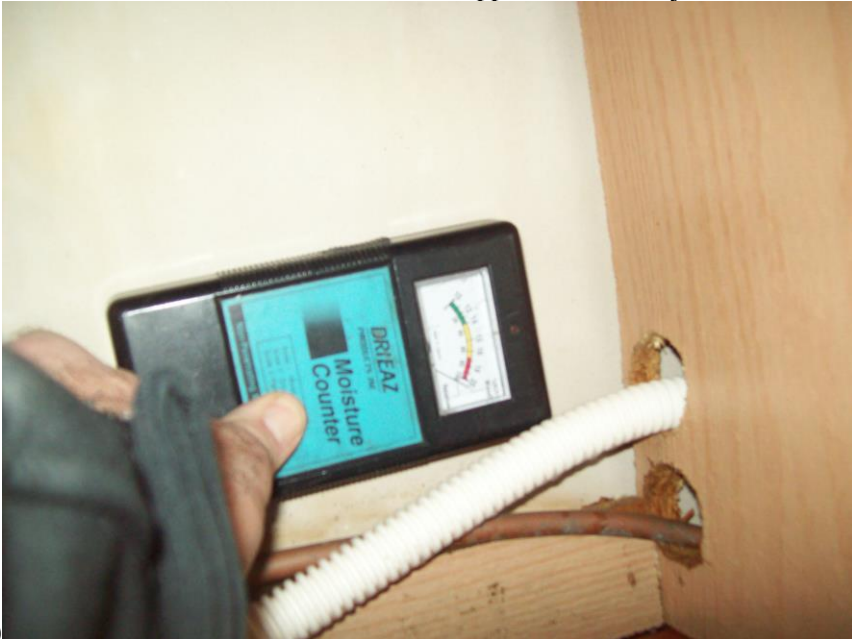
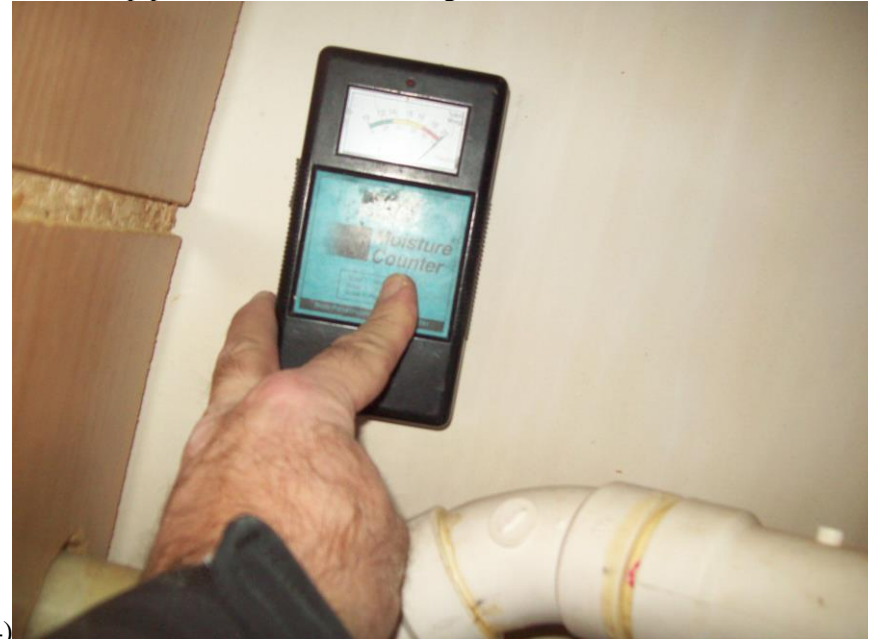
After getting water out of the cabinet, images 3 and 4 show maximum moisture meter readings on inaccessible back wall. This house has a poly plastic sheeting vapor barrier between the drywall and the insulation/stud fascia. This should be expected to grow mold.

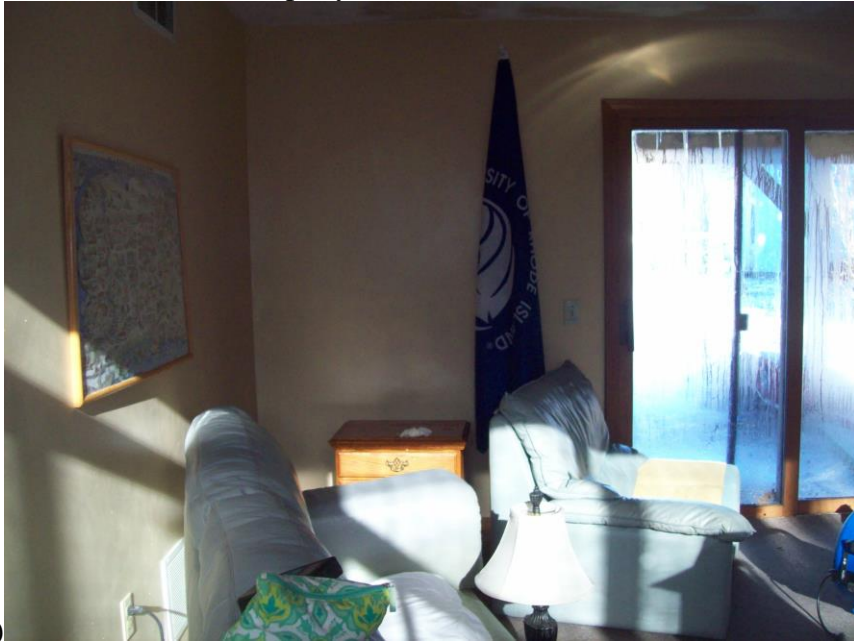
5)

Steam and vaporization of water in lower level family room

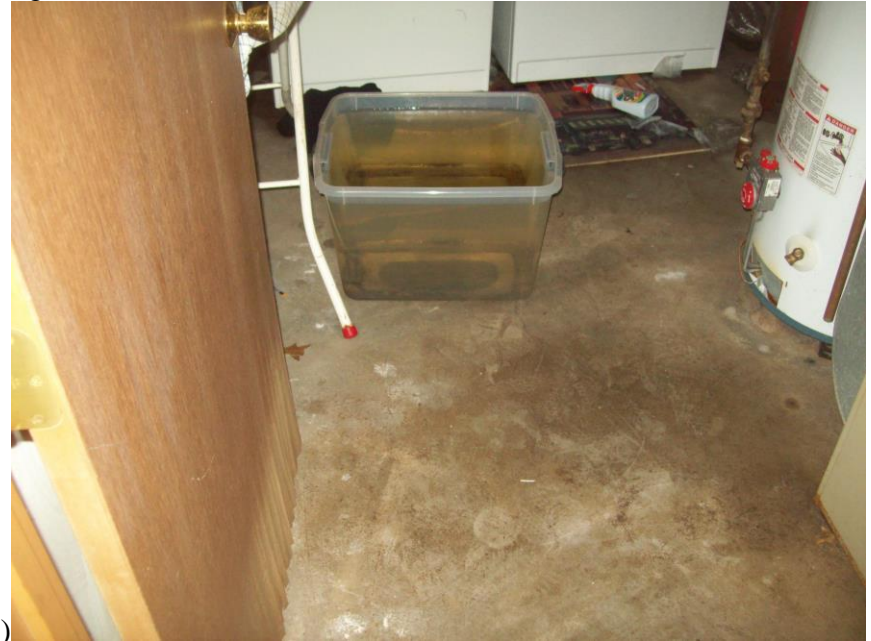
6)

Accumulated water in the laundry running between 1st and 2nd floors - laundry

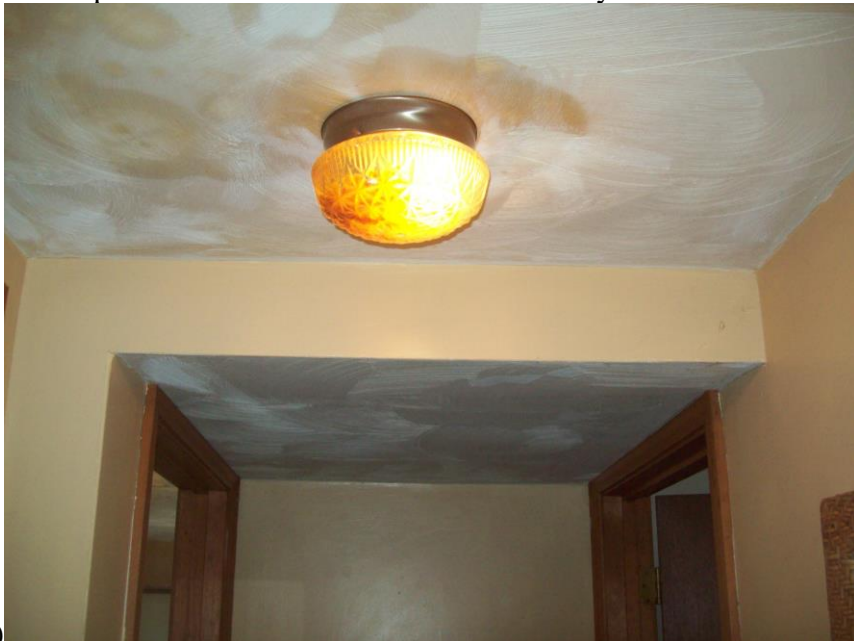
7)

Lower level images - The entire globe of this light was filled with water and this is the ceiling in the family room.

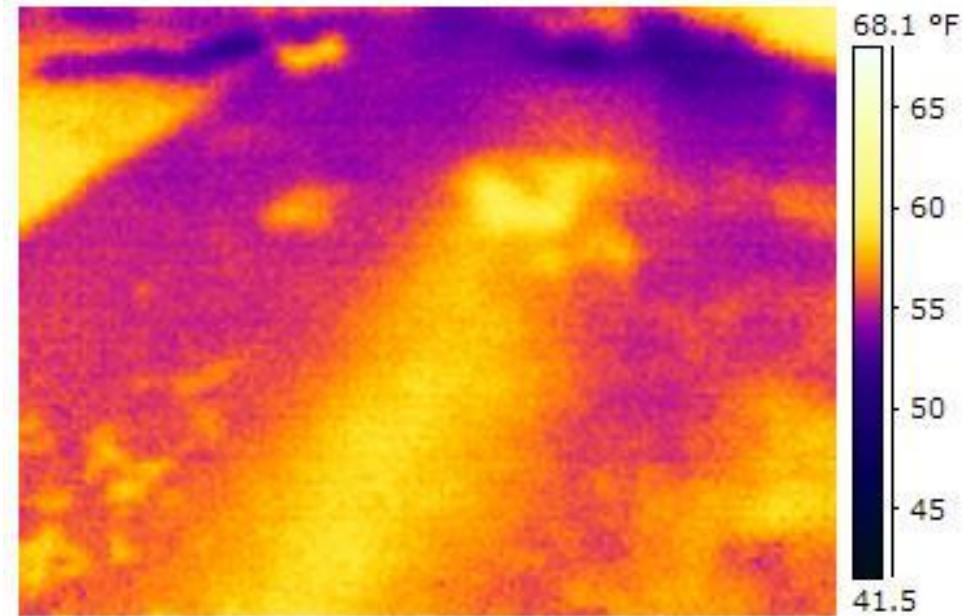
12)
This is the first floor dining area, and at far upper left is vinyl flooring

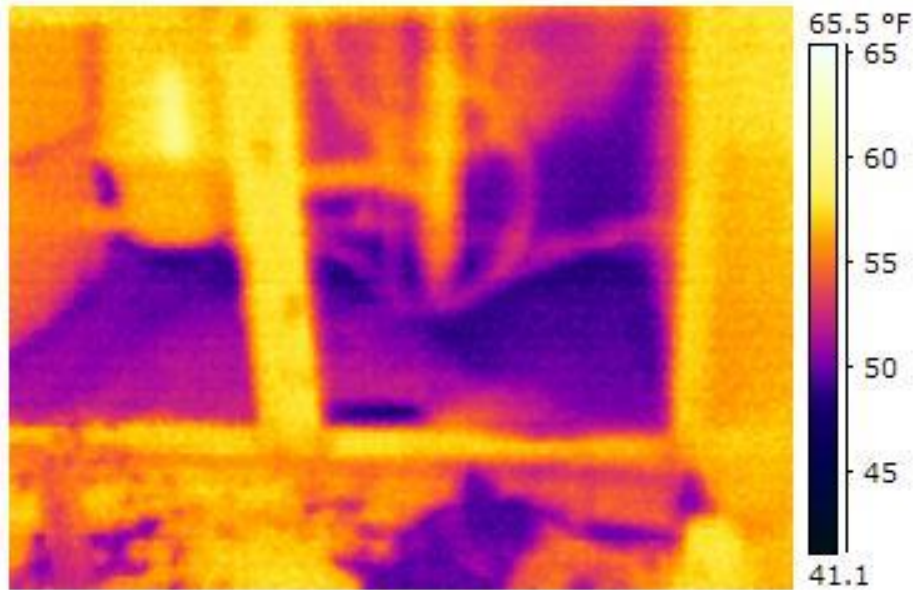
13) Image 13 is in front of, and within, the affected kitchen cabinet

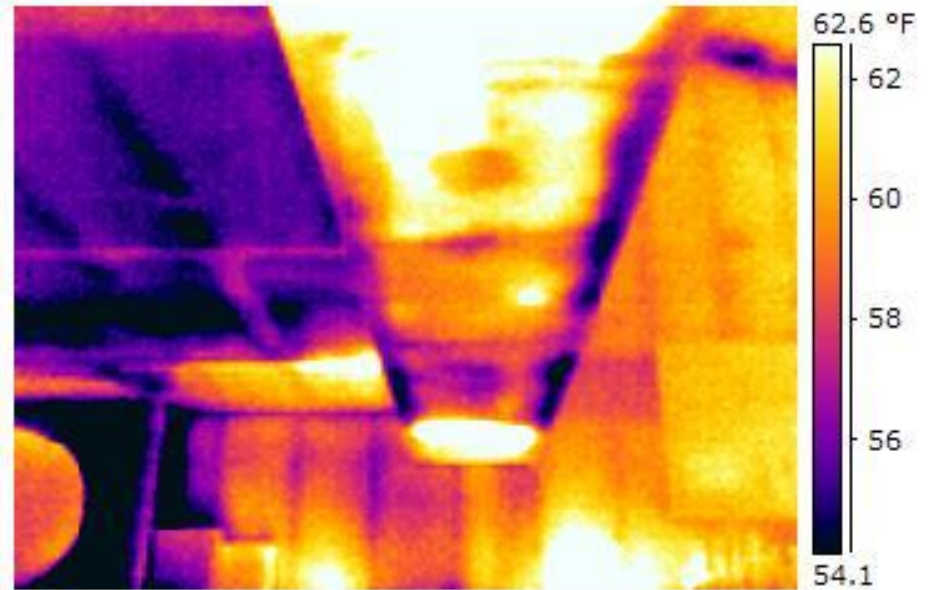
14) Image 14 center is the basement duct chase/soffit zone

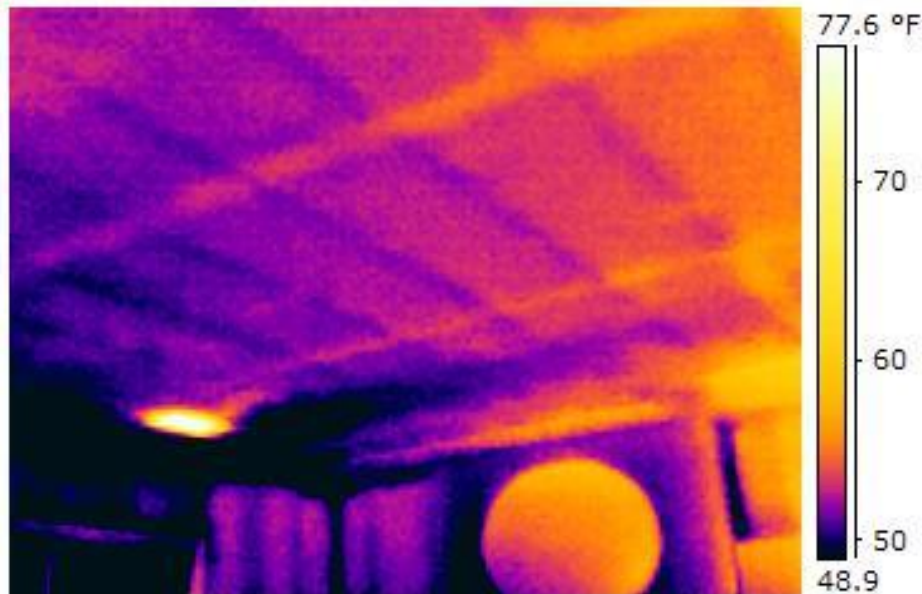
15) Image 15 is the family room ceiling in the basement level

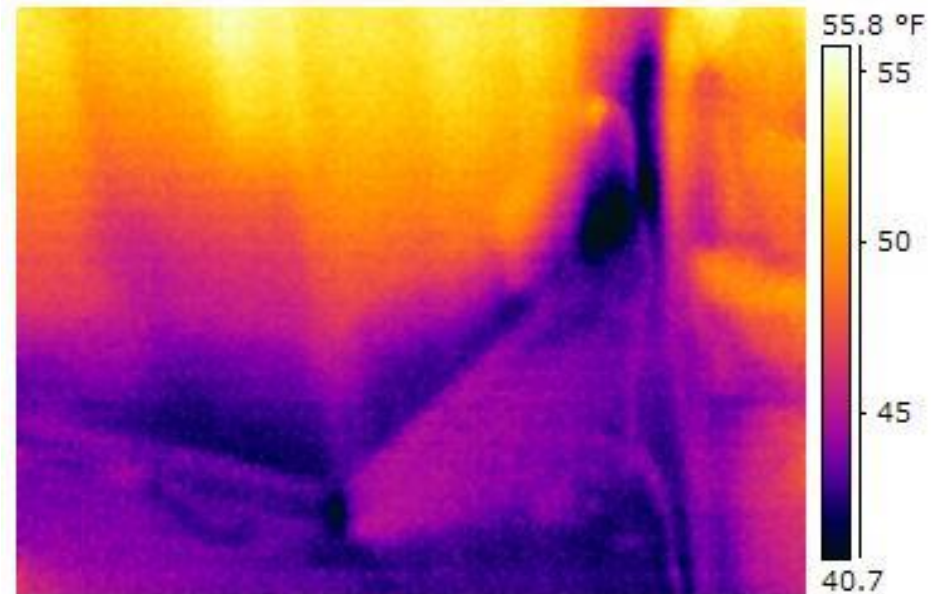
16) Image 16 is the common walls to the laundry/furnace room and the saturated carpet.

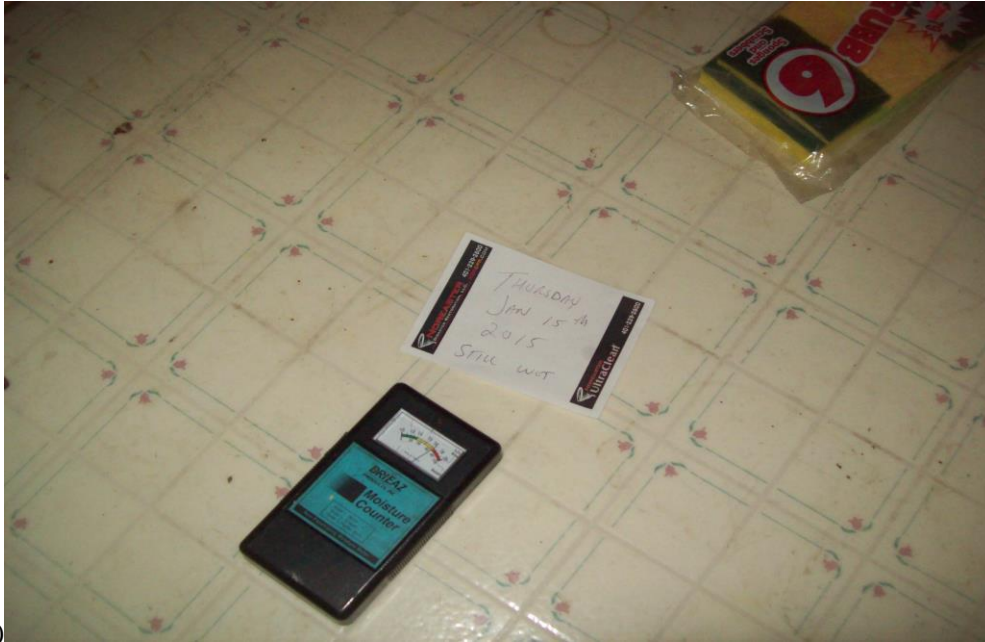
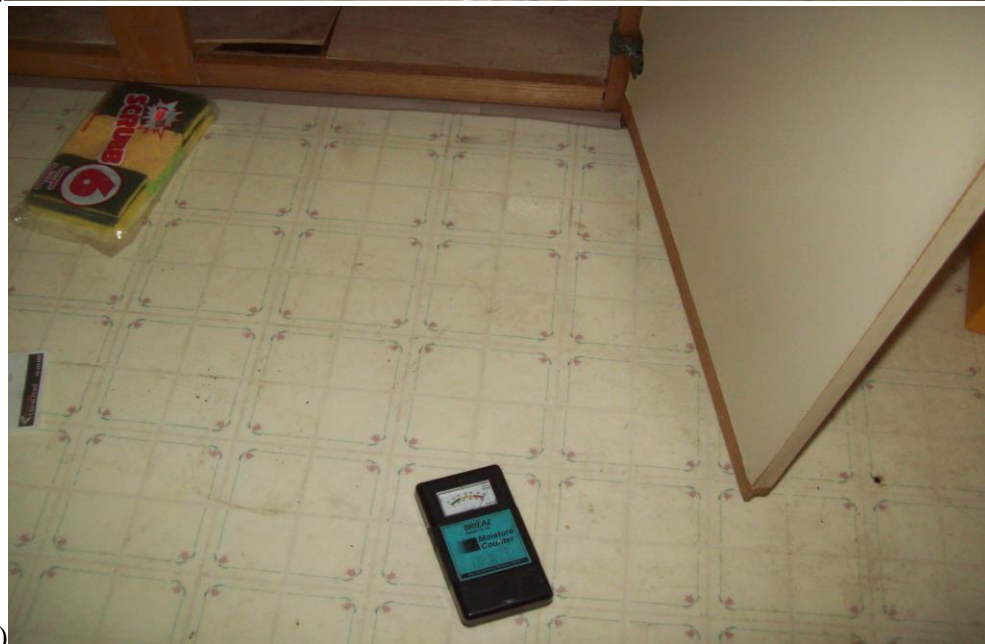
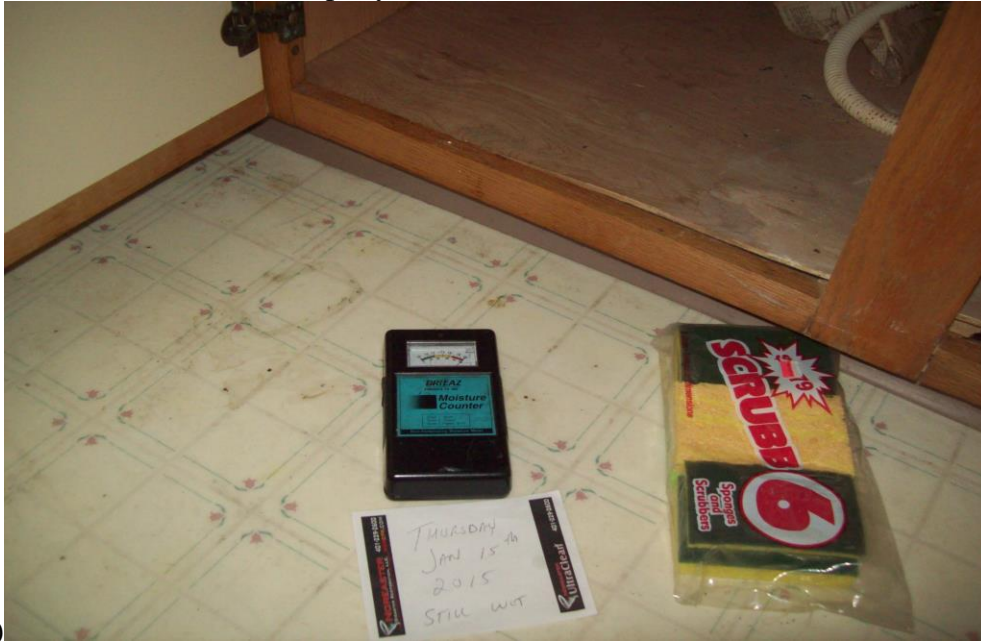
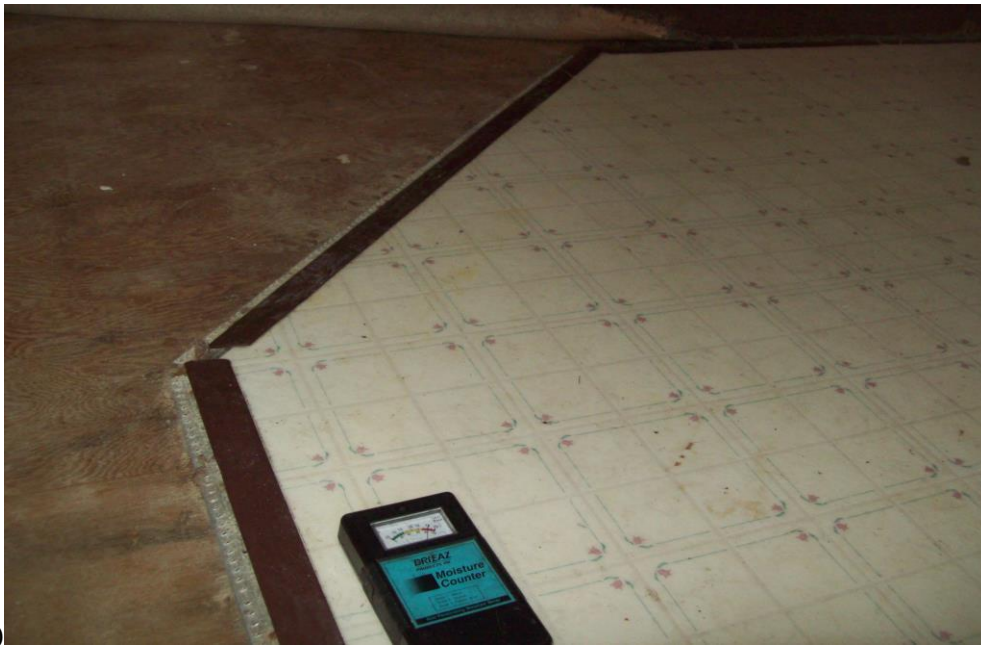
*****IMAGES 17 THROUGH 20 WERE TAKEN ON JANUARY 15, 2015 AND SHOW THAT WITHOUT QUESTION THE TWO LAYER VINYL SHEET FLOOR AND RESPECTIVE UNDERLAYMENT REMAIN WET*****
