NOREASTER DISASTER RESTORATION, LLC

Property Owner: XXX XXXX XXXX, XX Tiff Road, North Smithfield, RI

Taken: 2/11/2015 and 2/13/15

CONCLUSION & COMMENTS

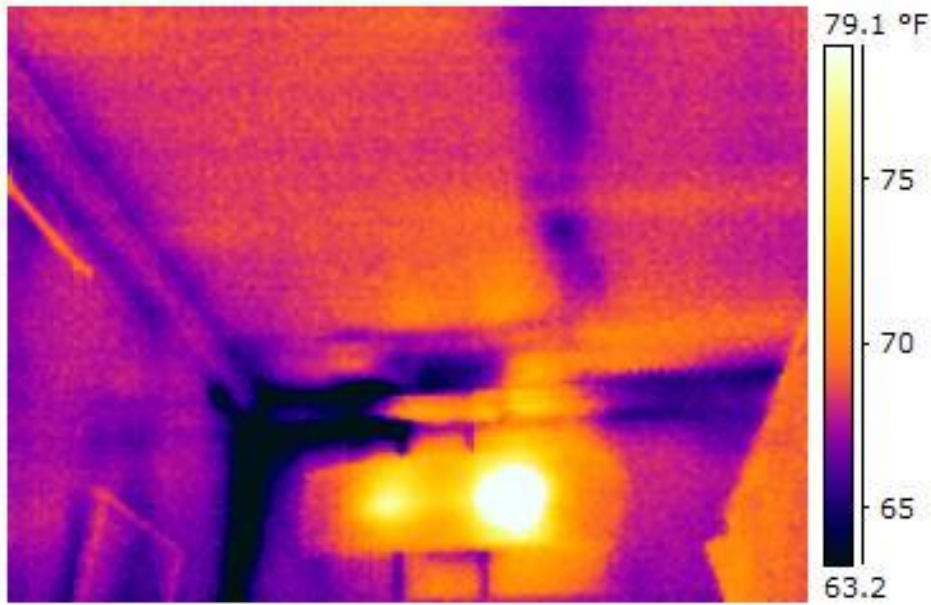
1) Bathroom images – water over ceiling and exterior wall facing the street

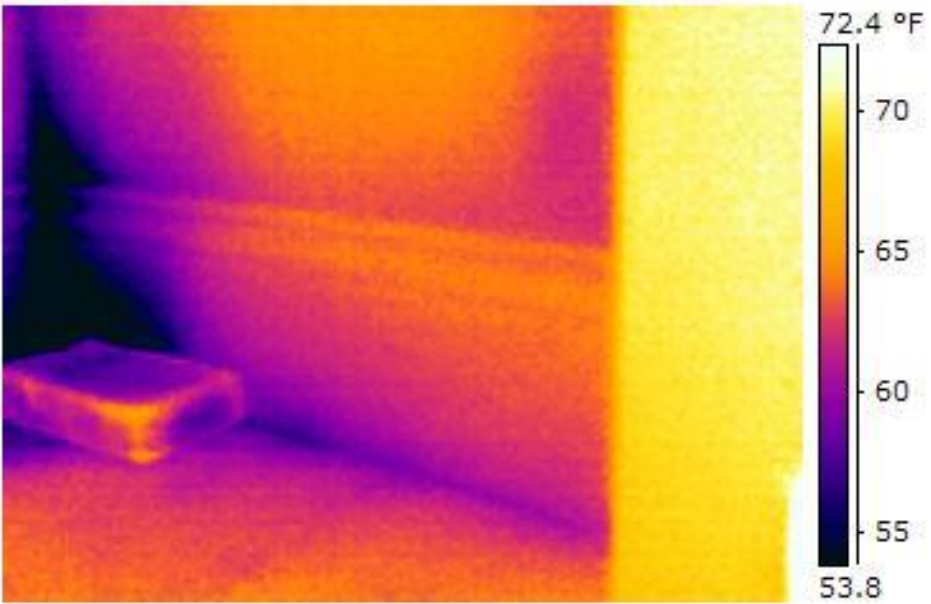
3) Kitchen images – water seeping to the floor and within the wall and ceiling cavities to this point.

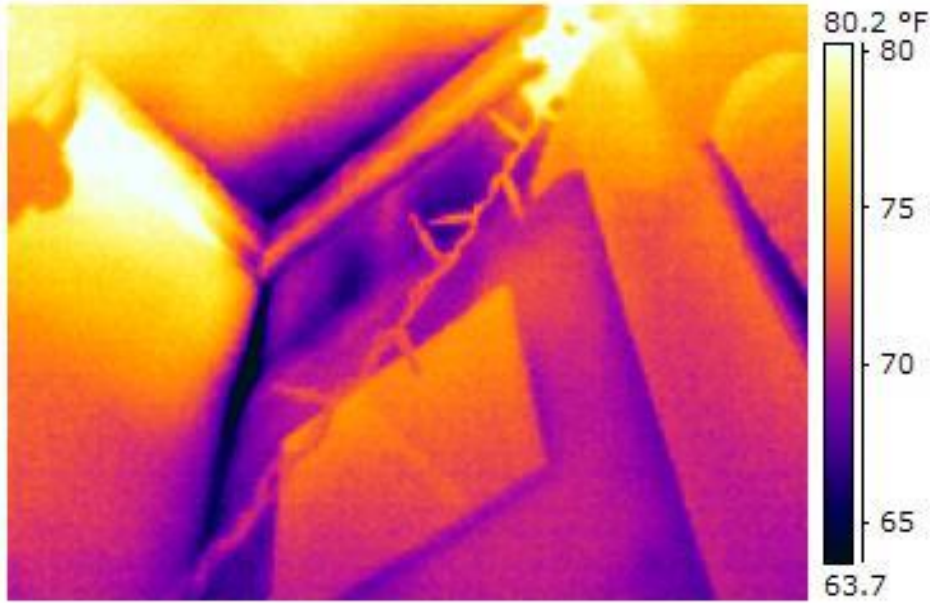
5)

#5 is another ceiling image, and #6 shows some of the equipment used at the onset of the emergency service call.

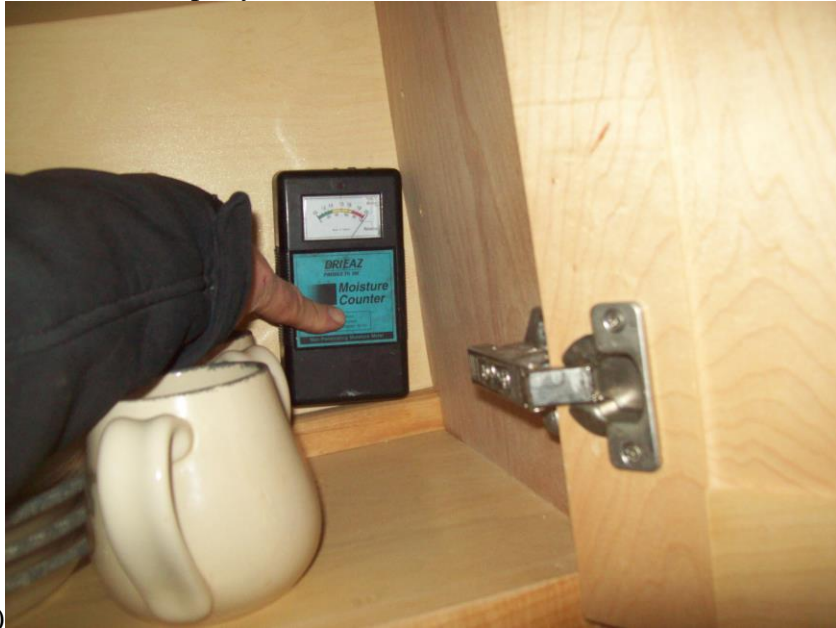
7)

Loss is worsening despite snow removal by the homeowner. The walls on the premises contains blown-in cellulose – we are not removing them until an Allstate claims rep authorizes it. Cabinets on the right side are now delaminating since the initial service call with new water penetration as shown in images 7 through 10. XX XXX XXX from Allstate called to speak with me, acting as crew chief and the certified thermal imaging and water restoration professional in charge at this site on Friday, 2/13 at about 3:00pm. We were expecting a call back or a text with an e-mail address to be able to submit this report to him, but we did not receive that e-mail address. We had to bring in a larger dehumidifier on Saturday (went from a Dri-Eaz Revolution up to a Dri-Eaz 1200) at that time during a snow storm that delivered another 10 to 12 inches of snow and when the humidity was increasing to about 70% inside the structure.
