ADVOCATE DESIGN/BUILD & CONSTRUCTION, LLC

Owner: XXXXXX, YYYYYYYY Mendon Road #ZZZZZ, Cumberland, RI 02864

Service Start Date: 2/20/2021

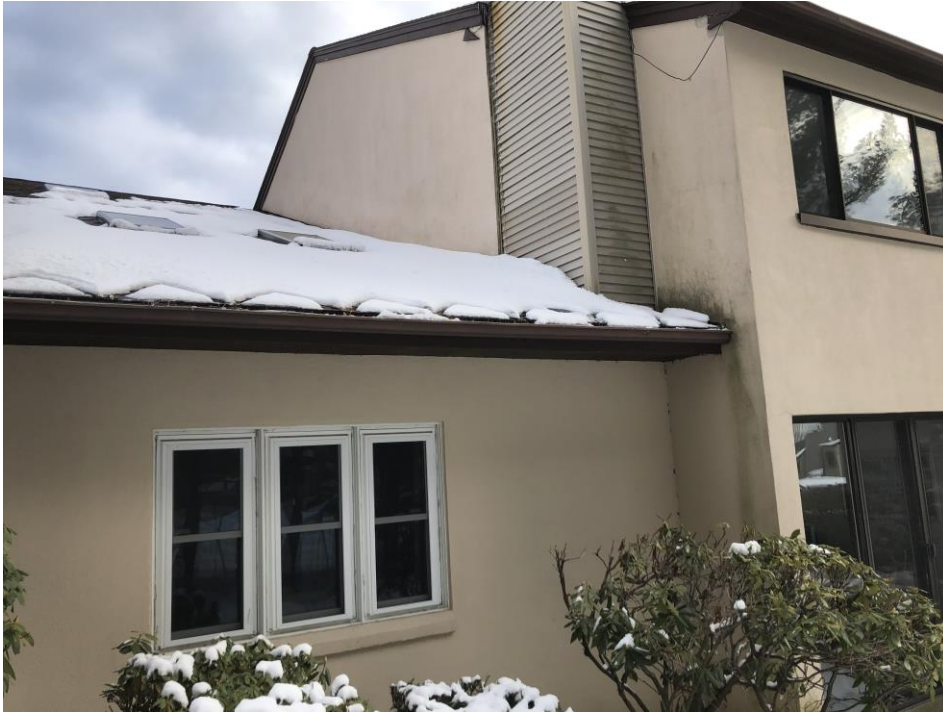
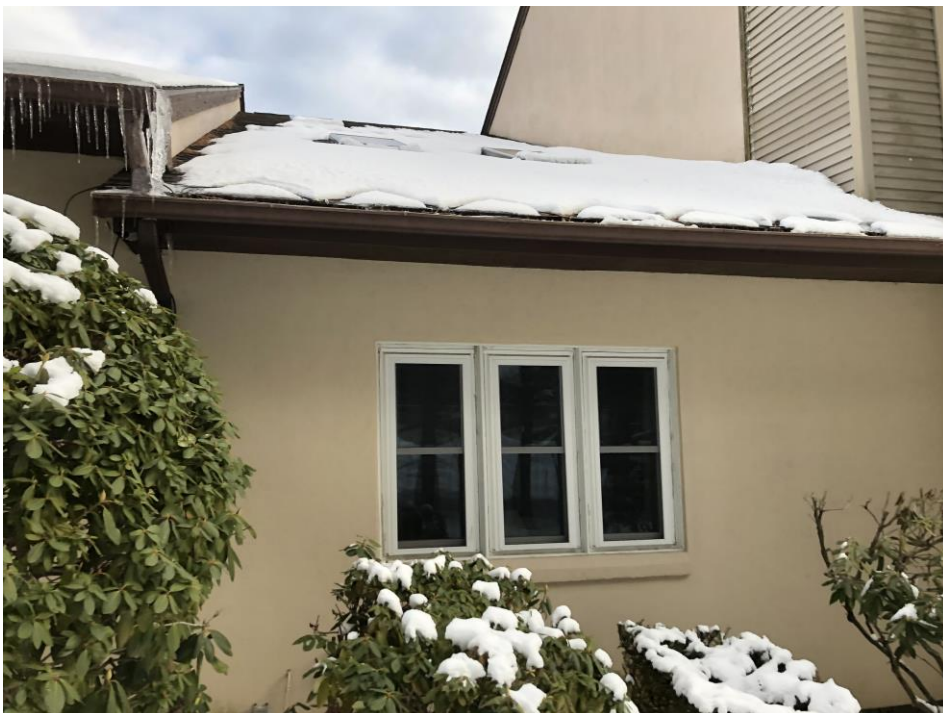
Heavy accumulation of snow on the side of the chimney chase at xxx Mendon Road #zzz, Cumberland. Water is coming in to the living room ceiling and walls near the lower end of the ceiling slope in the great room. These photos were taken at the time of the emergency service call at about 4:45 PM on Saturday February 20, 2021.

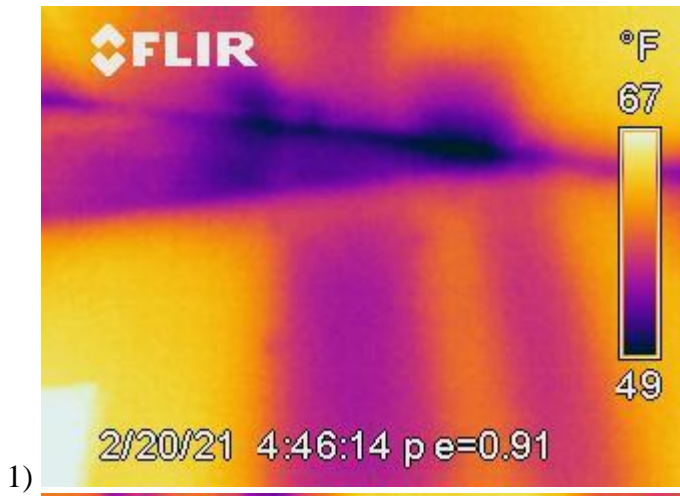
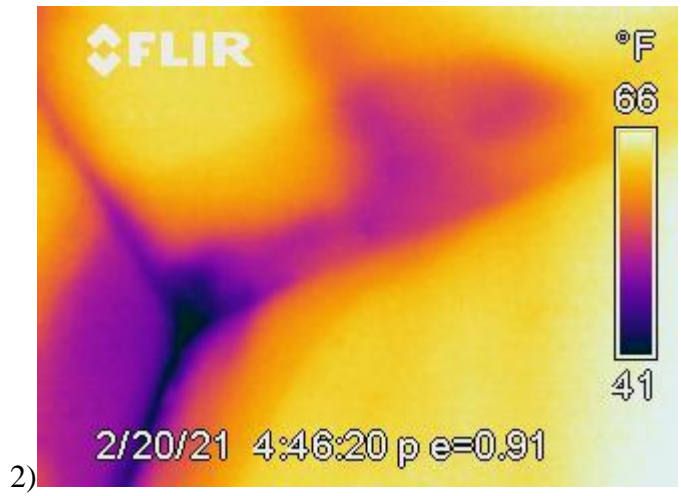
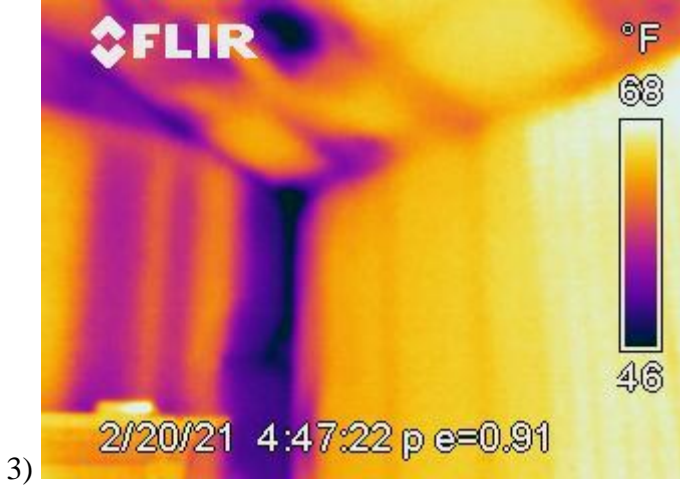
These three thermal images were taken during the emergency service call. The thermal images are date stamped. Heavy build up of water running down wall bays and up behind the ceiling in the living room. Since there was so much remaining snow build up, we only moisture mapped the loss on Saturday 2/20.

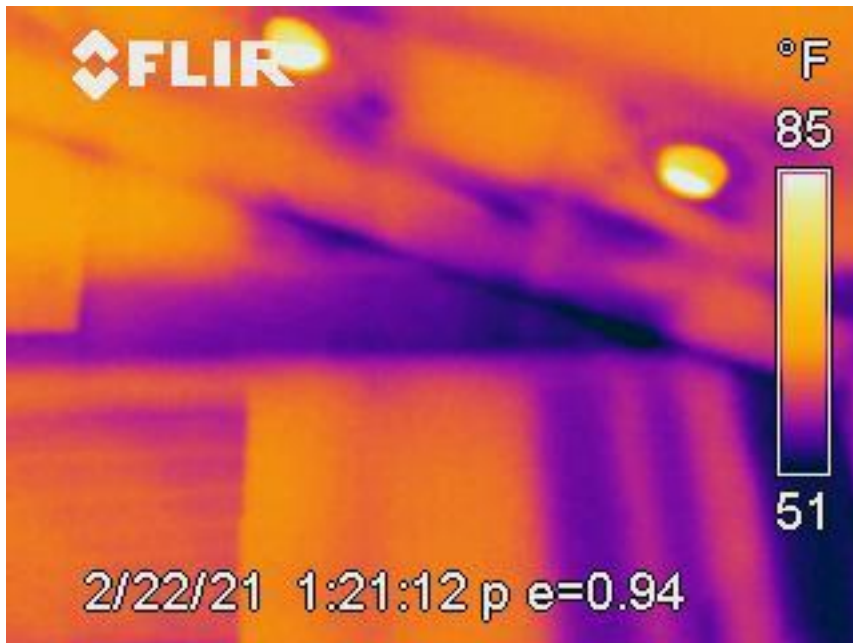
This thermal image taken as per date stamp on 2/22/2021

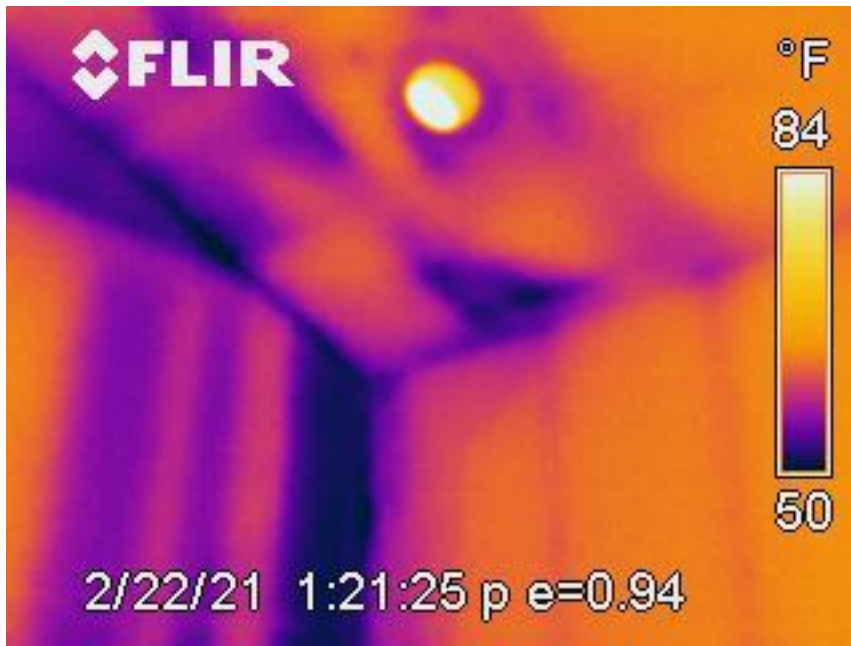
Water accumulation at the bottom of the ceiling slope and in the affected wall bays as shown.

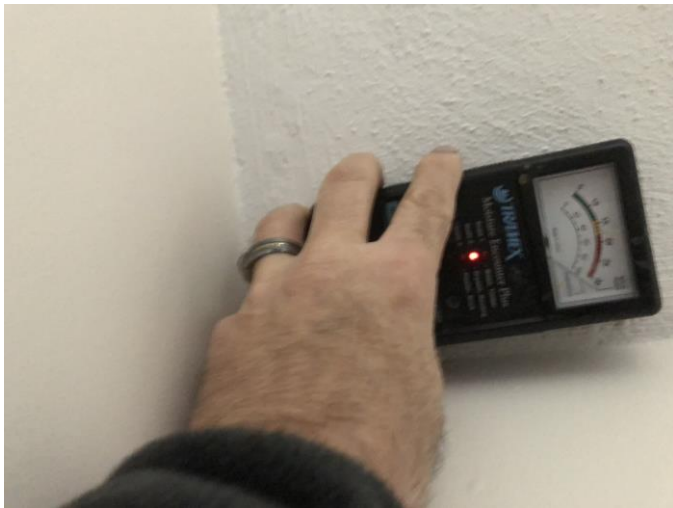
Water in ceiling 2/20

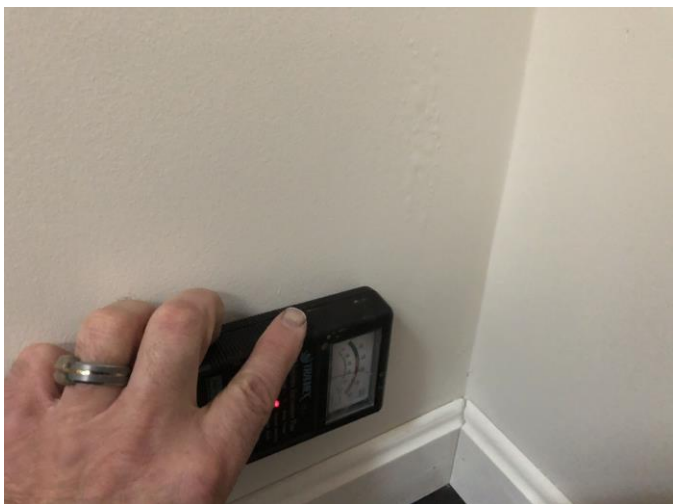
Water in stud bay on fireplace wall 2/20

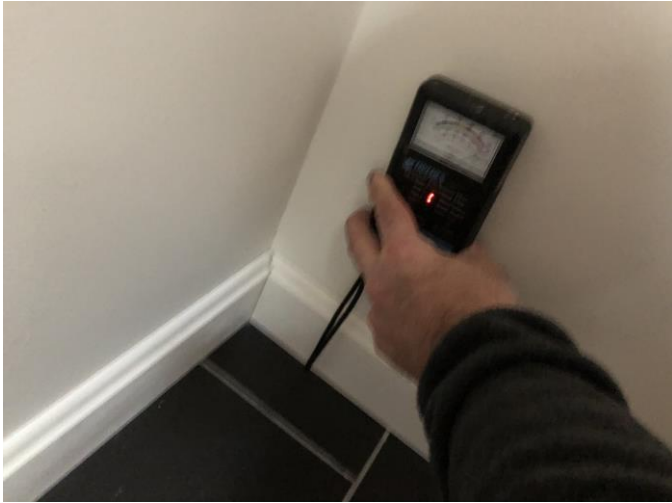
Water in wall bays on rear wall of great room 2/20

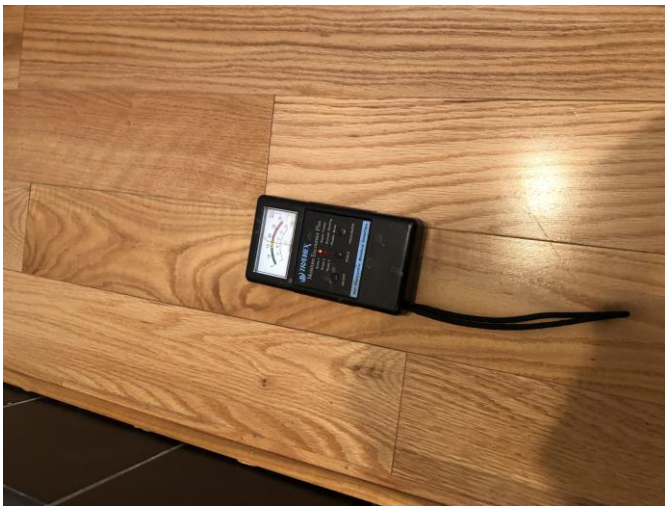
Water under engineered floor in front of fireplace 2/22

Floor area repairs will be needed in an 8-10 square foot area near fireplace. Minor amount of finish carpentry will be performed. Wall repairs will be required with extensive paint work, for which some staging will be necessary to reach 15'4" sloped ceiling height.

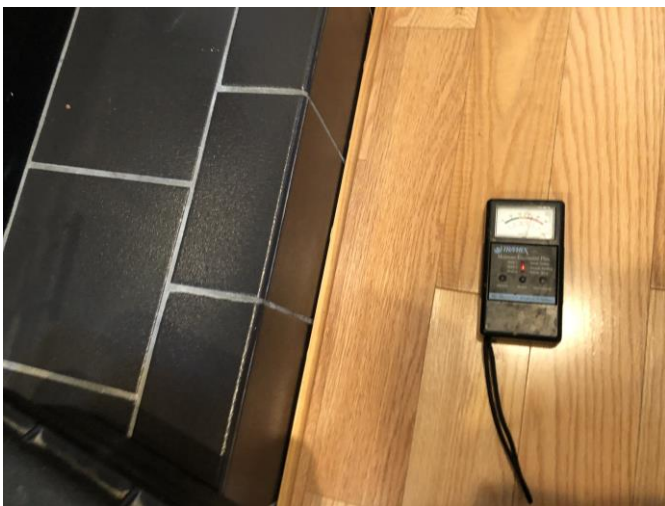
The water has run 4-5 feet under the clear grade engineered oak 2/22/21

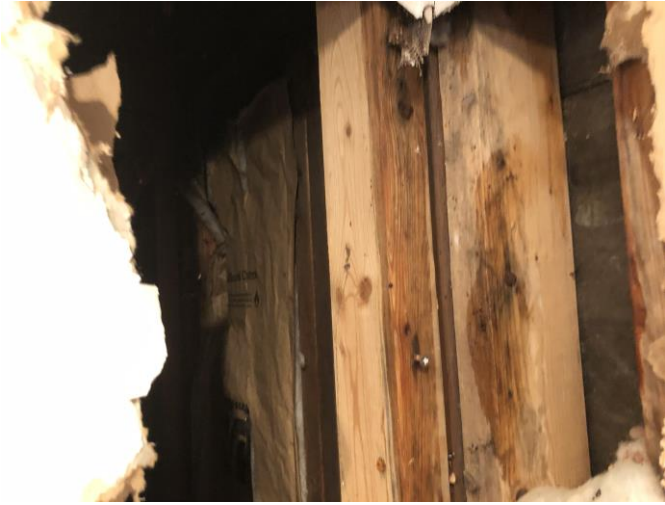
Active water photographed upon opening wall bays to the right of the chimney chase

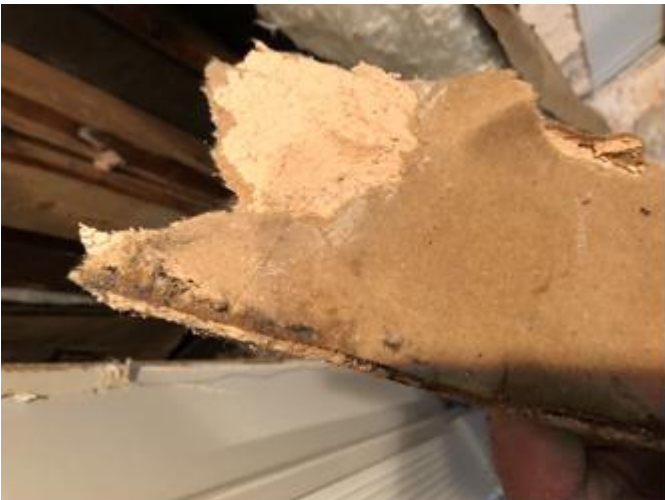
Some suspect mold presence on drywall

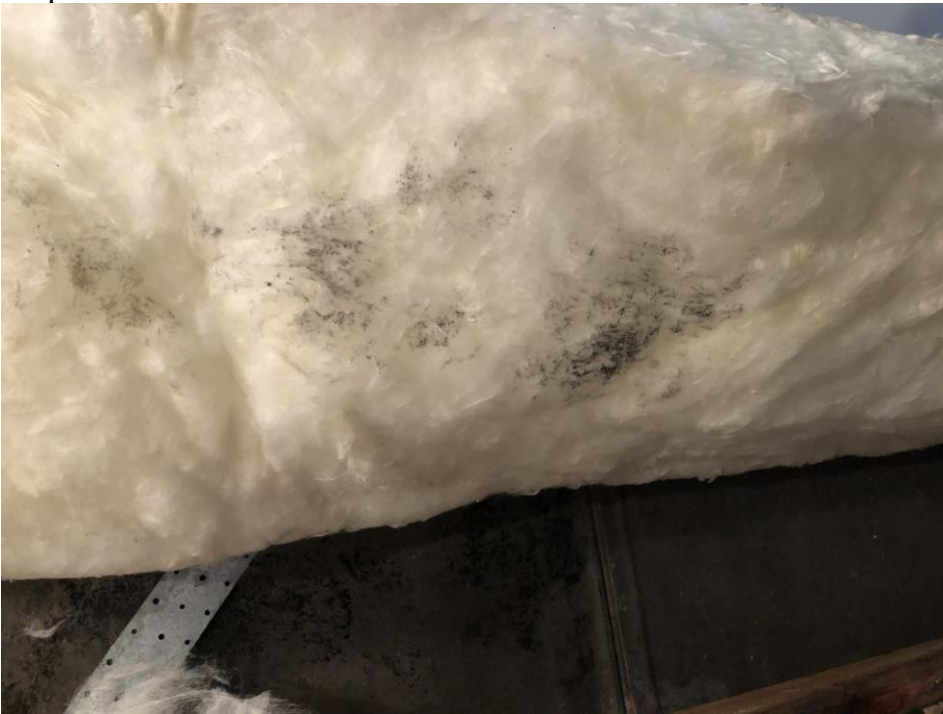
Suspected mold colonies on the back of the insulation

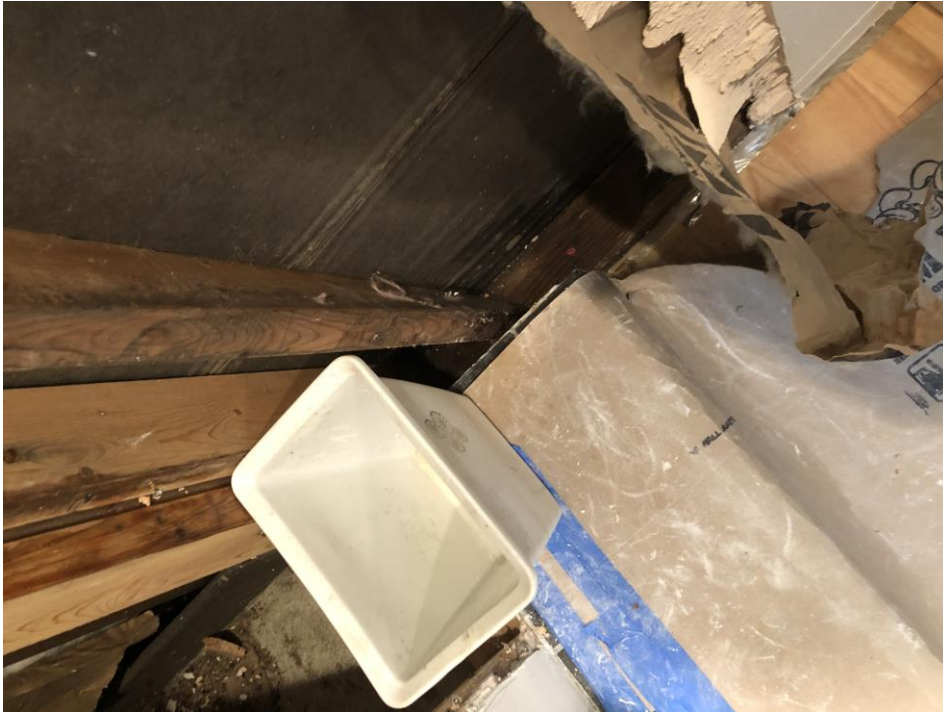
Water falling from ceiling into receptacle – 2/22/2021

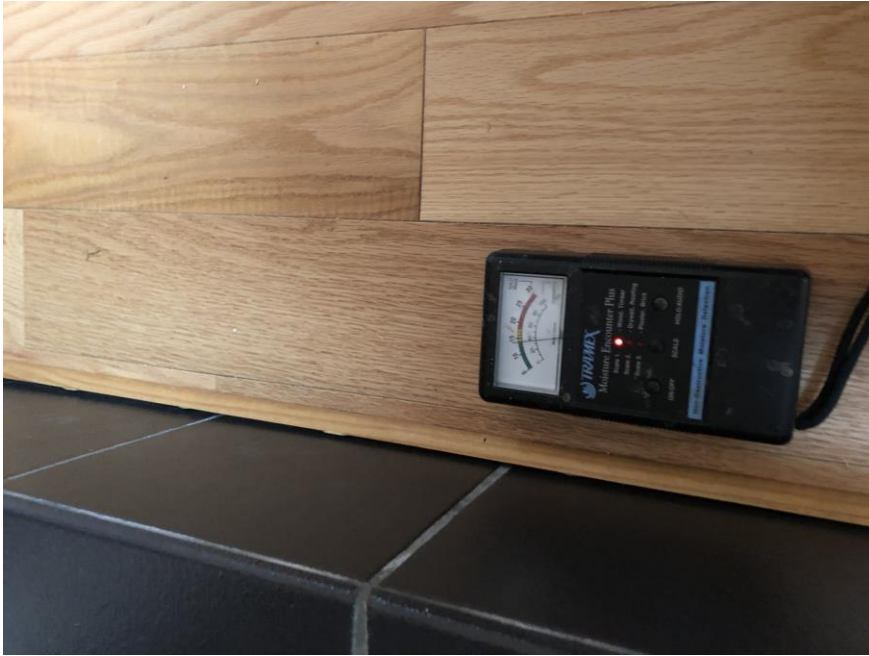
2/27/2021 – Removed dehu and floor drying equipment with normal wood material moisture content typical in New England in winter months.

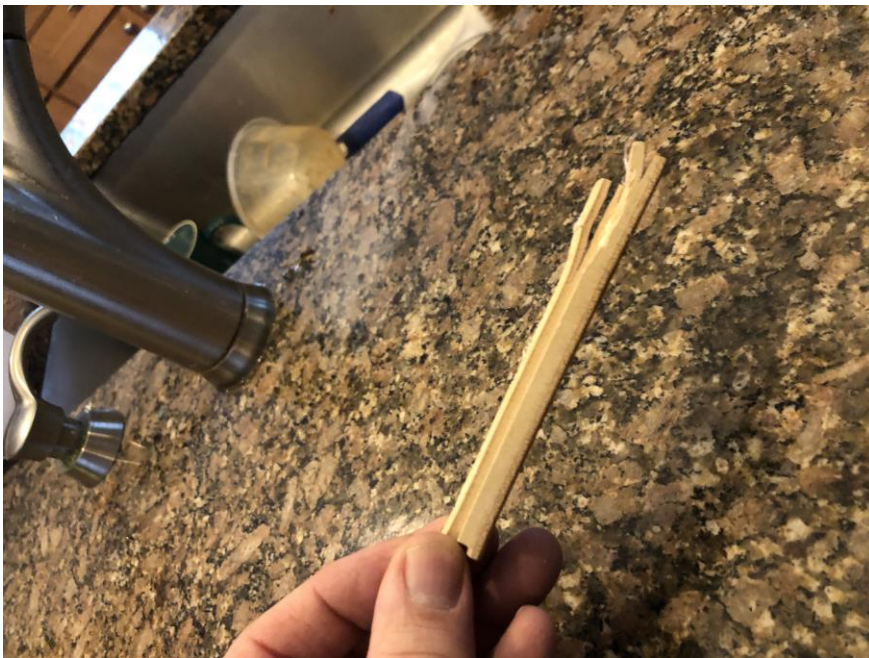
5-Ply Oak engineered flooring, clear grade. There will be a small area of engineered floor that needs replacement. Under 10 square feet.

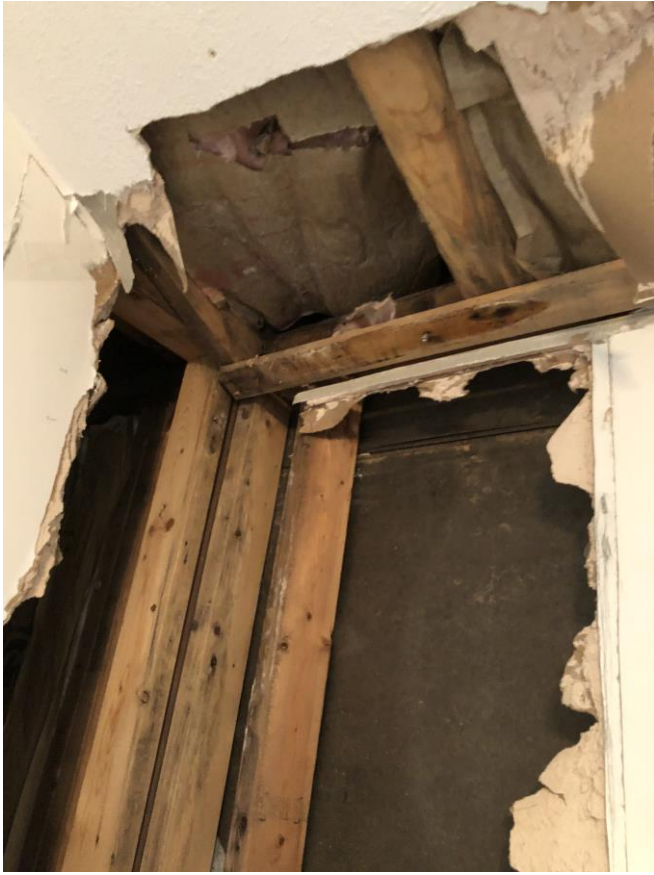
With the engineer floor finally dry, we opened ceiling to find additional mold conditions. These conditions were expected, which is why no fan drying was done on this job.

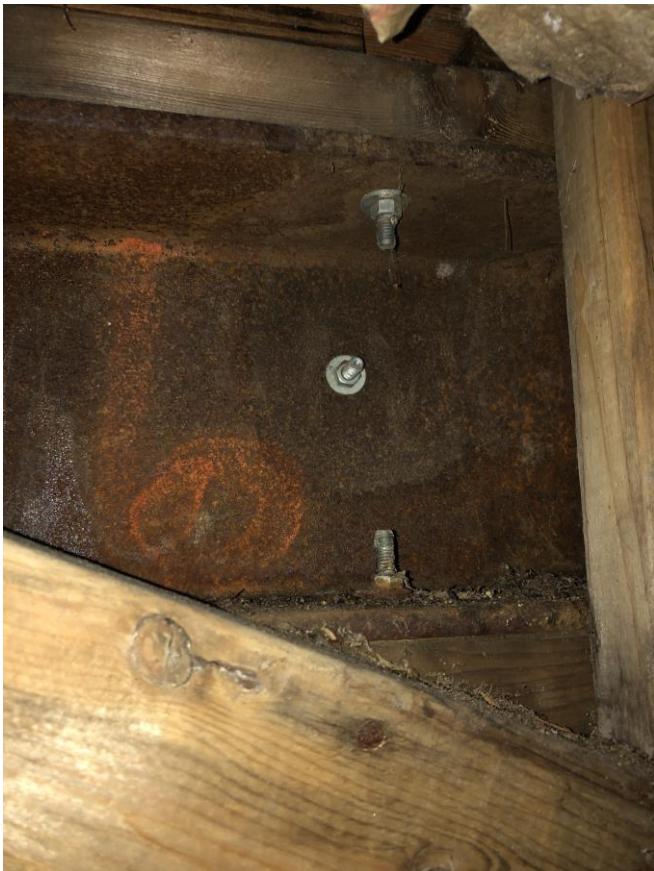
Steel beam structural component – no insulation. Also more evidence of fungal staining.

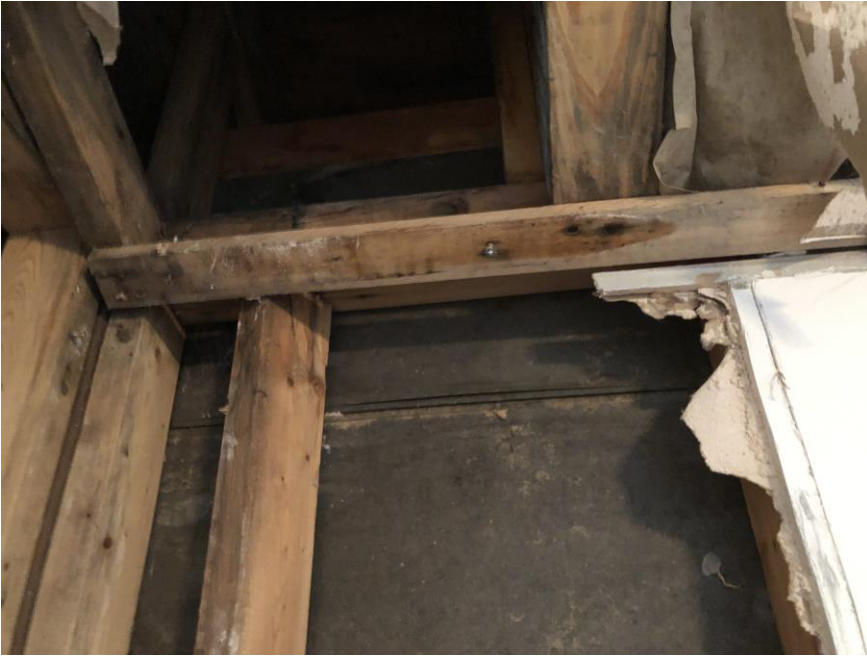
Furring for wall board is stained and wet in this area. 2/27/2021. Ambient drying will occur here. Snow is melted from roof top, and a tarp set up by the association was placed.
