ADVOCATE DESIGN/BUILD & CONSTRUCTION, LLC

Comments and conclusion

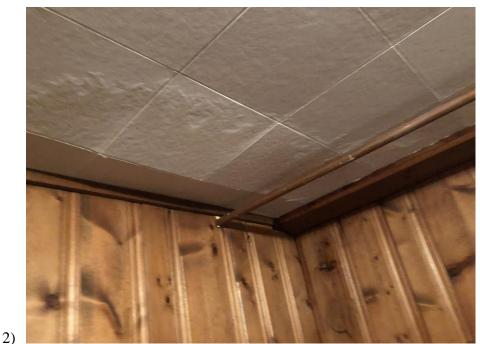
Customer found wet carpet in basement and saw water (still dripping down) to walls from above the acoustic ceiling.

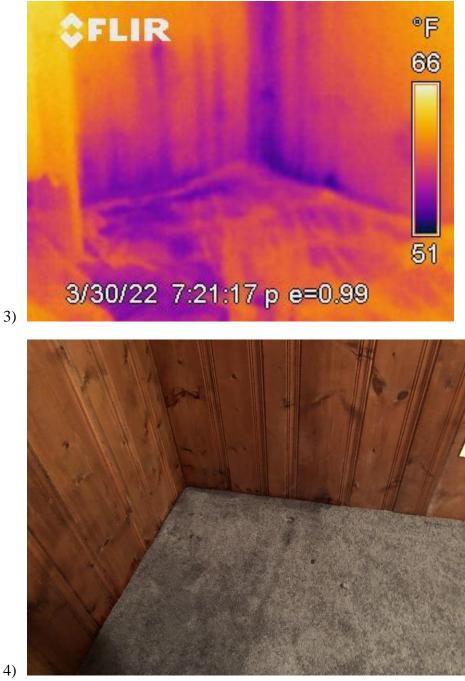
Heavy amount of accumulated water absorbed into wall framing plate and knotty pine walls as well as carpet and pad.

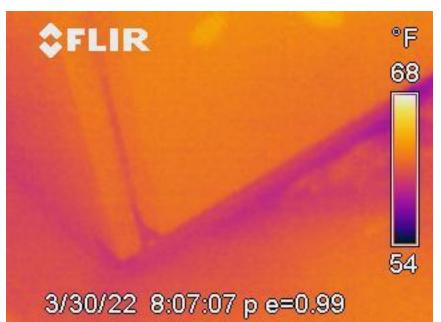
Last basement image at emergency response to site.

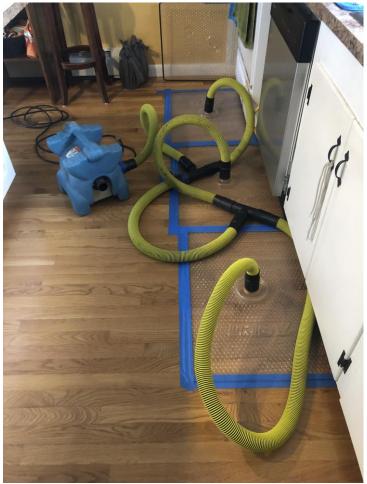
13)#12) Kitchen image at emergency response#13) Hardwood floor drying equipment placed the next day, 3/31/2022

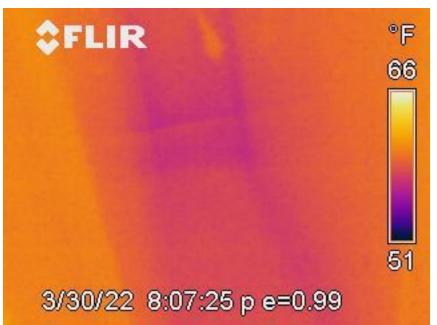
14) Image taken is the area between the stove and the cabinet end panel that separates the dishwasher in the kitchen.

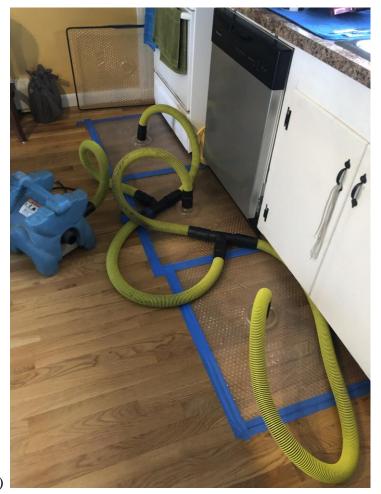
15)

Kitchen floor drying.

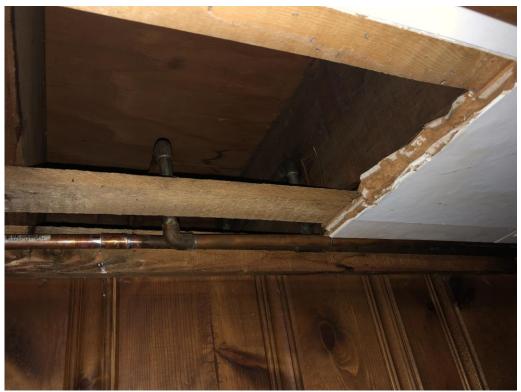
Per homeowner's plumber, kitchen main feed had a leak. Lines only capped at the time of our monitoring visit 3/31/2022.

As per caption under image 16, plumber found the leak. Insured's shut off water main upon finding the standing water, we responded that evening.
