NOREASTER DISASTER RESTORATION, LLC

Property Owner: xxxxxxx Dental, xxxxxxxx, xxxxxxxxxxxxxxxxxxxxxxx, RI xxxxxxxx Date Taken: 2/4 and 2/5/2015

CONCLUSION & COMMENTS

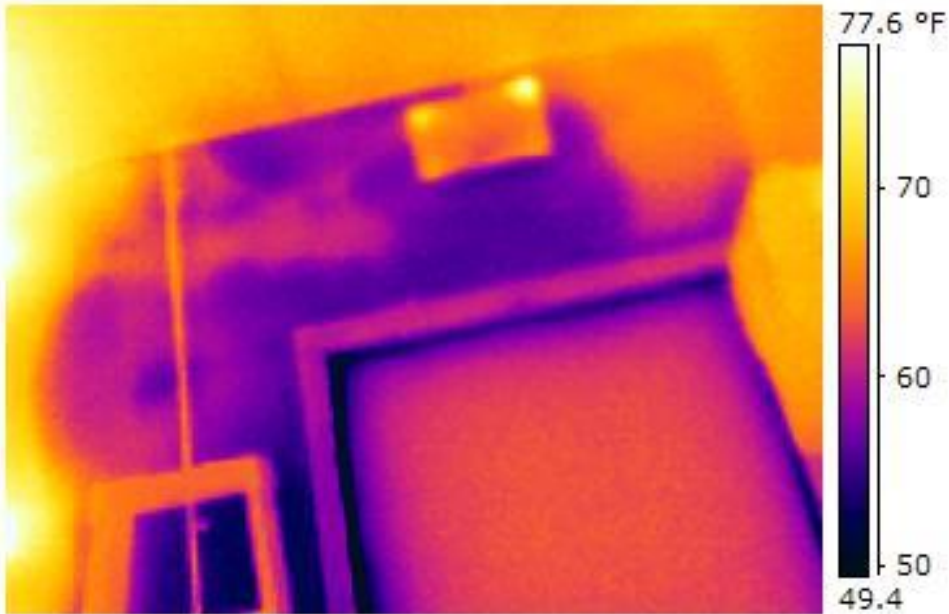
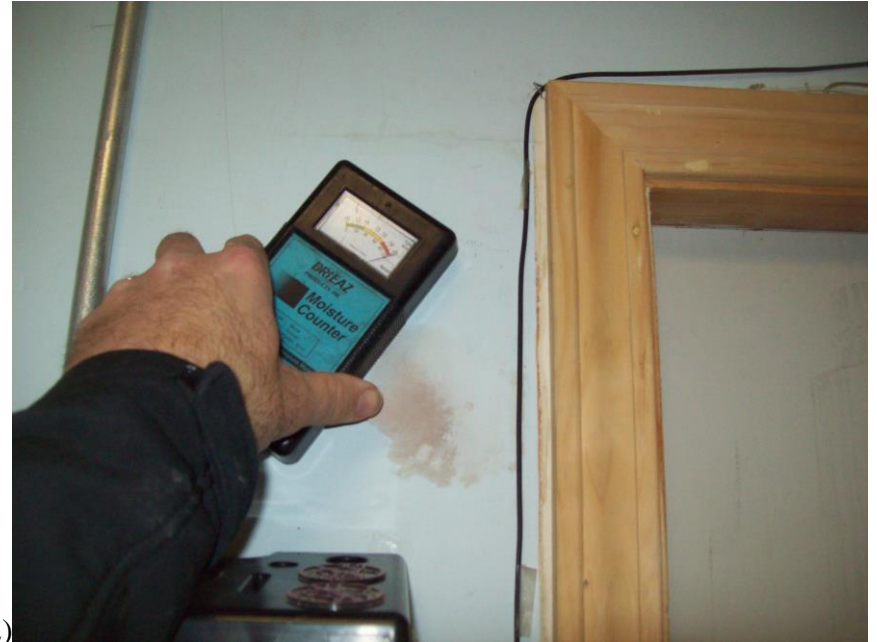
1) Images 1 and 2 are in the utility area at the dental office – heavy water penetration.

Loss called in to Noreaster on February 4 , 2015 citing water damage due to ice dams allowing water to penetrate this condo unit.

THIS IS AN INTERIM REPORT – We obtained these images at the time of initial equipment setup at about noon on 2/4/15. ON THE MORNING OF 2/6/2015, we will be returning to monitor progress, but will in all probability need to add a wall cavity drying system to the bathroom and corner office, at which time we will obtain more images, as well as measurements to get a reconstruction estimate.

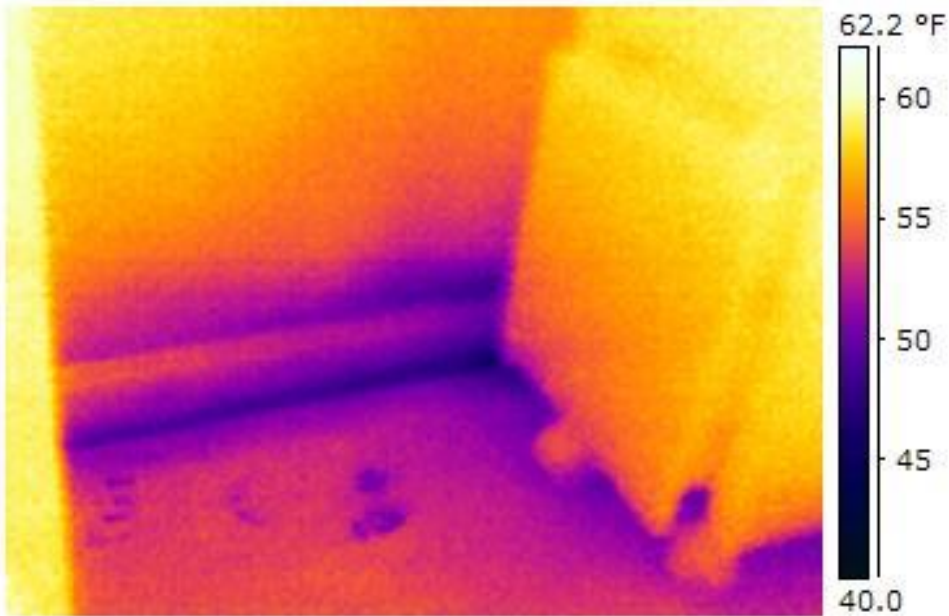
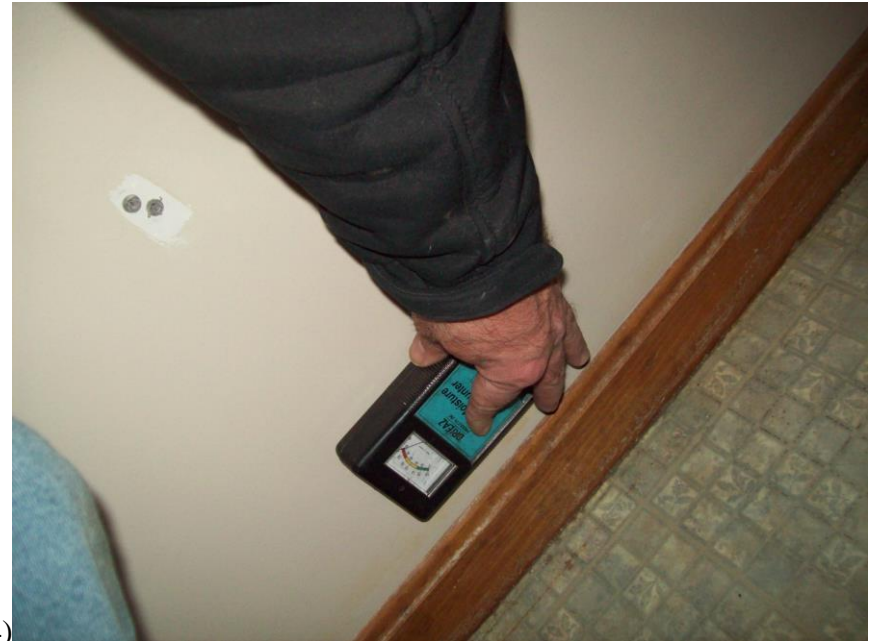
3) Images 3 and 4 are the common wall to the utility area in the employee bathroom– again the moisture meter is at maximum saturation readings

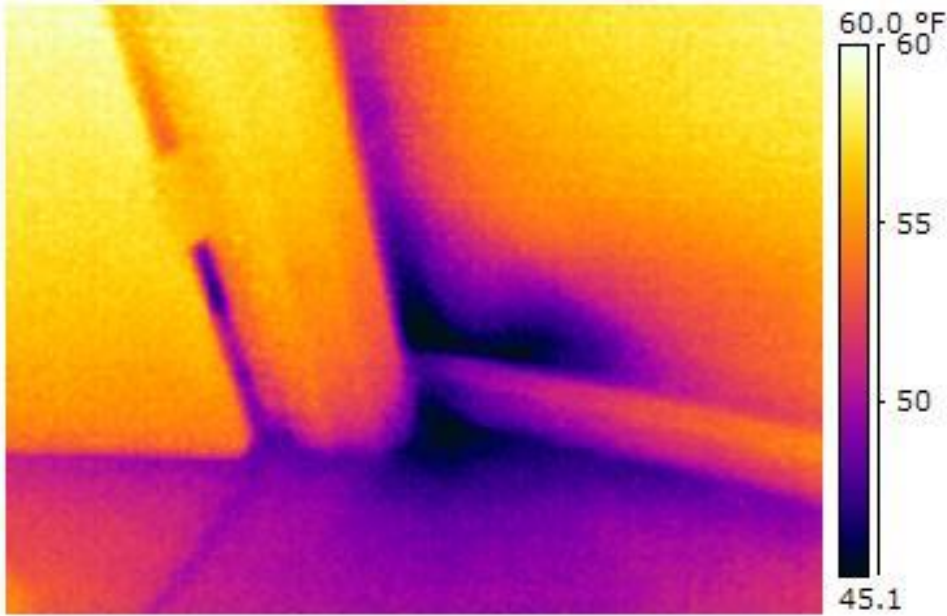
5)

Images 5 and 6 show the wall to the corner office common exterior shared to the bathroom shown in images 3 and 4.
