NOREASTER DISASTER RESTORATION, LLC

Property Owner: xxxx xxxxxxxx, xxx Farm Street, Blackstone, MA 01504

Taken: 2/1/2015 and 2/3/2015

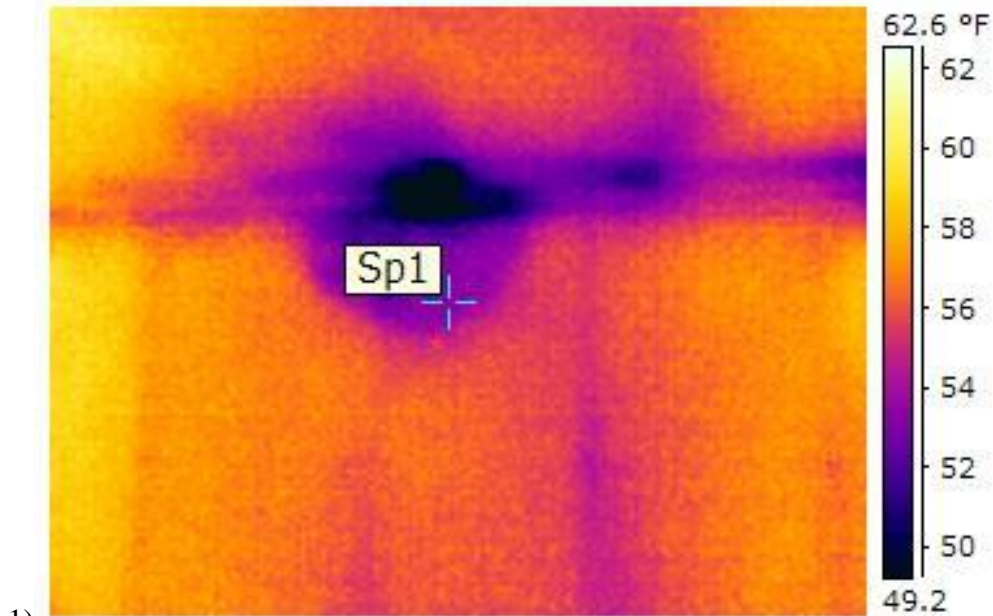
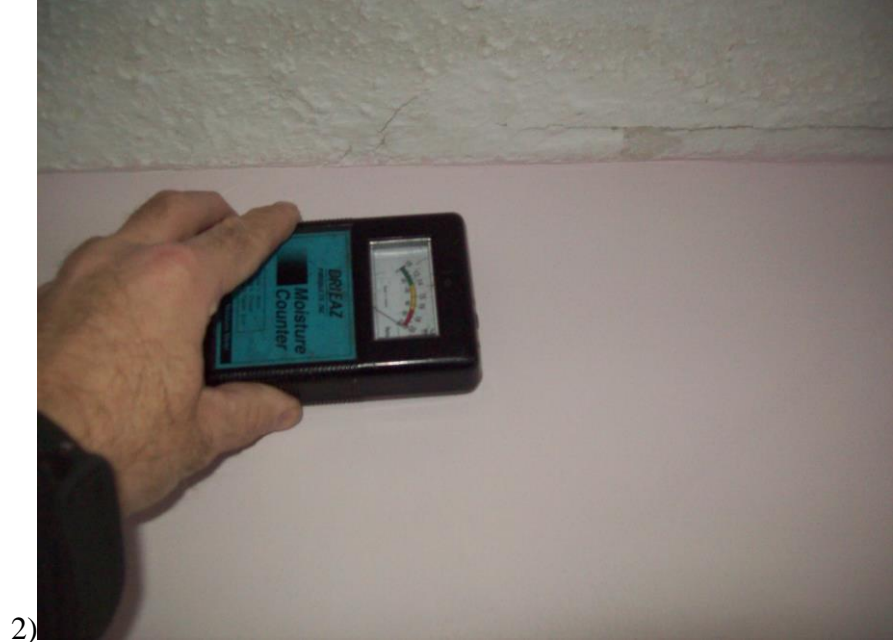
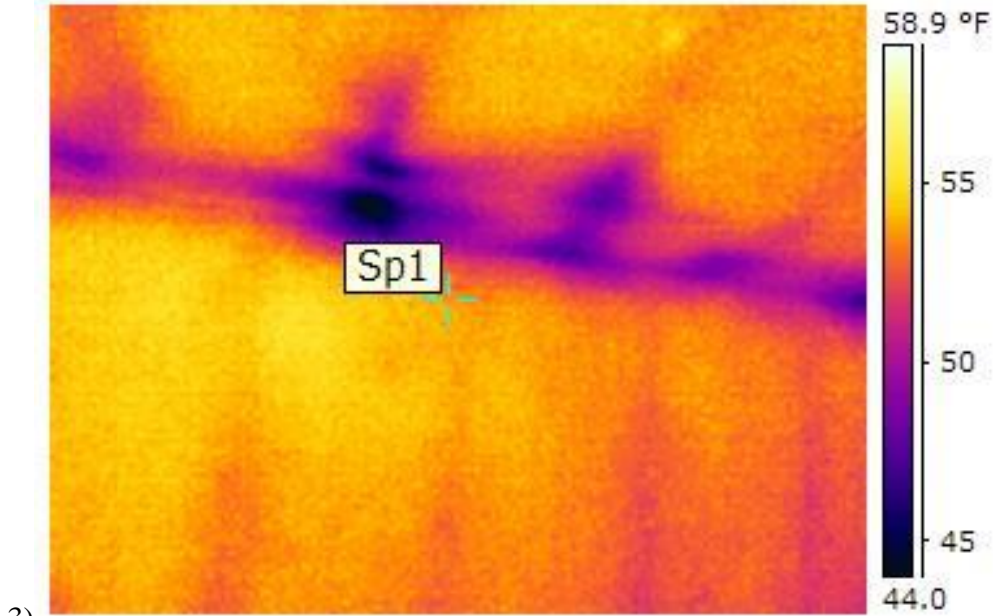
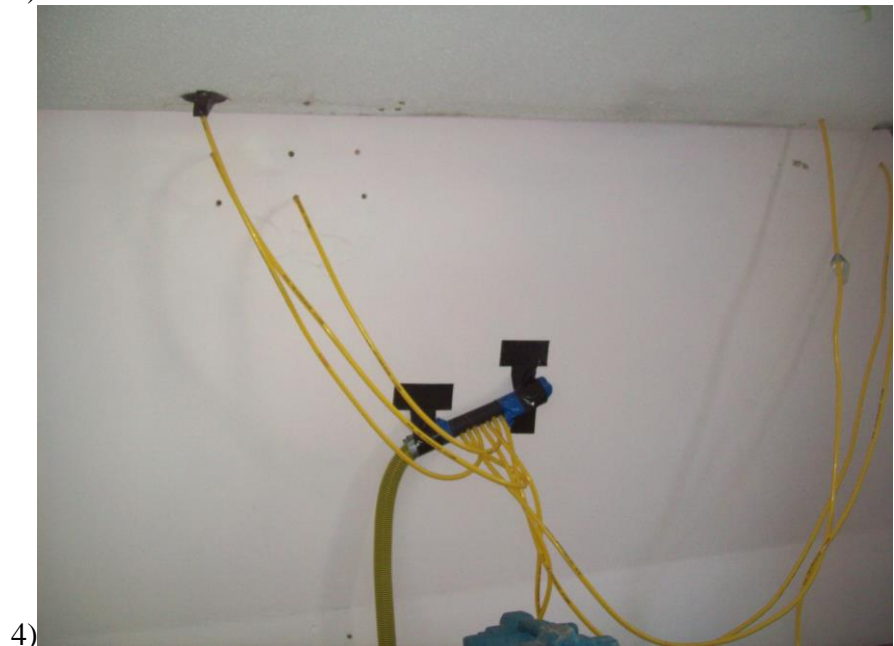
These images are in the second floor bedroom/office area where leak through the ceiling and walls first was noticed by the homeowners.

Loss called in to Noreaster at February 1, 2015. Some contents needed to be removed from areas in the upstairs room shown in images 1 -6 to allow equipment setup on the second floor. We were contacted by Ms. xxxxxxxx that she was getting a lot of additional water on Tuesday 2/3 and it now appeared there was water coming in to the kitchen. **THIS IS AN INTERIM REPORT – THE INSURED’S INSURANCE ADJUSTER AND ROOFER ARE ALL MEETING AT THE PROPERTY THE MORNING OF 2/4/2015.**

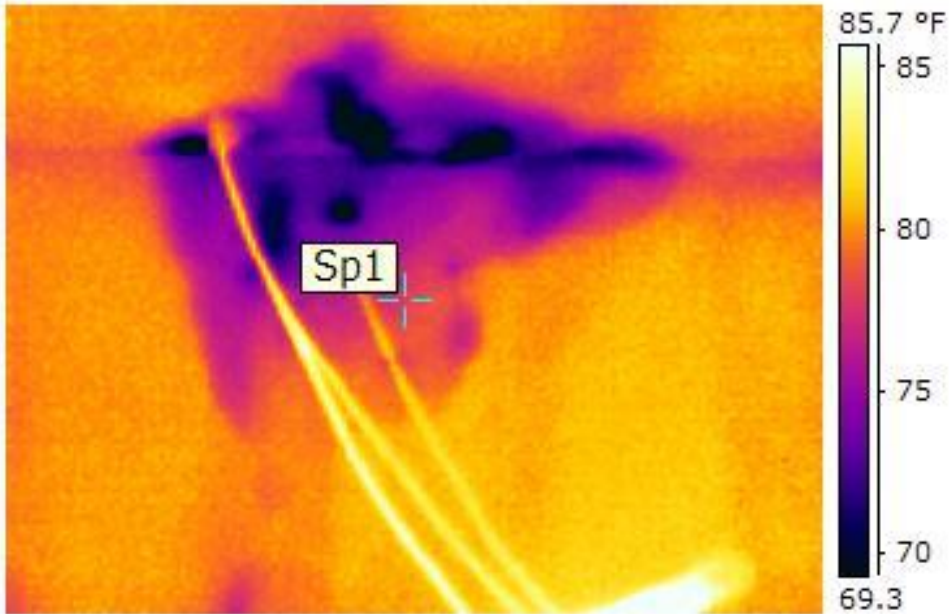
5)

These images were obtained on February 3, 2015 – despite the removal of snow & ice prior to our original arrival date Sunday 2/1/15. The damage is increasing with additional melting.

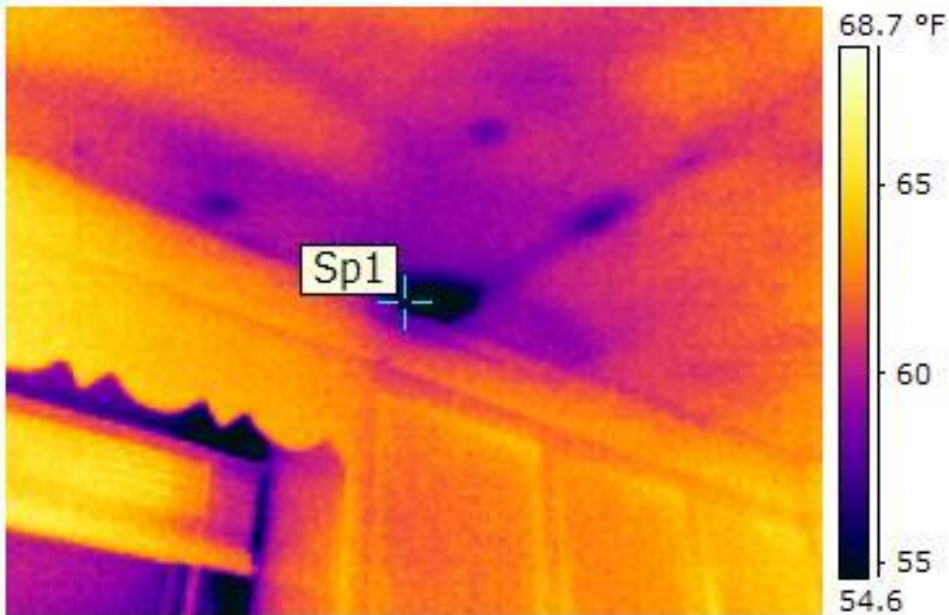
7)

The homeowner is now observing more water entering the structure, affecting the kitchen ceiling shown in images 7 and 8.
