# NOREASTER DISASTER RESTORATION, LLC

Property Owner: XXX XXXX XXXXXXXXXXXX, North Smithfield, RI 02896

Taken: 6/1/2014

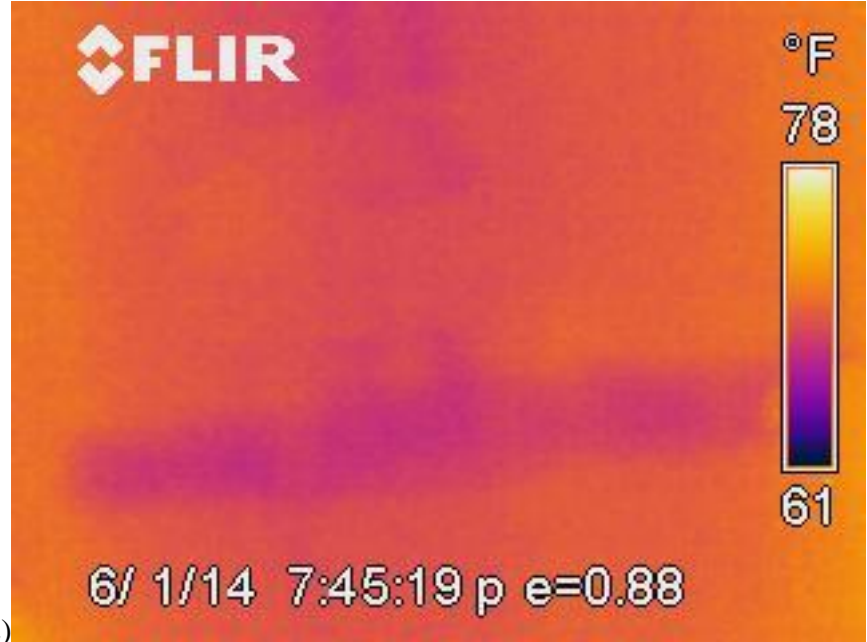
3) Water from the ceiling absorbed in the wall below the toilet and then migrated across the ceiling into the wall common to the staircase.

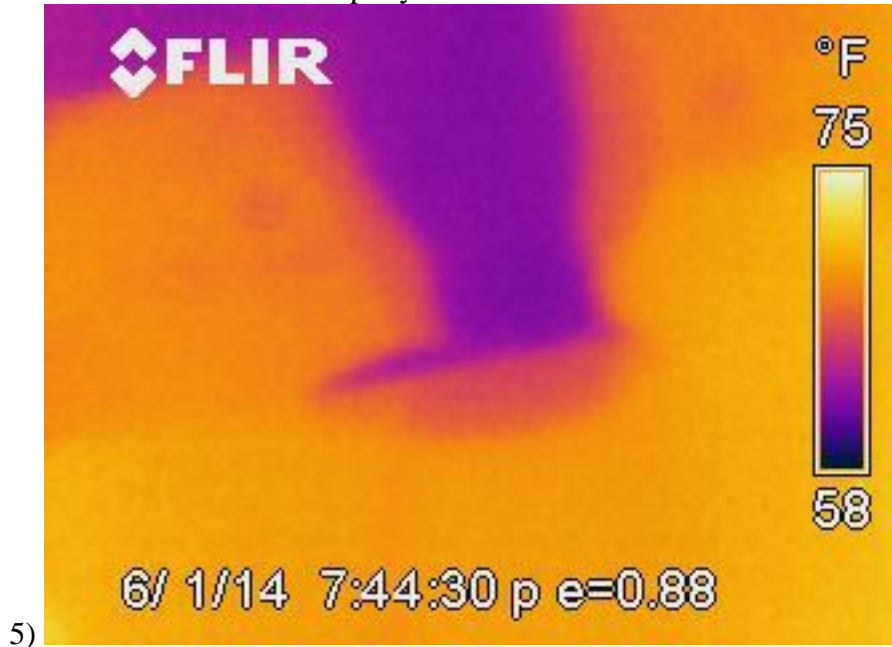
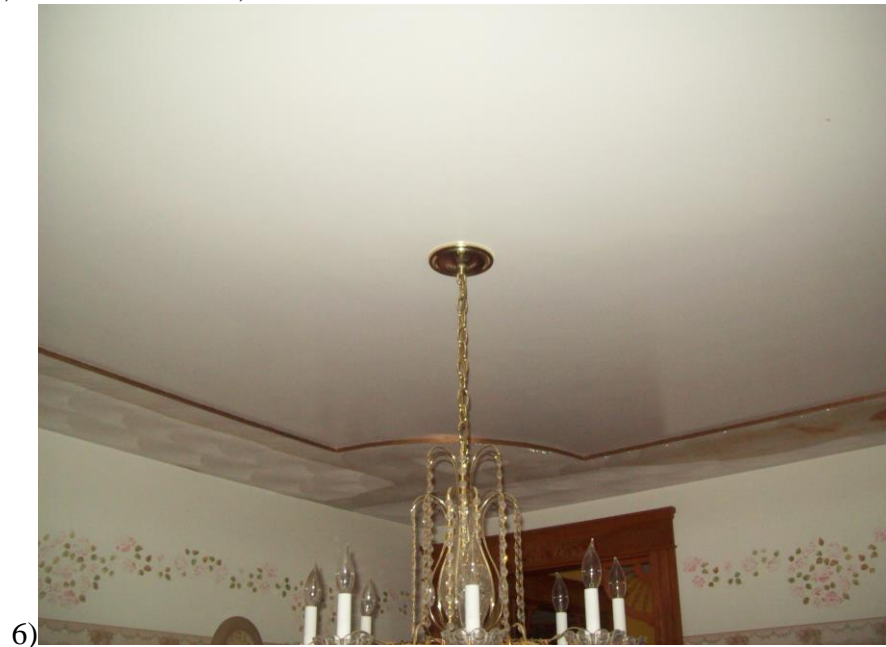
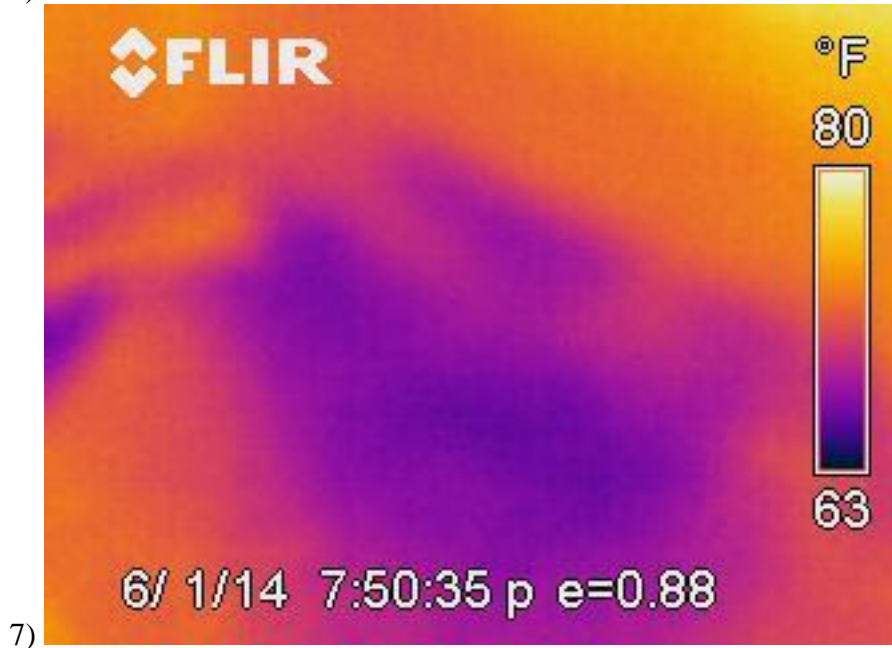
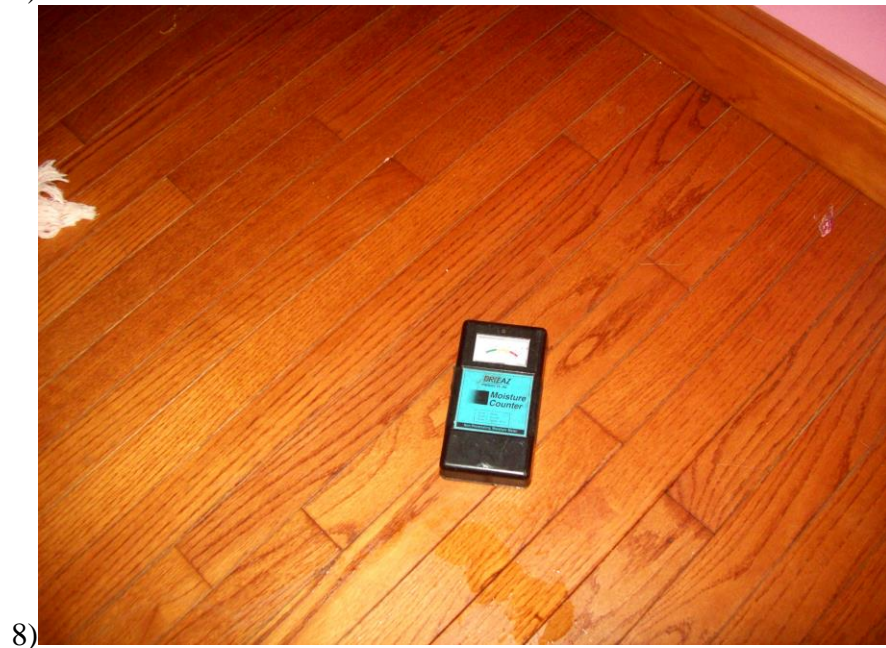
Leaking second floor toilet feed was shut off by the occupants prior to Noreaster's arrival at the loss. Images were obtained in the second floor bathroom where the loss originated and in the formal dining room below it on the first floor.

We believe the floor and the walls in the dining room will respond to the drying techniques - simple patching of drying access holes in the walls and sand/refinish the floor, which extends continuously to the adjacent hall and office area.
