NOREASTER DISASTER RESTORATION, LLC

Property Owner: xxxxxx xxxx, xxx Bedford Circle, Narragansett, RI 02882

CONCLUSION & COMMENTS

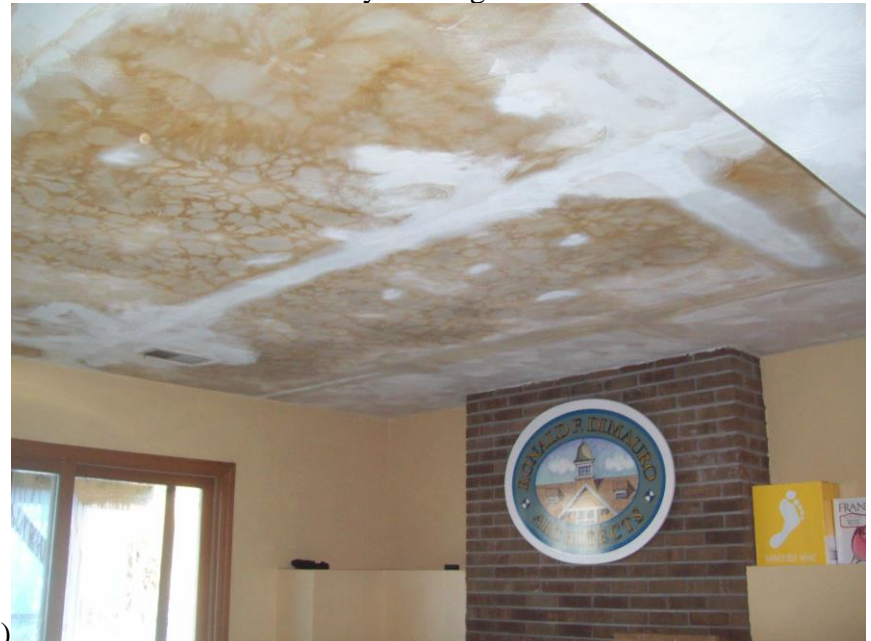
8)

Lower level images - The entire globe of this light was filled with water and this is the ceiling in the family room.
