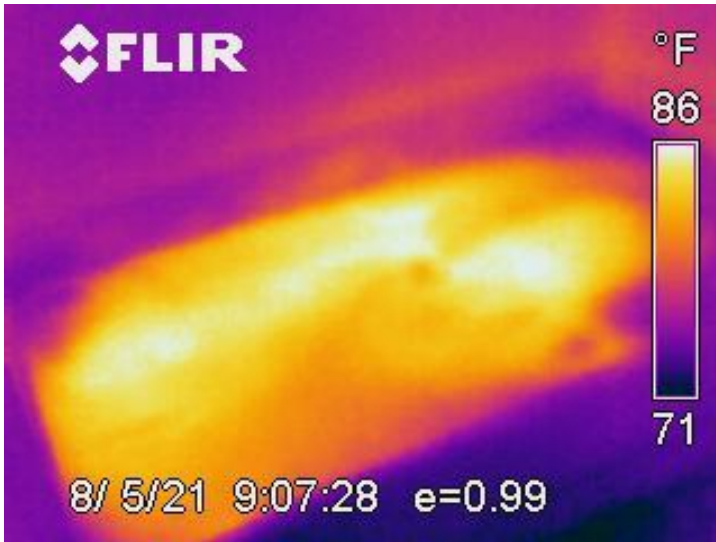
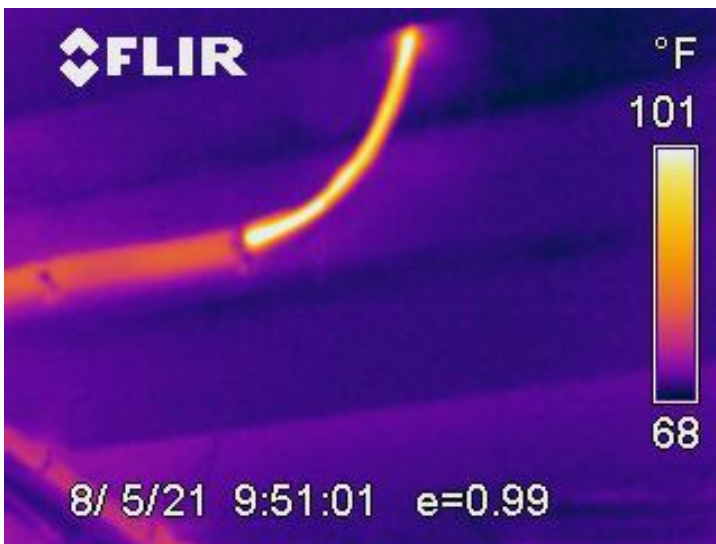
CLIENT REPORTED INSULATION FELL OFF THE UNFINISHED BASEMENT CEILING AND THERE WAS WATER ON BASEMENT FLOOR. THEY COULD NOT PINPOINT THE LEAK. IT TOOK ADVOCATE TWO MINUTES TO DETERMINE IT WAS THE FIRST FLOOR SHOWER MIXING VALVE – NOTE ON THERMAL IMAGE 3 THAT HOT WATER IS RUNNING OUTSIDE THE PEX HOT WATER FEED***
